WURDEE BULOC INLET CHANNEL FAILURE

Barwon Water

*78th Annual WIOA Victorian Water Industry Operations
Conference and Exhibition
Bendigo Exhibition Centre
1 to 3 September, 2015*

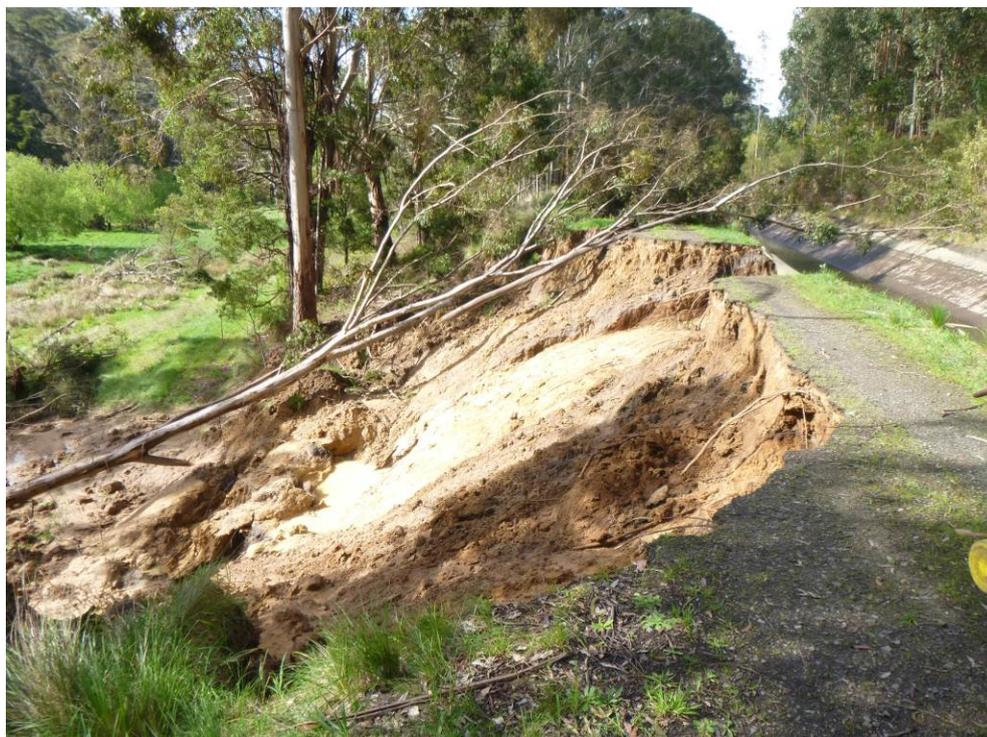
Figure 1: *Wurdee Buloc Inlet Channel Embankment Failure*

On the 8th October 2014, a steep section of the WBIC embankment slipped, rendering the channel inoperable. The failure was attributed to several factors but principally due to a blockage of a downstream trash rack. The blockage caused water to bank up and eventually overtop the channel, undermining the embankment.

On 8th October 2014, a significant embankment land slip occurred approximately 300m upstream of the Kings Syphon. The failure was the result of a blockage of the downstream trash rack, causing water to bank up and eventually overtop the channel and undermine the embankment.

A risk / cost analysis was undertaken comparing options to either repair the failed section of the embankment and reline the concrete channel or pipe approximately 700m with 2,000mm, fibre reinforced glass (FRG) pipe. As past rehabilitation attempts of the WBIC have only been moderately successful and given the poor structure condition of the embankment, piping was determined the better long term option.

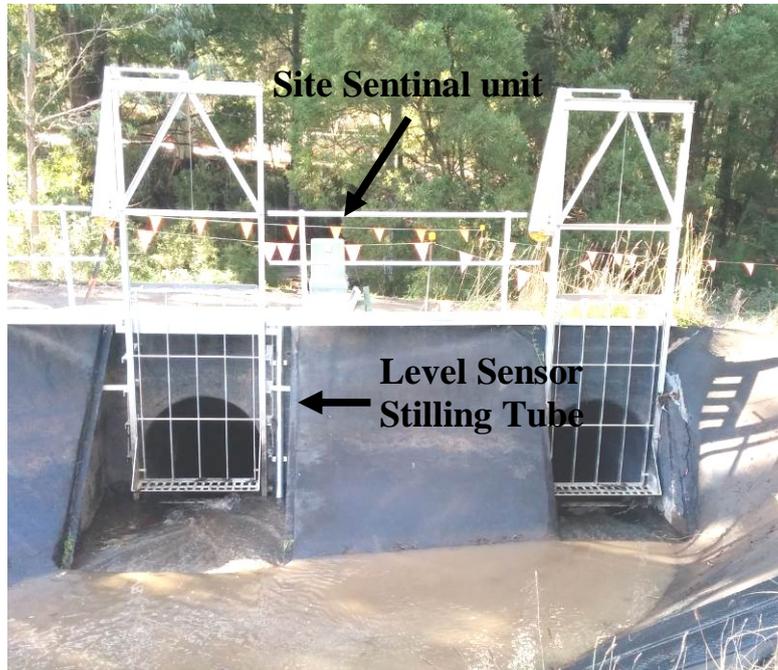
Figure 2: *Lynchies Syphon*

"Live" monitoring of the WBIC has been achieved through the installation of hydrostatic level sensors at four strategic sites. The level sensors are solar powered with a battery back-up. Via Remote Terminal Units (RTU's) they are able to transmit channel level data every 15 minutes to Barwon Water's SCADA system. A "site sentinel", which uses a sim card to transmit data to Barwon Water's SCADA system, was employed at one site (Lynches Syphon) as an RTU could not be economically installed.

Multiple alarm set points (Low, Low-Low, High and High-High) have been established to alert Operators of any abnormal water levels in the WBIC. These set points have been validated in the field by measuring free-board for each alarm level set point.

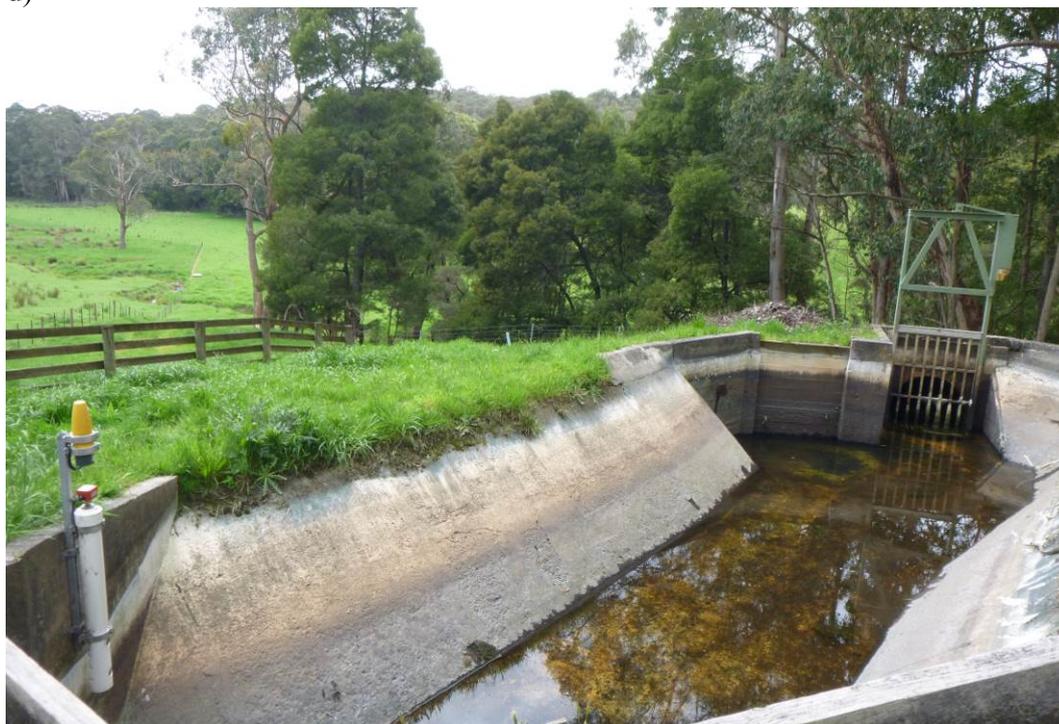
Figure 4: *Old King's Syphon Trash Rack & Blok-aid*

Barwon Water is currently reviewing the design, location and maintenance practices of trash racks servicing the WBIC. There are presently trash racks upstream of each of the syphons, however in most cases they vary in design. Work is underway to standardise designs and ensure they are fit for purpose, specifically:

- a) Determining the appropriate barrier / screen aperture and configuration to reduce the risk of syphon blockages by catching large debris but also minimising the potential for trash rack screen blockages by allowing small debris to pass through.
- b) Consider the introduction of controlled overflows / by-passes at selected locations (where upstream channel embankment failures may occur).
- c) Minimise manual handling associated with maintenance (ie. cleaning debris from the trash racks) through the use of winches and improved design.
- d)
