# KNOW YOUR SEWER- CORROSION PROTECTION OF SEWER ASSETS

**Nitin Apté**, *Business Manager Spray Slurry,*

*78<sup>th</sup> Annual WIOA Victorian Water Industry Operations  
Conference and Exhibition  
Bendigo Exhibition Centre  
1 to 3 September, 2015*

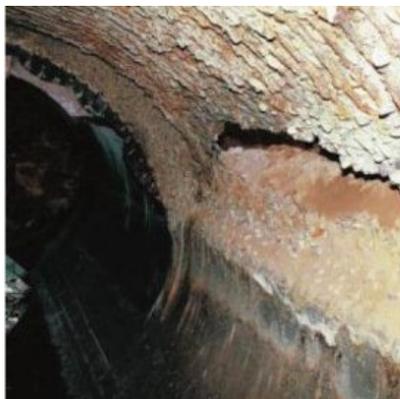
**Figure 2:** *Sewer Line Corroded by Acid Attack*

Stricter pollution laws have stopped dumping of industrial waste and poisons in the sewer system. In the past these wastes would counter the sulphur in the sewage keeping the H<sub>2</sub>S and thus acid levels low. In addition our eating habits have changed over the last 2-3 decades with the food containing more sulphur. Also the detergents contain more sulphur. The combined impact of these changes in the material entering the sewer system, has been a ten-fold increase in the corrosion rate of sewer assets. Sewer assets originally designed to last 100+ years now corrode away in less than 50 yrs. Figure 2 below depict a corroded sewer line.

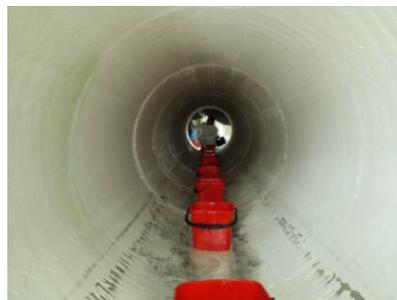
**Figure 6:** *MHL Coated Sewer Pipe*

Calix has been coating MHL from Sydney Water. In March 15, within 3 days of coating an asset, Sydney was hit with a one in 50 yrs storm event. The asset was flowing full with a turbulent flow for 3-4 days. CCTV carried out in the asset after the storm event showed that the coating was intact and without any dissolution. Photo Fig6, shows a coated sewer pipe.

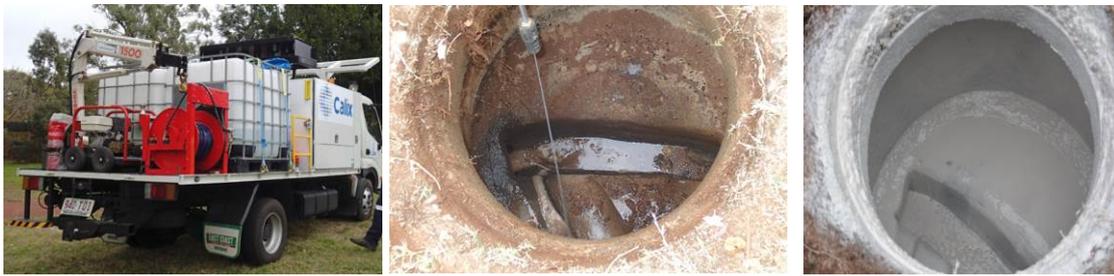
**Figure 7:** *Calix Coating Rig      Corroded Manhole      Ccoated Manhole*

Calix a developed a vehicle mounted rig that can safely, and cost effectively coat manholes with a quick turnaround time. Some of the key advantages are flow stoppage is not required, any overspray helps odour control, the base of manholes and manhole covers are also protected (fig 7 below). Also the coating is very forgiving, any damage to the coating during any riutine maintenance can be easily touched up.
