# REMOTE CONTROLLED CULVERT CLEANERS - CASE STUDY BOUNDARY ROAD COOPERS PLAINS

*41st Annual WIOA  
Queensland Water Industry Operations Conference and Exhibition  
Central Queensland University Sports Centre,  
Rockhampton  
1 & 2 June, 2016*

## ABSTRACT

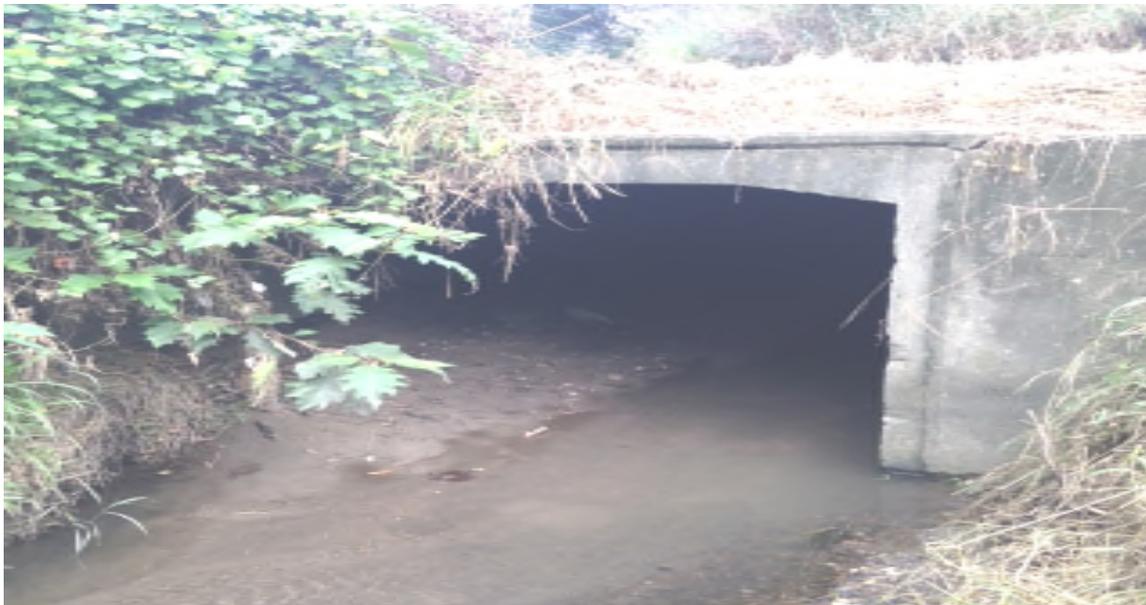
**Figure 2:**      *Culvert Headwall.*

During rain events the silted culvert at Boundary Rd caused localised flooding in the area and Council contacted Pipe Management Australia in an effort to come up with a cost effective solution for cleaning the culvert. The structure also encroached on both the Queensland Rail and The Aurizon Rail Corridors. Specific project management documents were developed by PMA and submitted and approval obtained before we were able to proceed. The culvert was estimated to contain 340 tonnes of debris which contained an amount of entrained water.

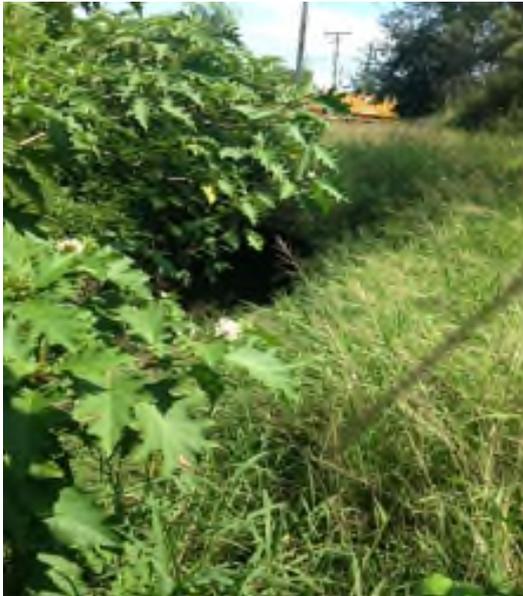
**Figure 3:**     *Overgrown Headwall.*

- Installing a 100mm trash pump used initially to remove the ponded water at the headwall which was discharged through a filtration system downstream.
- From there a sump was created at the low point where a 50mm flexdrive pump was installed to remove as much water as possible before commencing removal of the debris with the Microtraxx.
- As the outlet was overgrown slashing was undertaken to gain access (figure 3 below)
- Figure 4 below shows the outlet after slashing
- A ramp to the culvert was then constructed allowing access to the culvert (see figure 5).

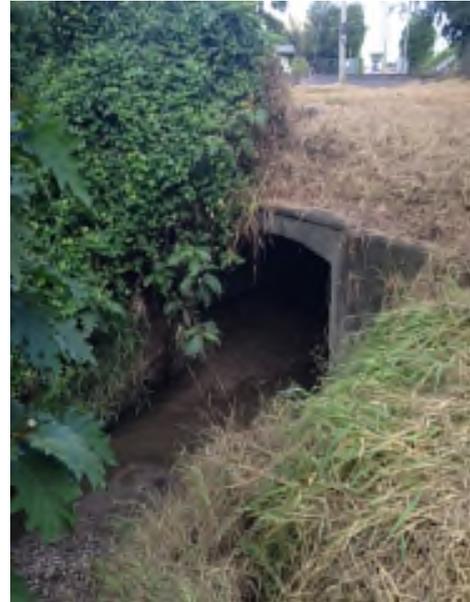
**Figure 4:**     *Headwall after Slashing.*

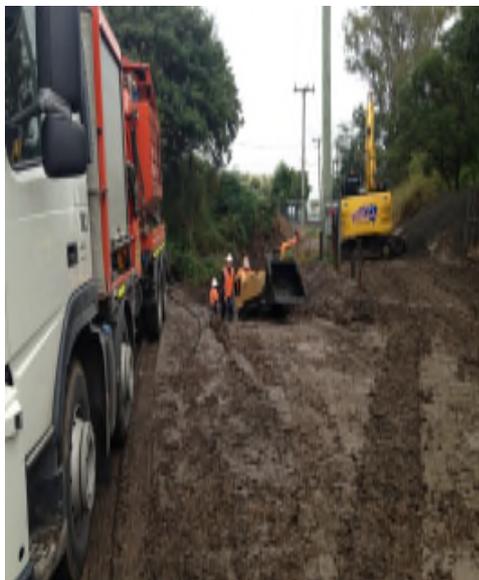
**Figure 5:**     *Access Ramp.*

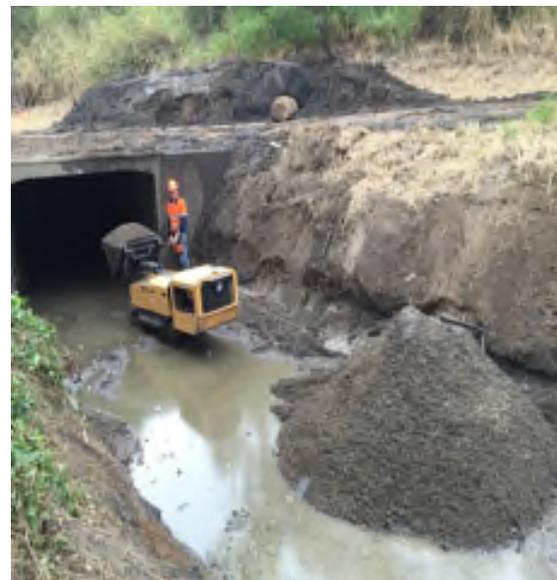
**Figure 6:**     *Microtraxx Hauling Back Debris.*

- The Microtraxx culvert cleaner was then used to remove the debris (see figure 6). The debris was removed in two ways:
  - a) Sucked up by a vacuum loader, through the access hole cut in the culvert roof, 50 metres from the headwall, removed from site and disposed of at a local landfill.
  - b) Stockpiled by the Microtraxx at the headwall and removed using an excavator and tip truck then disposed of at landfill.

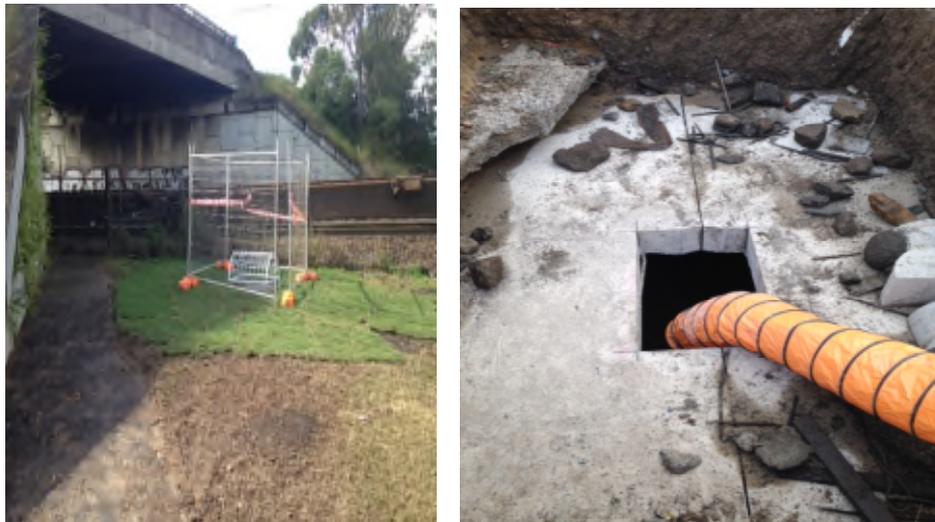
**Figure 7:** *An Access Hole Cut in the Culvert Roof During Cleaning was Converted to a Field Drain for Future Access.*

- The access pit was dug using Non Destructive Digging techniques on the other side of the rail corridor to reduce the distance travelled by the Microtraxx by some 50 metres. A hole was cut in the concrete roof of the culvert to allow the vacuum loader in (a) above to suck the debris stockpiled in the culvert at this point. This hole was then converted into a field drain for future access and to prevent the possibility of future flooding in the street (see figure 7).

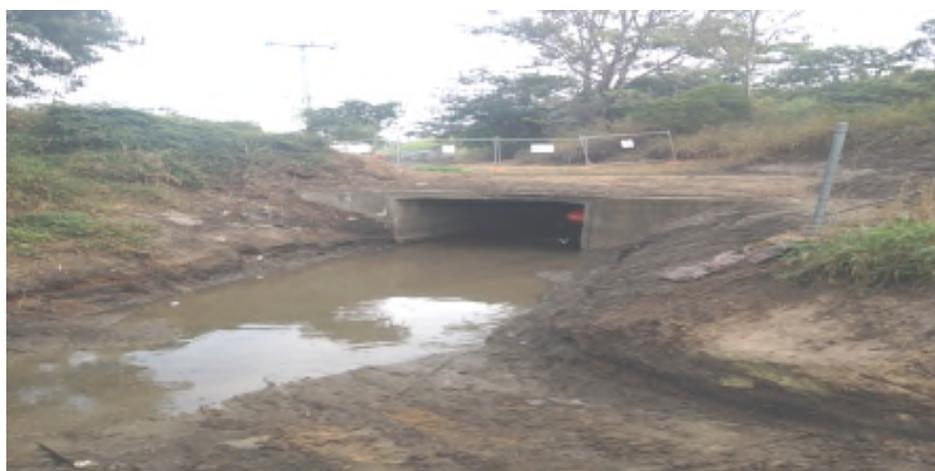
**Figure 8:** *Showing the Site During Cleaning and Access Ramp.*

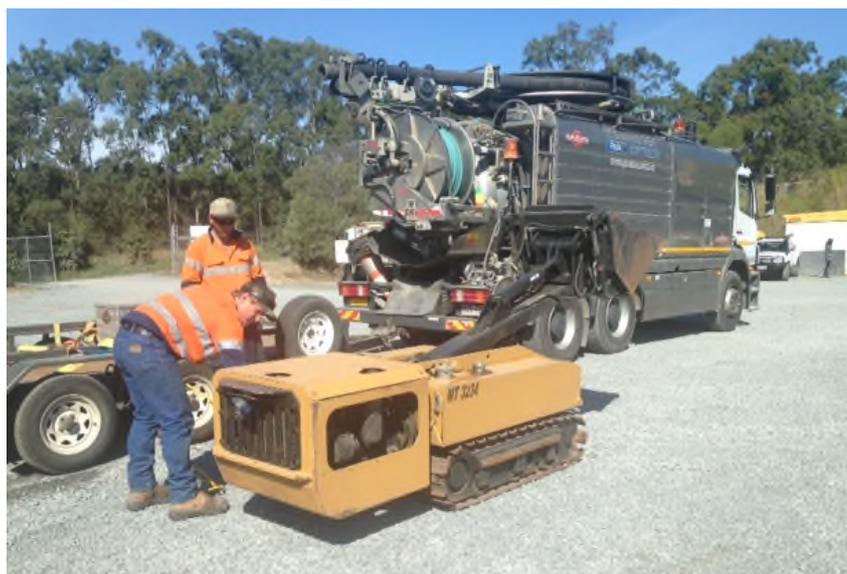
**Figure 9:** *Equipment used on site Microtraxx and Drain cleaner/vacuum truck.*
