SODIUM HYPOCHLORITE LEVEL INDICATORS

Toowoomba Regional Council

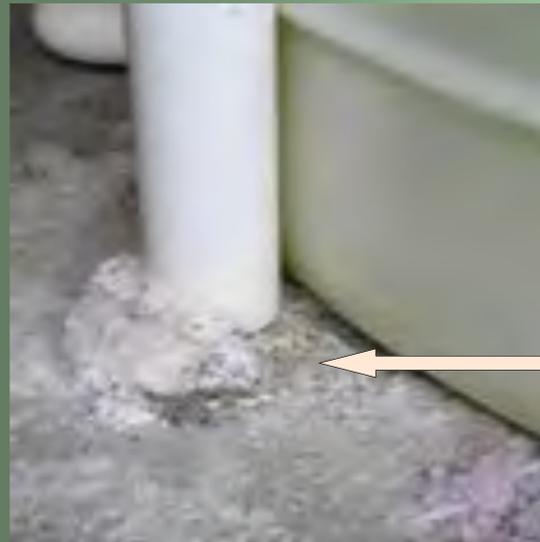
Chlorine solution corroding cast metal on indicator

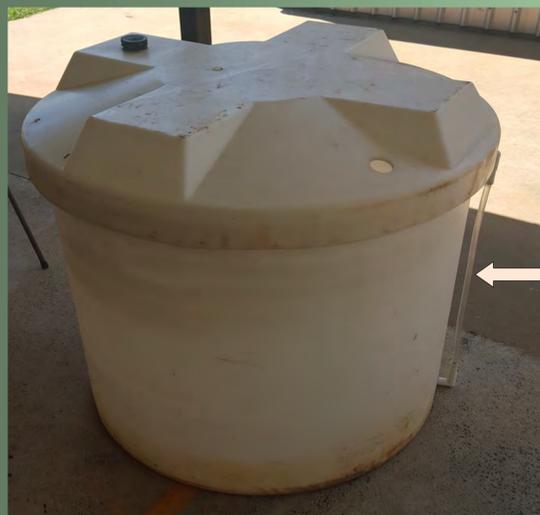
Chlorine solution corrodes PVC fitting causing leak.

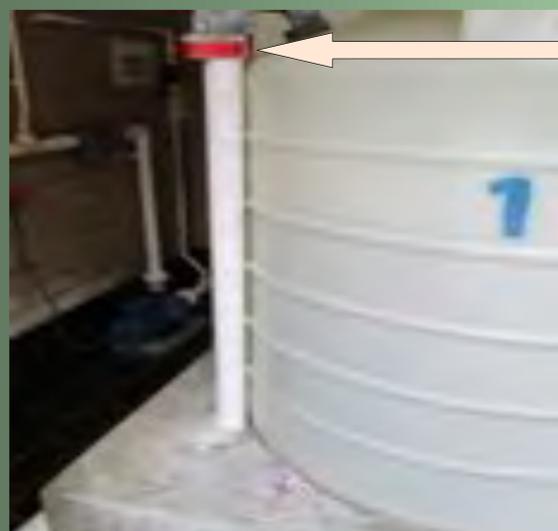
Corrosion of internal pulleys and nylon cord.

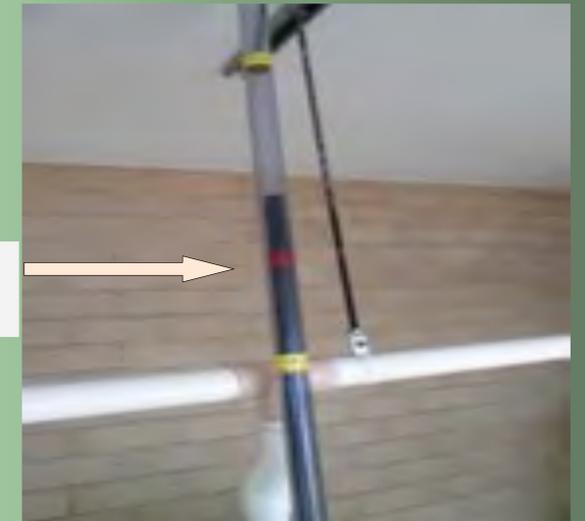
Accurate indicator

After consultation and several brainstorming sessions with the WTP Operators, a new hypo level indicator was born. The concept of a simple float constructed of 10mm UPVC pipe with EPDM rubber ring joint for straight connection with a clear 20mm PVC sleeve was trialled. The design is simple but effective and does not have intricate workings as it is positioned at the top of the hypo tank instead of on the side. Graduated markings on the clear tube indicate different levels, giving the operators an easy visual indication at all times. Chlorine suppliers have all given positive feedback on the level indicators saying they are easily read and a good design. With this in mind we are now starting to roll out these systems to other sodium-hypochlorite storage sites across the region. The low cost of these indicators, with its durability and ease of use is very attractive compared to other types on the market, as the savings from purchasing and replacing broken units, can add up to thousands of dollars for council rate payers.

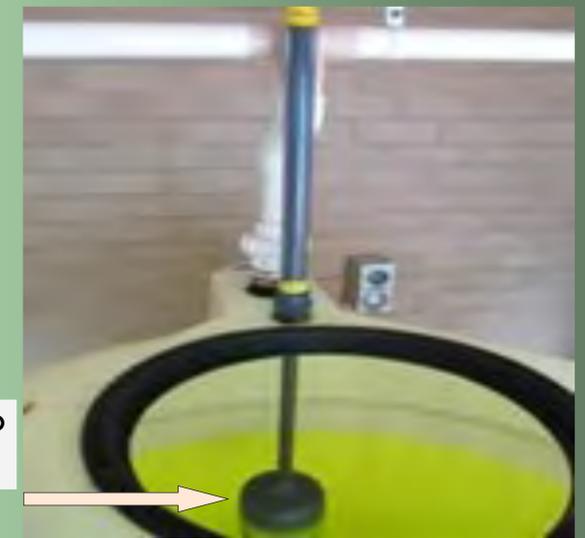
Float heavy to stop bouncing

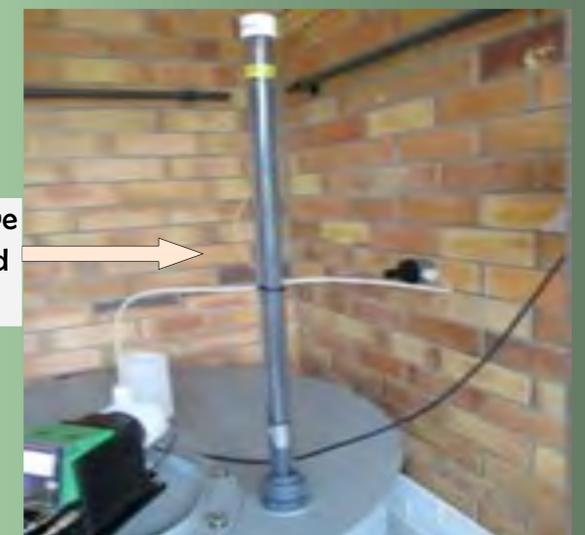
Clear PVC sleeve with graduated markings
