PICKING UP THE PIECES – LESSONS FROM TAKING OVER A TRADE WASTE TREATMENT PLANT

Kate Pauley, *Operation Systems Project Officer,*

North East Water

*79th Annual WIOA Victorian Water Industry Operations
Conference and Exhibition
Bendigo Exhibition Centre
31 August to 1 September, 2016*

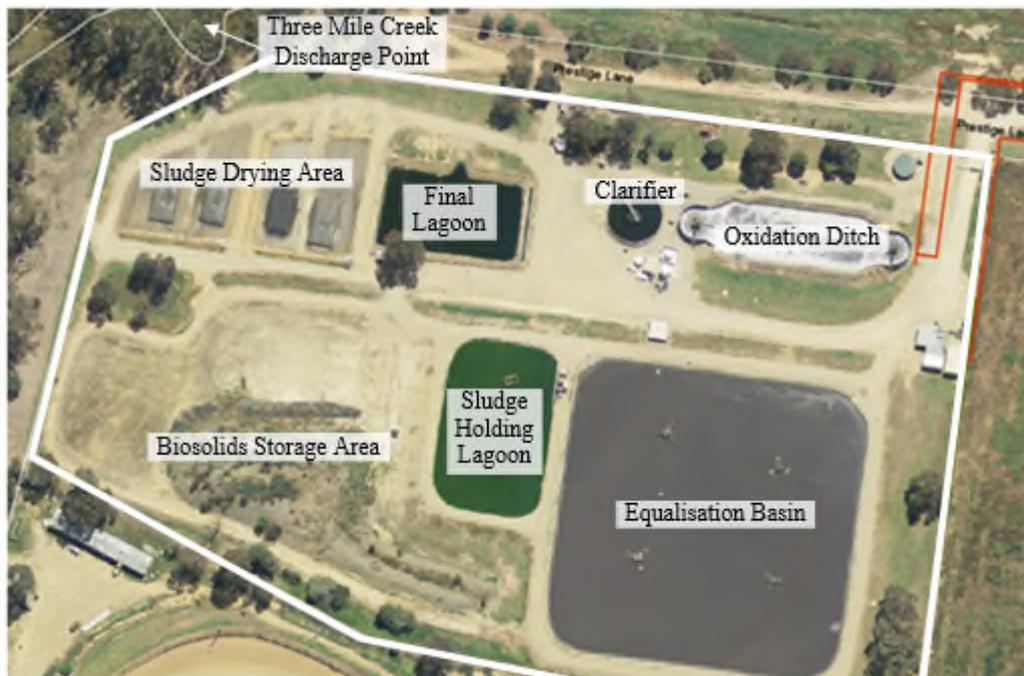
The TWTP is a dedicated trade waste treatment facility and only services two textile customers. Textile waste received at the facility is very different to domestic sewerage and industrial waste sourced from food manufacturing, as it largely consists of poorly biodegradable ‘chemical’ waste, which has elevated concentrations of colour, metals, nutrients and salts. The treatment processes on site consist of a 42 ML mechanically aerated biological Equalisation Basin, an out of service 3.2 ML Oxidation Ditch, chemical dosing, clarification and discharges to an ephemeral creek under EPA license. Waste sludge from the process is transferred to the Sludge Holding Lagoon. Geobags are then used for dewatering and the sludge is stored in windrows in a Biosolids (Biomass) Storage Area. The key components of the TWTP layout and process are displayed in Figure 1

Figure 1: *Layout of the TWTP site*

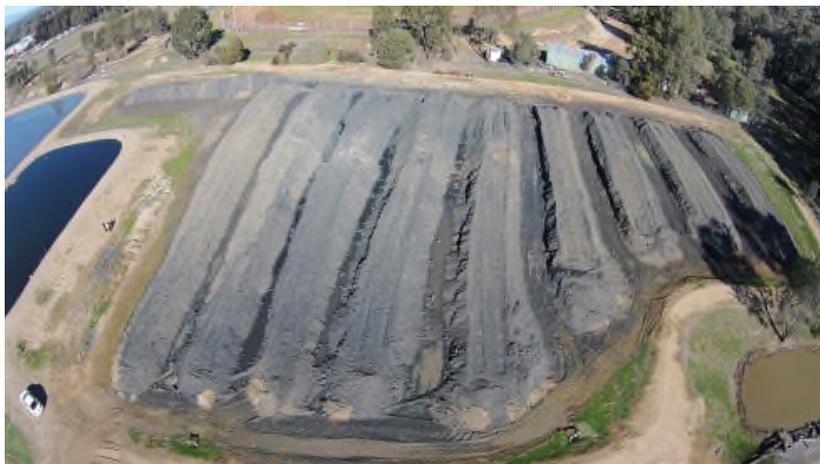
The site has a large stockpile of dried Biomass as seen in Figure 2. NEW windrowed the stockpile and undertook an extensive survey of the sludge to understand the levels of contaminants and enable classification of the waste. As a result of the monitoring program the majority of the waste could be classified as an Industrial Waste however elevated levels of contaminants were identified in some 'pockets' of the stockpiles.

Figure 2: *Windrows of Biosolids Stockpiled at the TWTP*

One ongoing issue for the site is the management of in-situ wet sludge within the process and the onsite stockpile of Biosolids (Biomass) which have been removed from the process. The onsite stockpile has been accumulating for many years and has now reached a point where it is inhibiting the removal of wet sludge from the process which is impacting treatment. The Equalisation Basin, Oxidation Ditch and Sludge Holding Lagoon all hold significant quantities of wet sludge. NEW is in the process of developing a plan to engage a contractor to de-sludge the facility over the next 12-18 months.

There have been ongoing trials and investigations into possible beneficial uses for the Biomass to prevent sending the stockpile to landfill as a significant cost. Trials have included the possible use of the material in daily cover of landfill. NEW and the EPA are involved in ongoing discussions to determine an appropriate sustainable use of this product.

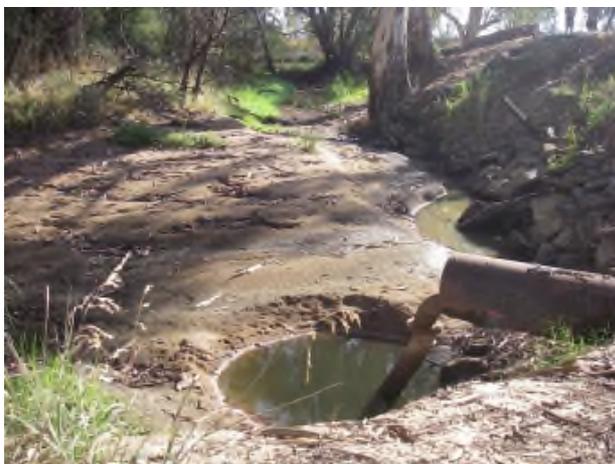
Discharging treated effluent into an ephemeral creek presents a number of immediate concerns which need to be further understood. In recent years, fish kills have been observed in the local creek system, however it was inconclusive that the discharge from the TWTP contributed. Regardless of the cause, a connection between the discharge from the site and any fish deaths could lead to reputational issues. NEW has had an approach to undertake an Ecological Risk Assessment (ERA) for all discharges from WWTP to determine whether the discharge is impacting the beneficial uses within the receiving waterway. Of particular concern to NEW is discharging to the creek during summer when natural flows cease and the discharge can make up to 100% of the creek flow (see Figure 3). The local creek is ephemeral and is often dry for up to six months of the year between Spring and Autumn. The findings of the ERA will be used to assist NEW in determining the most appropriate future options for the site to ensure ongoing sustainability of the site and to minimise any environmental impacts.

Figure 3: *TWTP Discharge point into the local creek during summer*

The ERA process at the TWTP commenced in December 2015, with the collection of additional creek and effluent monitoring data. This was followed by an initial problem formulation session held with various stakeholders to identify stressors in the discharge and beneficial uses in the receiving environment. The outcomes of this session were used to develop the risk assessment, which using a range of data and other information to determine the level of risk for each stressor.
