WATERWORKS

OFFICIAL JOURNAL OF THE WATER INDUSTRY OPERATORS ASSOCIATION

June 2008

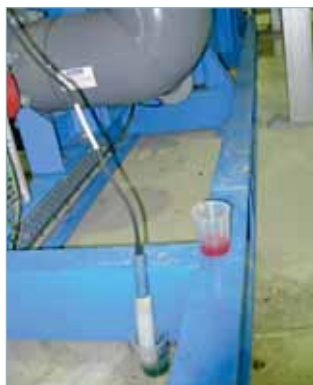
Figure 1. The pH probe removed from the process flow and "tricked" by using standard pH buffer solutions.

Some examples of recently observed issues include a new combined DAFF/microfiltration plant where clearly the link between the DAFF contractor and membrane contractor was very much less than seamless, the operators have to shift a pH probe from one beaker at one pH to another beaker at another pH just to keep the plant operating. Not good enough.

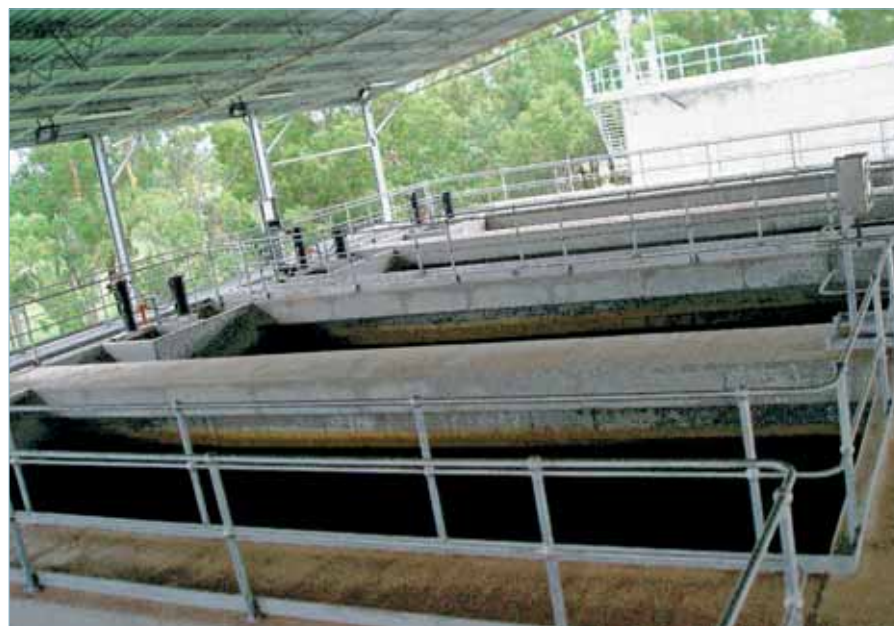
New filters.

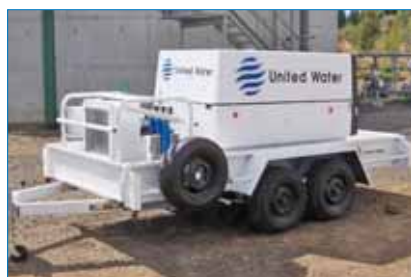
Figure 3. Trailer mounted air scouring unit.

The major equipment used for air scouring is a compressor unit and air filters, filter bags, lay flat hose and standpipes. Figure 3 shows the trailer mounted air scouring unit and Figure 4 shows the filter bag in use.

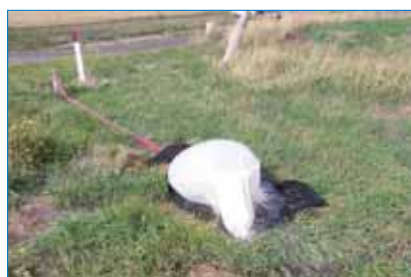
Figure 4. Filter bag being used to filter the water coming out of the hydrant.

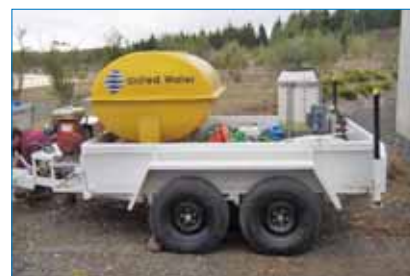
Figure 5. The disinfection trailer.

Following each air scouring run, the main requires disinfection. This is achieved by injecting sufficient 12.5% sodium hypochlorite solution into the main to achieve a minimum 10 mg/L free chlorine residual after 3 hours. At the end of the 3 hours the highly chlorinated water needs to be removed from the main. This water needs to be dechlorinated prior to discharge to the environment. This is achieved using a sodium thiosulfate solution injected into the discharge stream. An alternative method of dechlorination is to pass the discharge water through a diffuser containing ascorbic acid tablets, however, care must be taken with this method as it is not as effective at reducing chlorine at very high concentrations and the level of chlorine in the discharge must be checked. Figure 5 shows the mains dosing trailer, Figure 6 the temporary supply trailer and Figures 7 and 8 the two dechlorinating methods.

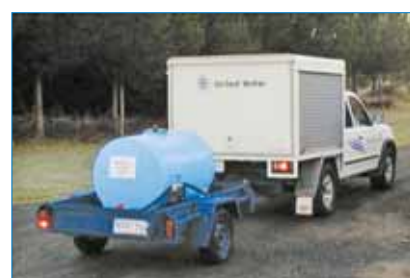
Figure 6. The temporary service trailer.

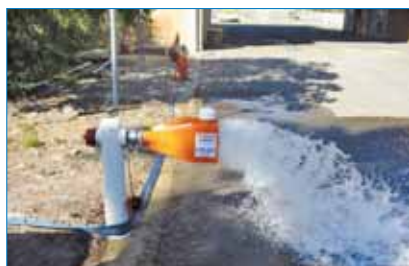
Figure 7. The dechlorination diffuser.

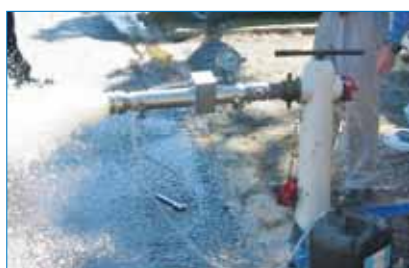
Figure 8. High concentration dechlorinator.

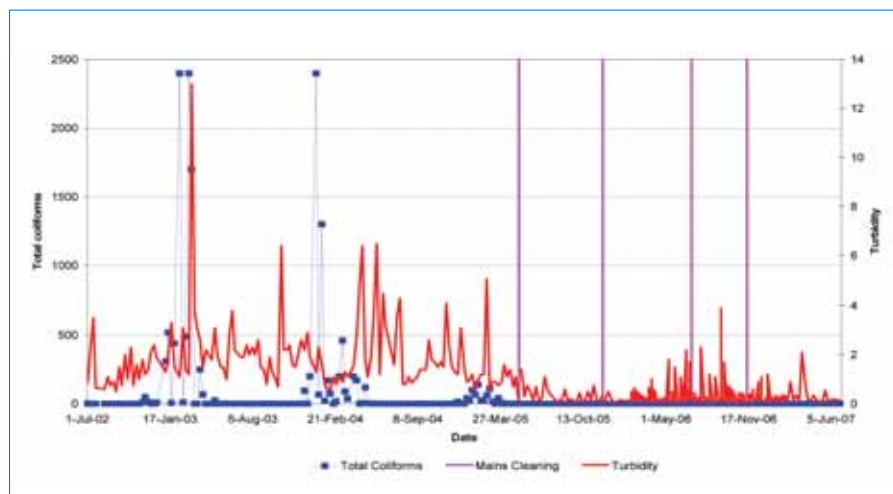
Figure 9 Blackwood Network Total Coliforms and turbidity in the Blackwood network before and after the mains cleaning program.

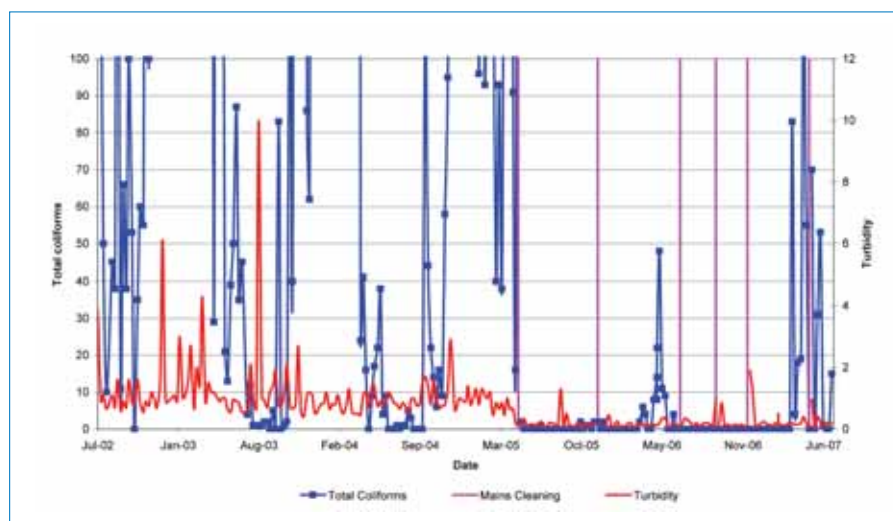
Figure 10. Beaufort network Coliforms and turbidity.

the frequency of the original program however as shown in Figure 10 total coliforms still persist in the Beaufort network. The boil water notice remains in place. A possible reason for the difference between the results for the two towns is that Beaufort has an old water supply network, with a high failure rate, compared to Blackwood. It consists of various pipe types which have, for the majority of their life, transported untreated water, it is not unexpected to see the results obtained.

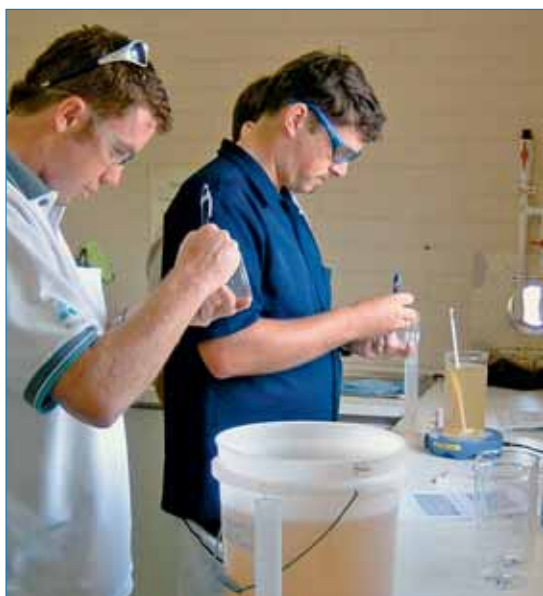
Figure 1. Testing the effect of coagulants on pH.

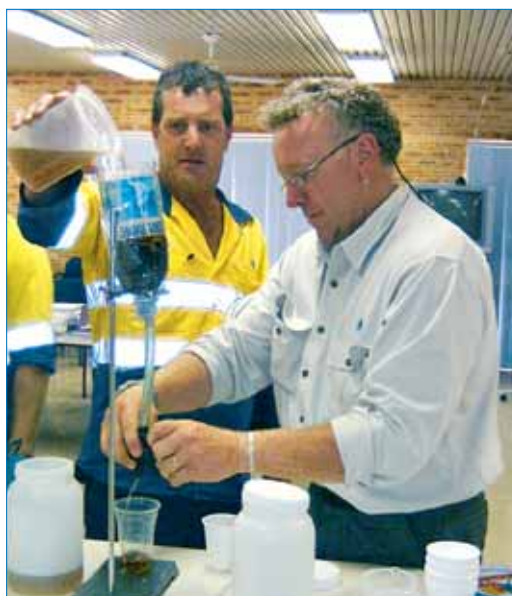
Figure 2. Testing the organics removal efficiency of powdered activated carbon.

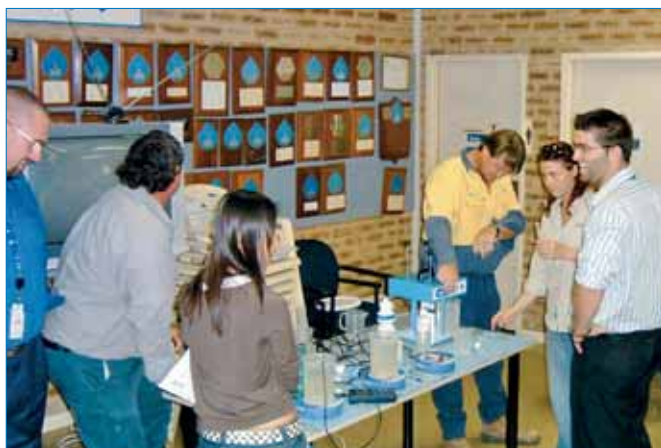
Figure 3. Simulation of a basic water treatment process.

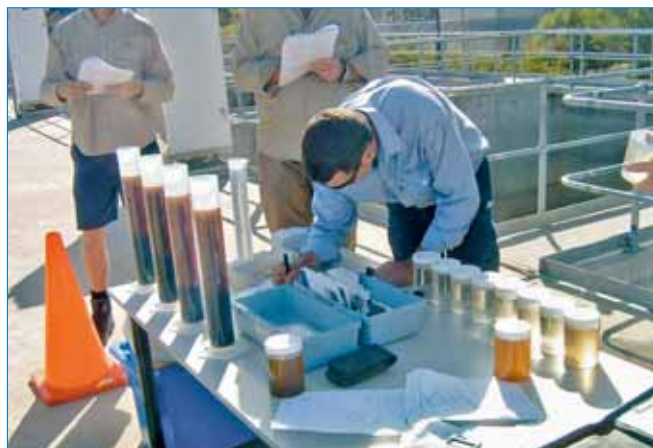
Figure 4. Carrying out filter optimisation tests – backwash times and sludge retention.

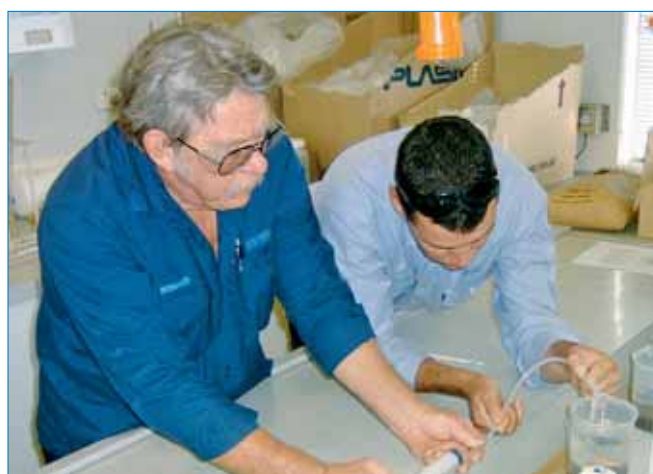
Figure 6. Determination of optimum clarifier surface loading.

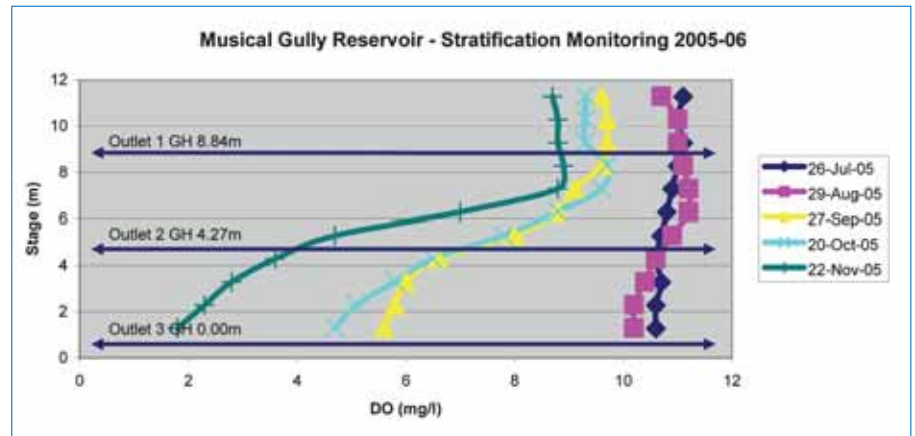
Figure 2. DO profiles at Musical Gully Reservoir during the Winter and Spring of 2005.

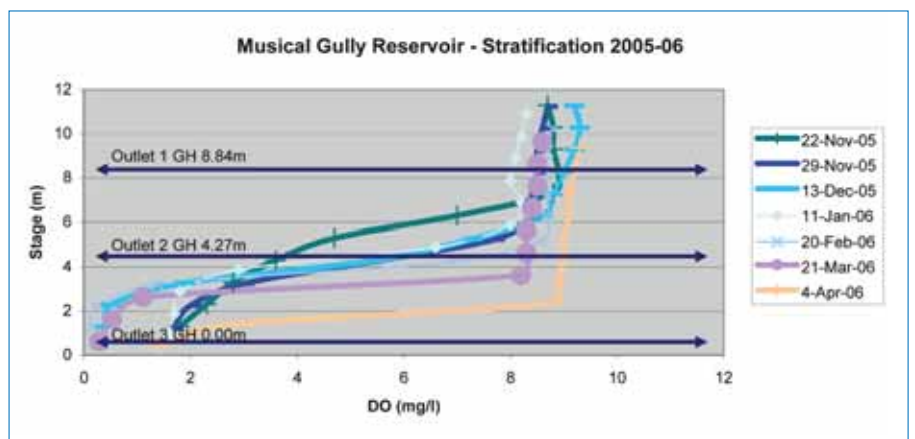
Figure 3. DO profiles at Musical Gully Reservoir during Summer 2005-06.
