WATERWORKS

OFFICIAL JOURNAL OF THE WATER INDUSTRY OPERATORS ASSOCIATION

June 2010

PIPES, MATERIALS AND FAILURES

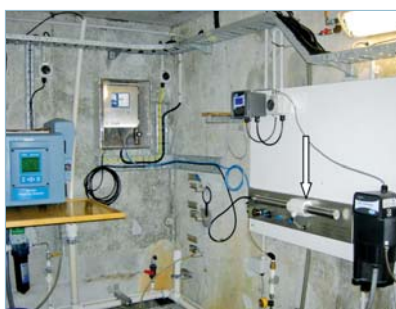
Figure 1. The spectrolyser that collects the data is indicated by an arrow.

The Com::pass system as it is called, is based on data collected by an S::CAN Spectrolyser (Figure 1), an instrument that continually measures the UV Vis absorption spectrum of water. The Com::pass system completely controls the dosing of coagulant at the Wainuomata WTP in response to changes in raw water turbidity and organic content. The plant was originally commissioned in 1995 using a streaming current meter (SCM) to control the coagulant dose. Com::pass was installed just under four years ago and the plant has run using this control system since then. Com::pass has also been used on another of the GWRC plants for the last two years.

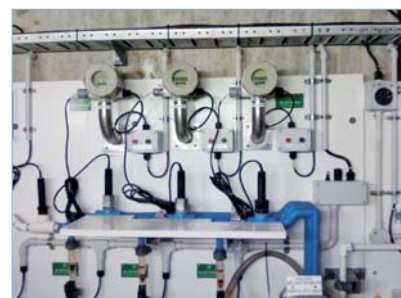
Figure 2. Coagulation pH is critical for good coagulation and flocculation. Here 3 pH meters provide "triple validated" pH control of the coagulant pH. This type of monitoring while very rare in Australia is quite common in the UK and continent.

Excellent coagulation requires fine control of pH. For this reason coagulation pH is monitored using three pH meters (Figure 2).

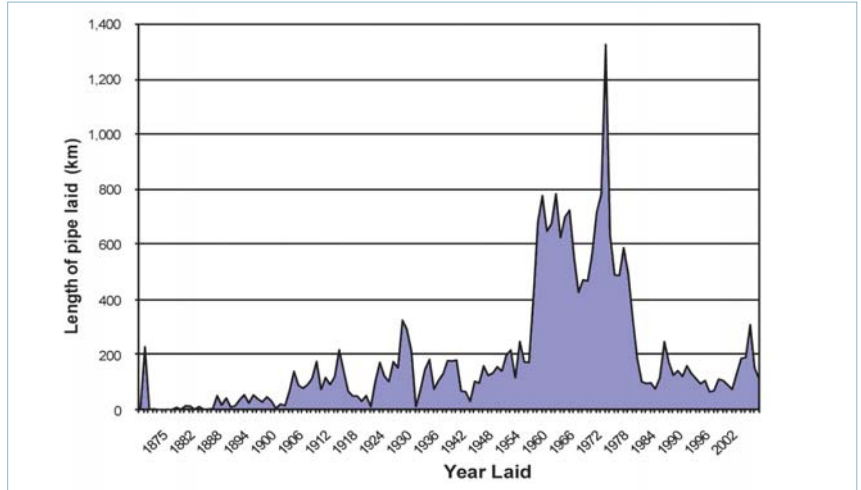
Figure 1. Lengths of pipe laid by one large Australian water utility each year between 1875 and 2002.

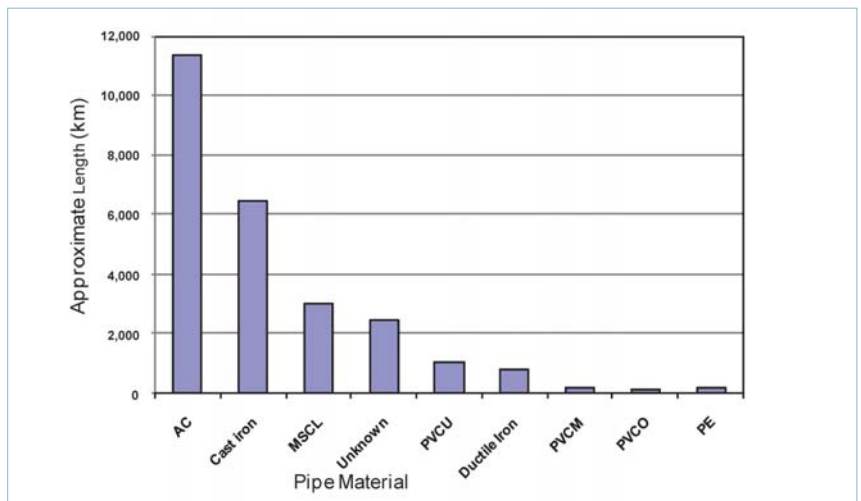
Figure 2 Lengths of different pipe types for one large Australian water utility.

Figure 2 shows the types of pipes of different materials for one large Australian water utility. However pipeline material do vary between water utilities. This is primarily due to water quality. Asbestos Cement (AC) pipes were not generally used where water was soft, such as in Melbourne or Sydney. In these systems the AC component was replaced by grey cast and ductile cast iron pipes which therefore make up the largest percentage of pipes in these water reticulation systems.

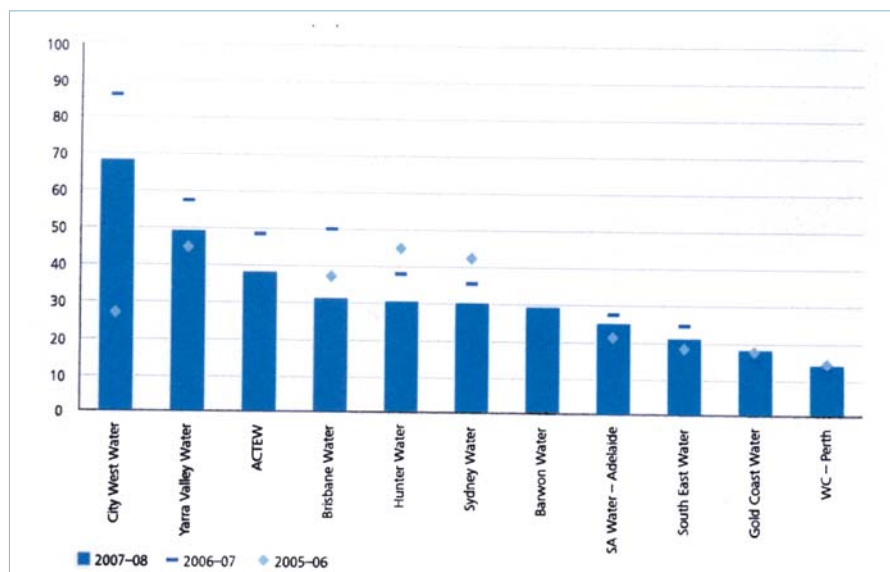
Figure 3. Watermain breaks per 100 km for mains in 2007-2008.

Pipes don't last forever and pipeline failures are a fact of life for water utilities. Figure 3 shows the number of pipeline breaks per 100km for a number of Australian capital city water utilities. The graph clearly shows the significant differences between utilities.

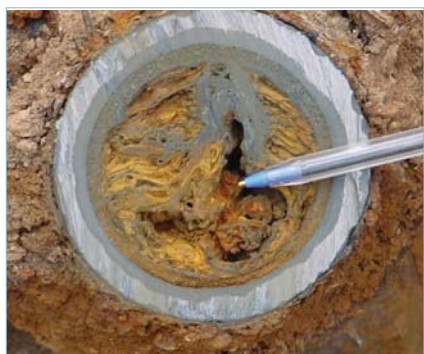
Figure 1. Internal Corrosion of an unlined cast iron pipe.

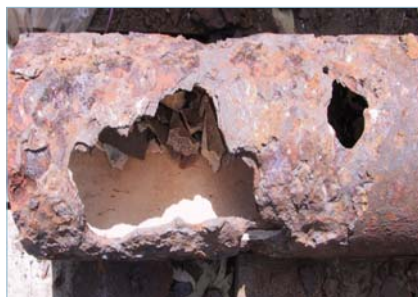
Figure 2. External Corrosion of a cast iron pipe.

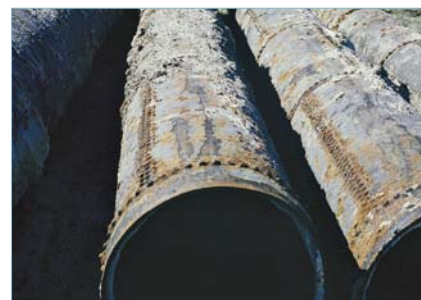
Figure 3. Riveted steel pipe.

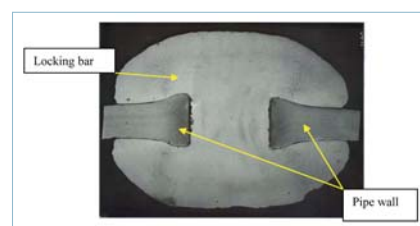
Figure 4. Cross section of locking bar joint. The two edges of the pipe barrel are formed into a dovetail shape which fits into a grooved metal bar which is then rolled down over the dovetailed ends to lock the the pipe together.

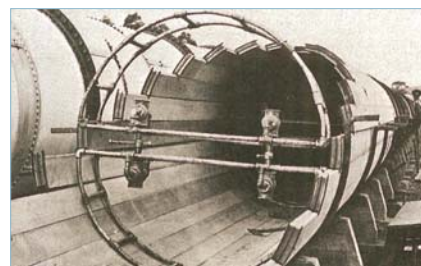
Figure 6. Construction of an early wood stave pipe.

The first pipes used in ancient times were made of clay or wood and are only of historical interest as none of these are in current use. Some pipes used in Australia were however of wood construction known as wood stave pipes where slats of timber

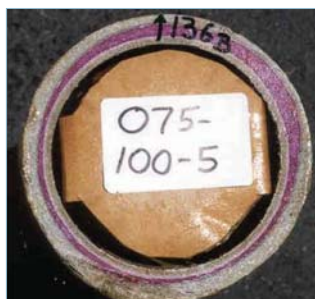
Figure 7. Cross section of AC pipe showing internal and external deterioration. Undeteriorated portions of AC are coloured magenta (Courtesy Opus International Consultants).

The common method used to assess the depth of deterioration or degradation of an AC pipe wall is by staining with phenolphthalein indicator. Phenolphthalein is a weak acid indicator that changes to a progressively deeper magenta colour from a pH of 8.3 to 10.0. This colour change can be used to highlight the difference between the alkaline areas where the cement matrix is sound and the lower pH areas where the $\text{Ca}(\text{OH})_2$ has been leached away (Figure 7).

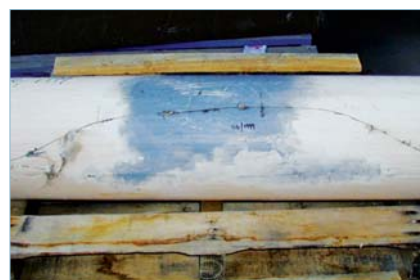
Figure 8. A longitudinal crack in a PVC-U sewer pressure main.

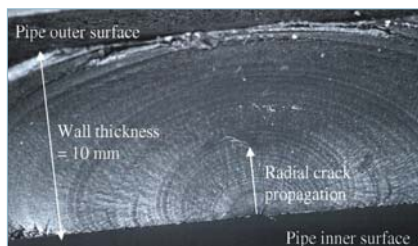
Figure 10. Slow crack growth in PE pipe material.

Plastic pipes are made of a visco elastic material. This means that when the material is placed under constant stress, the material creeps and in the long term the stresses required to cause a pressure rupture are less than those when the pressure was initially applied. This change in the rupture stresses can be related to ageing effects such as heat or UV, but in a buried pipe these effects are not relevant and changes to the rupture stress will occur very slowly under constant stress. All plastic pipe standards use a figure of 50 years to determine the design wall thickness of the pipes to account for visco elastic creep. This has created a lot of confusion in the industry as this has regularly been interpreted as the pipes only have a design life of 50 years, after which they will start to fail. This assumption is incorrect. There are high expectations on the long term performance of these plastic pipes and there are many examples of this but also some examples of plastic pipe failure. Plastic pipeline failure can be complex but the fundamental cause is its resistance to slow crack growth and subsequent rapid crack propagation resulting in brittle cracking (Figure 8). It is these aspects along with a desire to reduce the amount of material in the pipe that have driven the development of different PVC and PE materials with ever increasing resistance to slow crack growth.

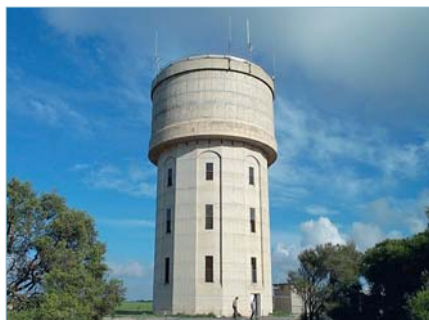
Figure 1. One of the elevated storages.

Elevated storage tanks (Figure 1) are a good example of neglect. OHS departments restrict access to these structures. Most personnel are not comfortable or competent to climb anything more than a basic, low ladder system. Consequently high, restricted areas are often left unattended or unchecked. Without checking, water utilities do not really know what is happening to the water in these storages. Somehow the restrictions placed by OHS must be replaced by a system to allow regular inspection and correction of any problems. Ignoring this requirement puts many members of the public at risk compared with one or two utility staff. Two case studies are presented here and the fact that these cases are typical is rather scary for anyone consuming water from a distribution system.

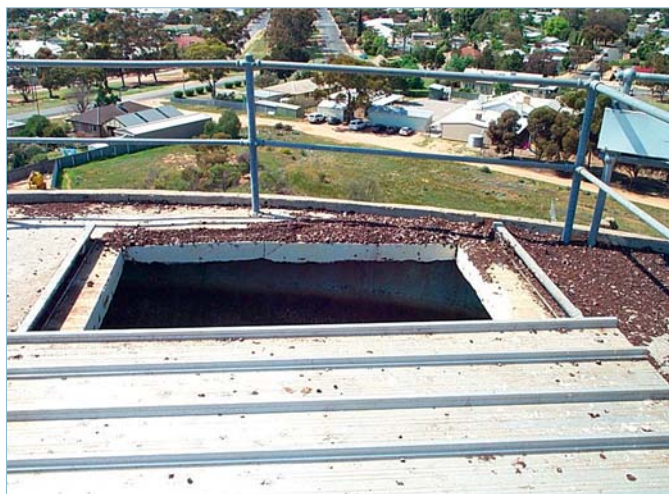
Figure 2. The access hatchway surrounded by piles of bird droppings.

access hatches. The situation was further complicated by significant bird activity and large amounts of faeces that had collected on the roof area (Figure 2). When the tank was finally accessed safely by trained personnel, a thick, smelly, green, soupy material was found to be draining directly into the stored water (Figure 3). This mixture of dirt, bird faeces and storm water had blocked the roof drains due to a lack of regular inspections and maintenance! The irony of this tank was that the internal ladders had been designed to meet AS1657-1992 (Fixed platforms, walkways, stairways and ladders) and yet there was no safe access to the roof and the hatches.

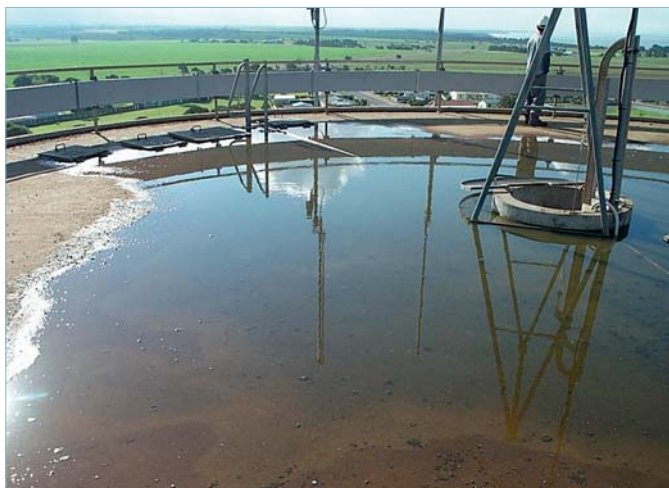
Figure 3. Ponded green water with easy access to the hatches.

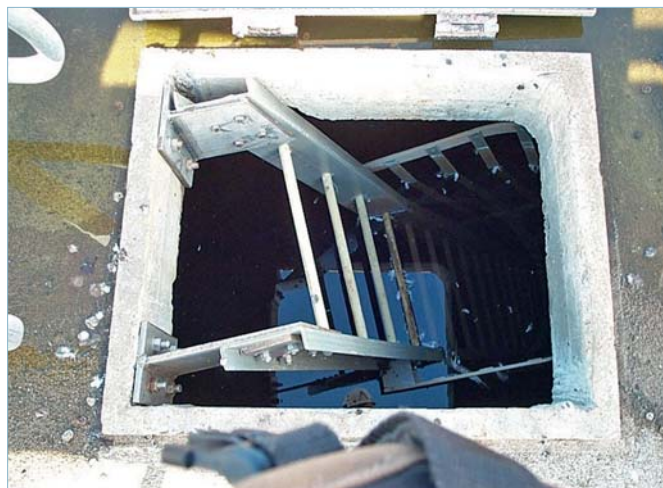
Figure 4. Feathers on the surface of the water. Clear proof of contamination.

An elevated tank situated inside the main depot of a water utility where at least 50 personnel were had been left unattended due to OHS restrictions. It was an obvious habitat for pigeons that were frequently observed flying around and roosting on the tank. This bird activity led to an accumulation of faeces across the roof and around the entry hatch area, due to a lack of regular maintenance. When the hatch was opened, the surface of the water was covered in feathers (Figure 4) that had blown into the tank past the unsealed entry hatch frame.

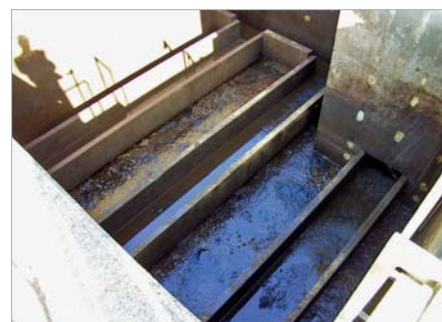
Figure 5. A filter with a relatively high risk of injury during entry. Fall arrest would be appropriate here.

There is no single procedure for entry to a filter since they are all quite different (Figures 5 and 6) but all open filters can be entered quite safely. Mosse and Murray (2009) provide an example risk assessment and generic filter entry procedure. This can be taken as a basis for site specific entry procedures to be developed. Enclosed filters such as the one shown in Figure 7 do pose some difficulties but inspections are always possible.

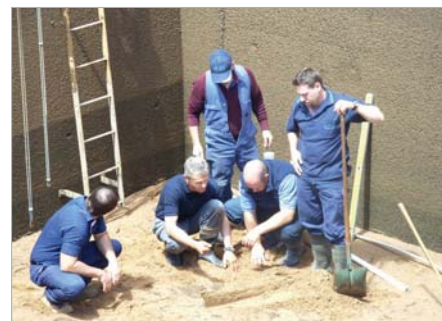
Figure 6. A safe easy filter to enter. Fall arrest would not be necessary here.

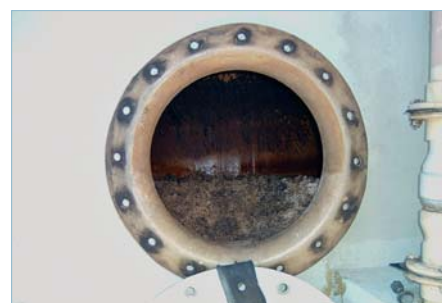
Figure 7. A fully enclosed filter. Actual entry to the filter would require full consideration of confined space entry however simple inspection of the surface of the media is simple and safe.

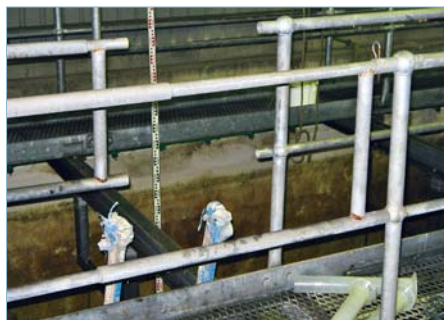
Figure 8. A simple "trombone slide" entry gateway has been cut in the rails surrounding a filter

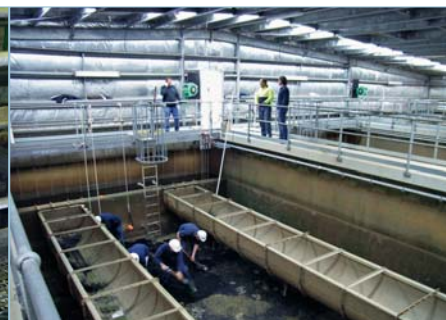
Figure 9. A purpose built filter access point.

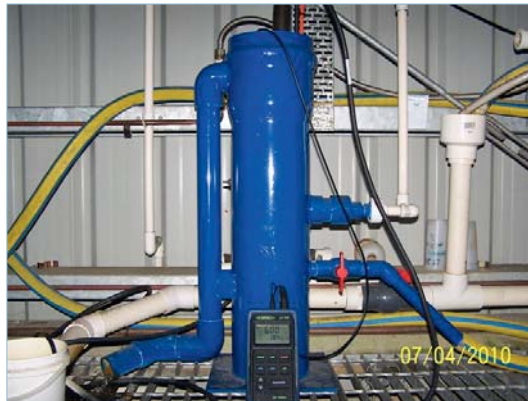
Figure 1. Stilling vessel.

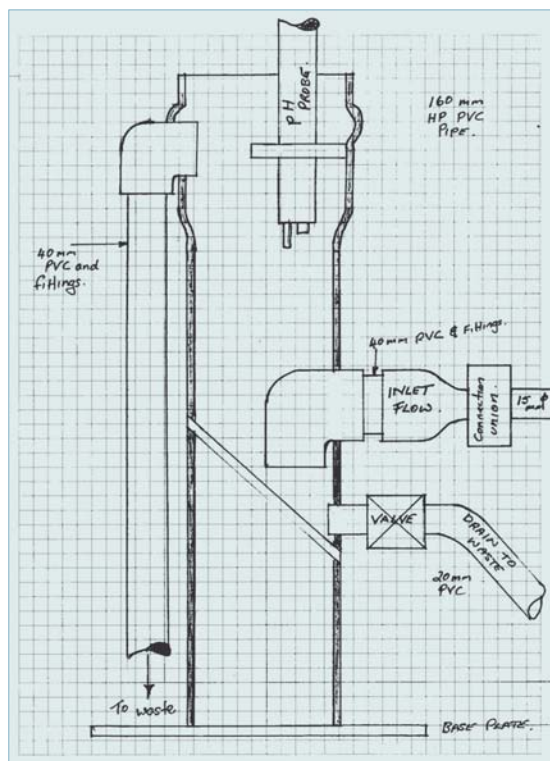
Figure 2. A "technical drawing" of the stilling vessel.

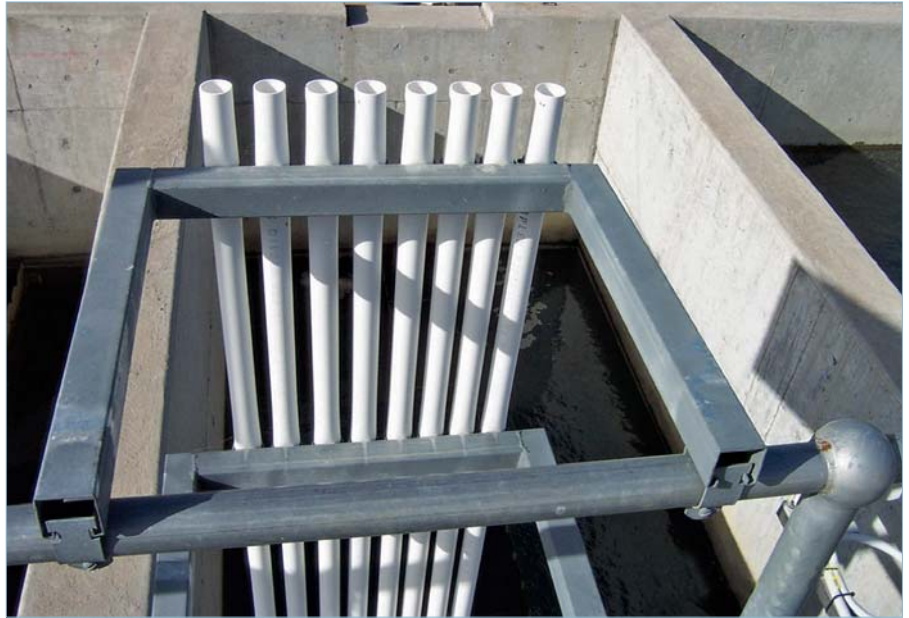
Figure 1. A set of head loss tubes permanently installed in a filter at Mt Pleasant WTP.

The technique involves the installation of a number of open-ended tubes to

various depths into the filter bed (Figure 1).

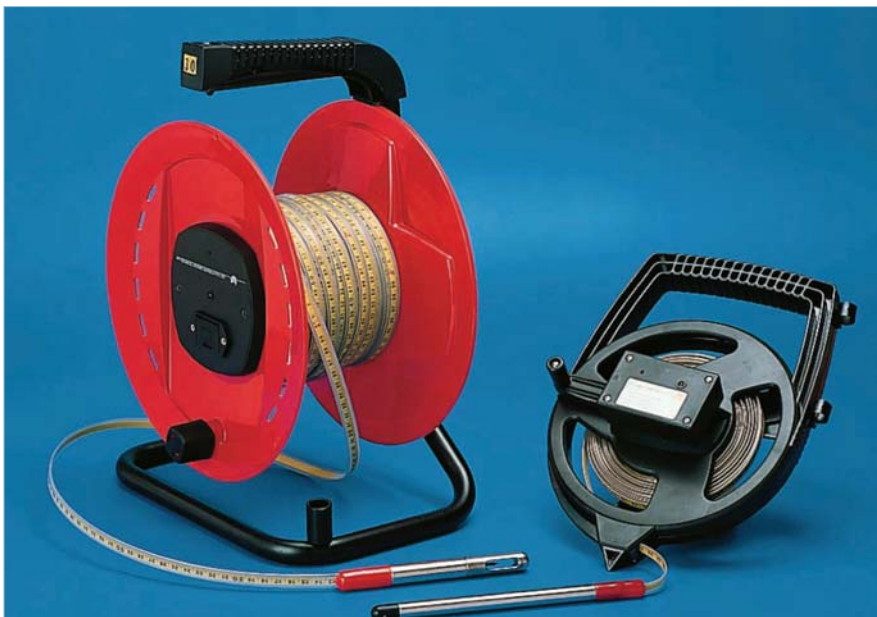
Figure 2. Examples of water level measuring equipment (photo supplied by Geotechnical Systems Australia Pty Ltd).

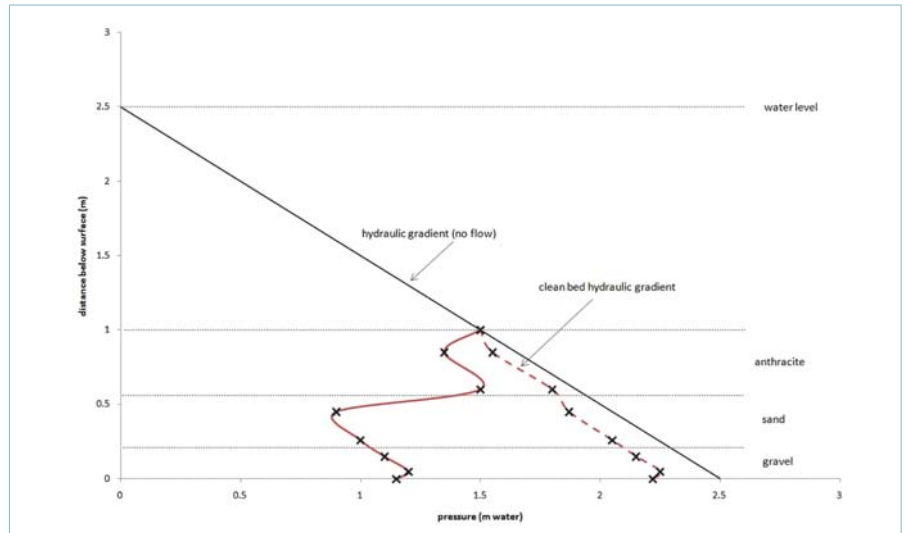
Figure 3. Typical hydraulic gradient resulting from high head loss at a filter media interface.

3 represents the measurements taken at a new Adelaide metropolitan WTP some years ago, where it was identified that the rapid development of excessive head loss (where the line dives to the left) was predominantly occurring at the interface between the anthracite and sand layers. This indicated that the filter media chosen was not correctly matched, and resulted in the media being replaced.

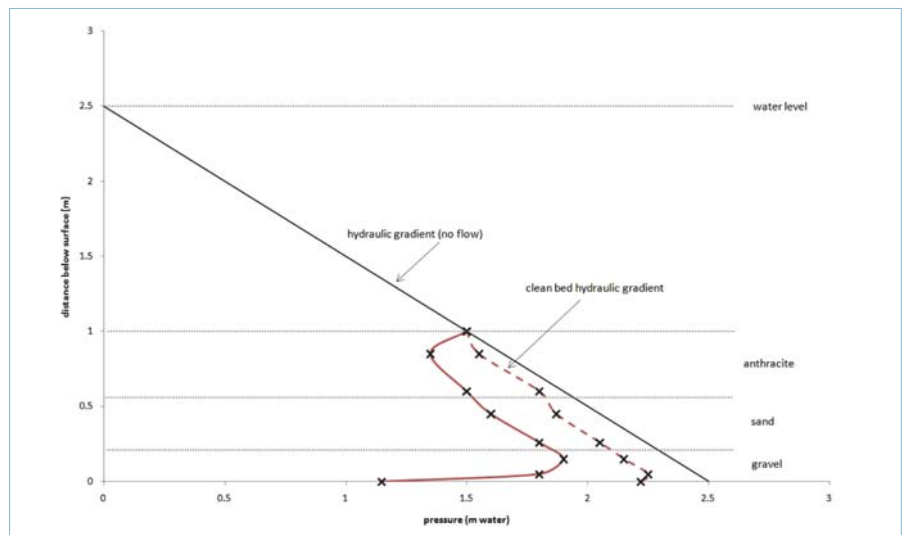
Figure 4. Typical hydraulic gradient resulting from blocking filter nozzles.

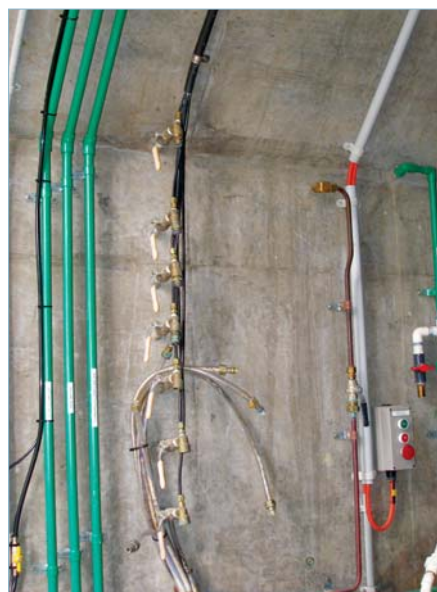
Figure 5. Headloss fittings in the wall of the filter gallery. The flexible tubing is disconnected.

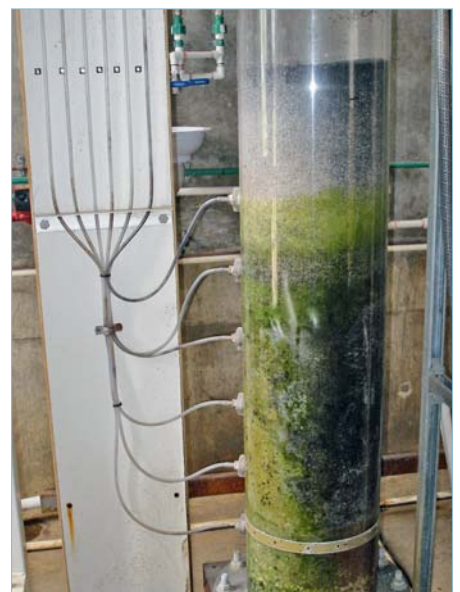
Figure 6. Example of flexible head loss profile tubes fitted directly into a pilot plant filter.

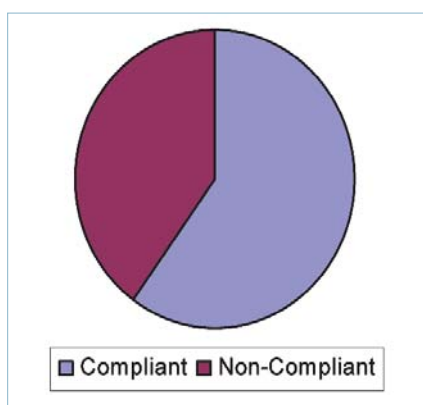
Figure 1. Results of 2008 audits.

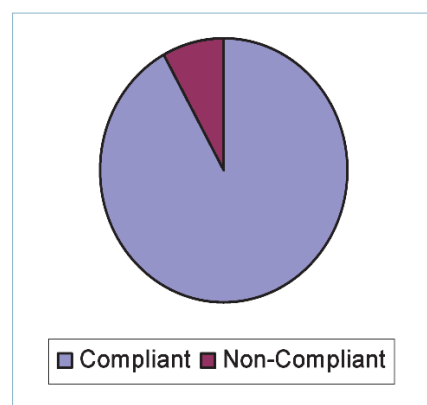
Figure 2. Results of 2009 audits.

This time, 23 of the 25 audits were compliant. Two returned a non-compliant result (Figure 2). This was a significant improvement on the 2008 round of audits, and demonstrated the commitment of water businesses to improve their risk management practices.
