TECHNICAL PUBLICATION OF THE WATER INDUSTRY OPERATORS ASSOCIATION OF AUSTRALIA

MAY 2018

WATER WORKS

CONTENTS

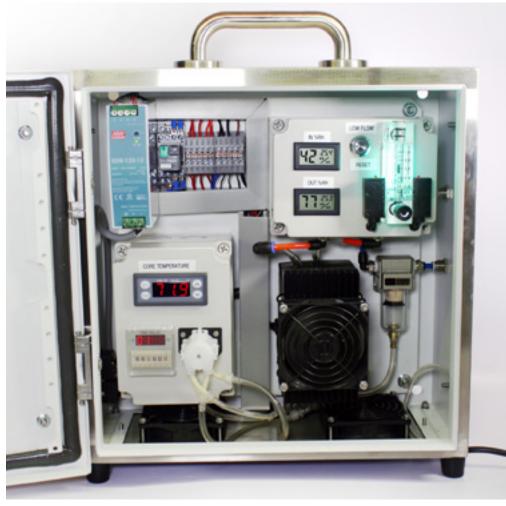
Transportable Sampling System used with handheld instruments

A powerful air aspirator pulls samples from distances up to 50 metres (longer if required). These are then filtered and conditioned before being passed across one or multiple sensors.

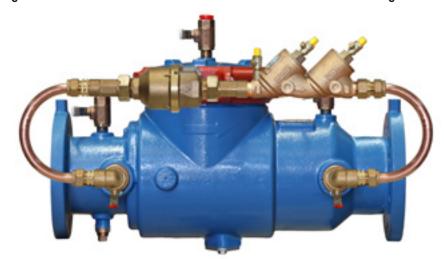
Figure 6. A large Double Detector Check Valve.

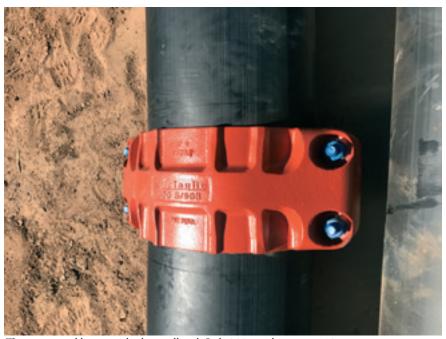
The crew was able to completely install each Style 908 coupling in just 10 minutes.

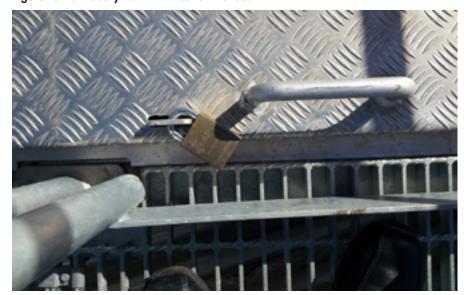
Figure 2. Hatch latch with potential ingress point.

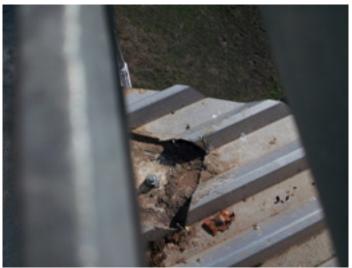
Figure 6. Ends of the roofing ridges not sealed after the roof walkway installation leaving a point of ingress.

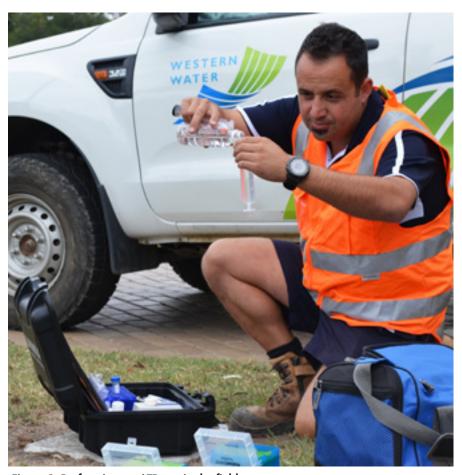
Figure 1. Performing an ATP test in the field.

Water quality monitoring is critical to understanding the network and acting on any issues. We measure the chlorine residual and turbidity and have recently started using a new test that measures ATP (Adenosine Triphosphate). ATP is a molecule associated with cellular energy in all living cells including bacteria and any other living microorganisms in water samples. When a specific enzyme is added to a water sample with ATP present, light is produced. The intensity of the light produced is then measured with an instrument called a luminometer. The more living microorganisms, the more light is measured. The test takes approximately 8 minutes to complete. All tests are performed on site, regardless of the weather (Figure 1).

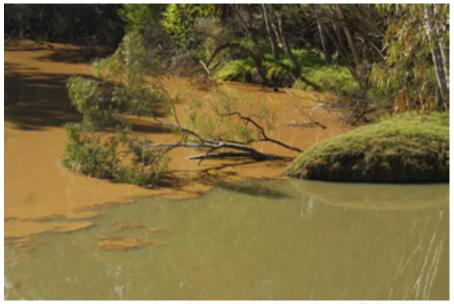
Figure 1. Poor quality water being followed by terrible quality runoff after the 2003 Victorian forest fires.

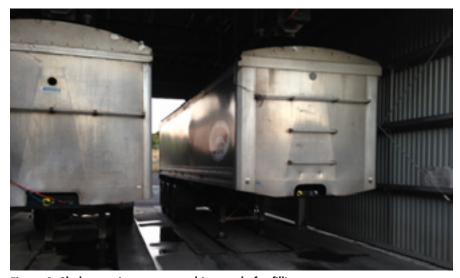
Figure 1. Sludge carting contractor bins ready for filling.

When connecting the trailer bin for filling with biosolids, the contractor would typically hook up the truck's air supply for the bin trailer's air bag suspension. The trailer had a pressure gauge on the side. We started checking the pressure gauge against the weighbridge dockets and found that we could estimate when the bin was full, purely based on air pressure.

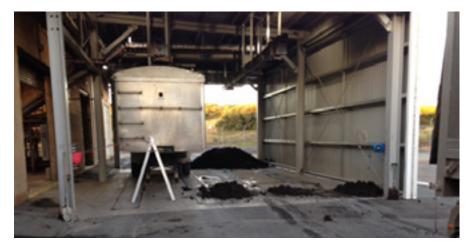
Figure 2. Accessing the top of the bin to see the level of the biosolids posed a safety issue.

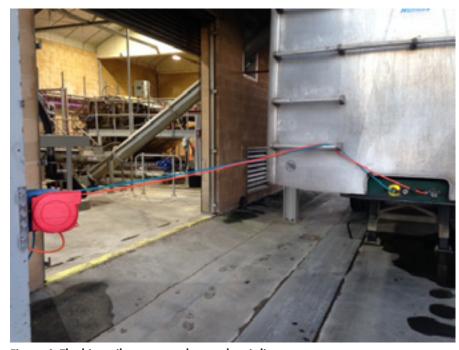
Figure 4. The bin trailer connected up to the air lines.

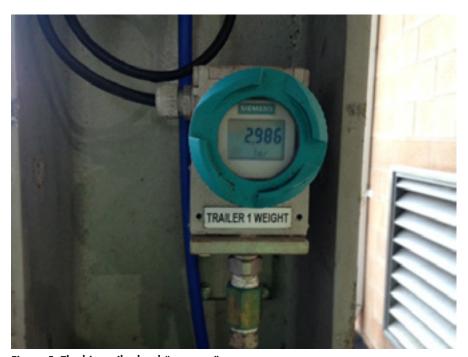
Figure 5. The bin trailer load "pressure" gauge.
