SHOALHAVEN RIVER CROSSING (NOWRA NSW) SEWER MAIN REPAIR

Steve Glennan

*4th Annual WIOA NSW Water Industry Engineers & Operators
Conference
St Stanislaus' College, Bathurst
20 to 22 April, 2010*

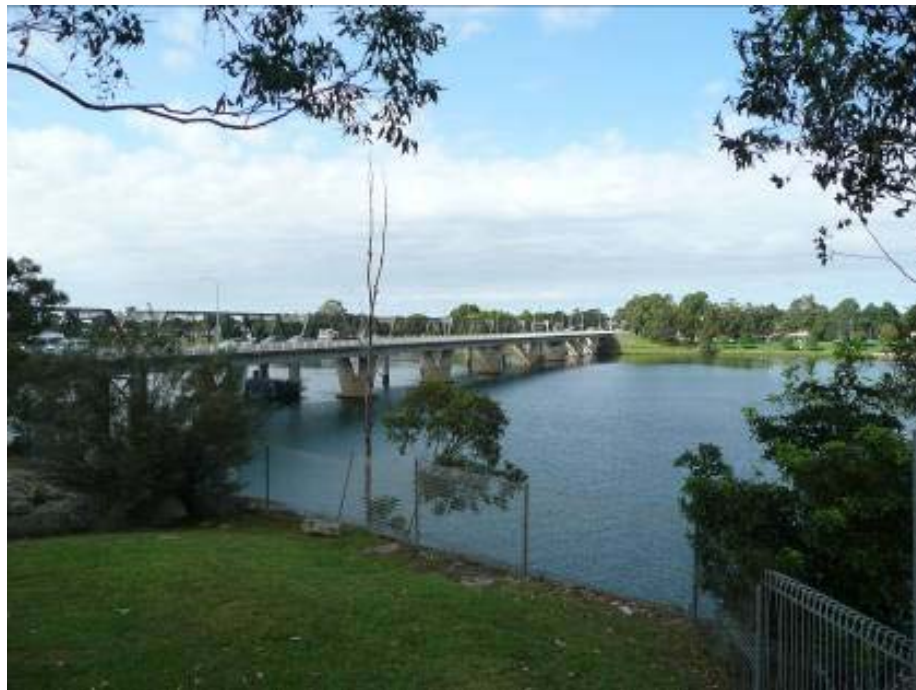
Figure 1: *Shoalhaven River bridge*

Wastewater from North Nowra is transported across the 400 metre long Shoalhaven River Bridge via a 300mm AC surcharge main, suspended under the bridge with Gibault joints. Due to hot weather and up to 70mm movement of the bridge deck, a minor leak occurred at the expansion joint and first Gibault joint at the northern abutment. Repair work was carried out at night to avoid peak flows and allow transport of wastewater by tankers. Emergency repairs were affected after contacting EPA, oyster growers, adjacent residents and media. The bridge crossing was drained down twice more to complete permanent repairs.

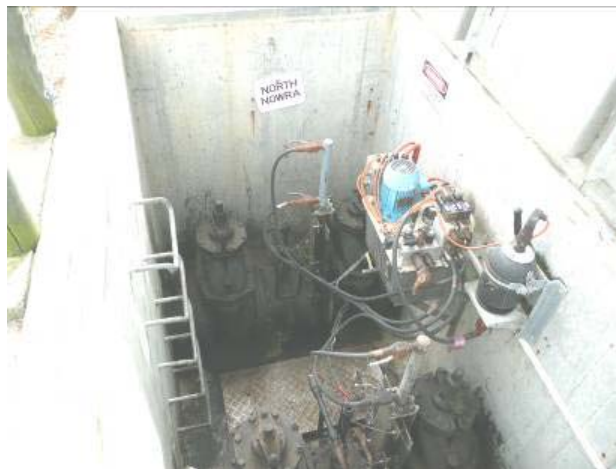
Figure 3: North Nowra surcharge main control valve

The North Nowra surcharge main operates by filling and emptying, which is controlled by a pressure sensitive automatic opening & closing valve, located at the Nowra STP. The valve is normally closed and the main fills until it reaches a pressure of 180Kpa, at which time a signal is sent via telemetry for the valve to open. Once opened, it stays open for 30 minutes to allow for the main to empty and scour any sediment etc that may have built up each time the valve closes. This process operates continually unless there is either a power failure or the line pressure reaches 200Kpa which forces the valve to open and stay open until the normal operating conditions return. (Figure 3).
