THERE'S A HOLE IN MY BIOREACTOR WALL

Adrian Harper, *Senior Engineer Wastewater Treatment,*

Gippsland Water

*77th Annual WIOA Victorian Water Industry Operations
Conference and Exhibition
Bendigo Exhibition Centre
2 to 4 September, 2014*

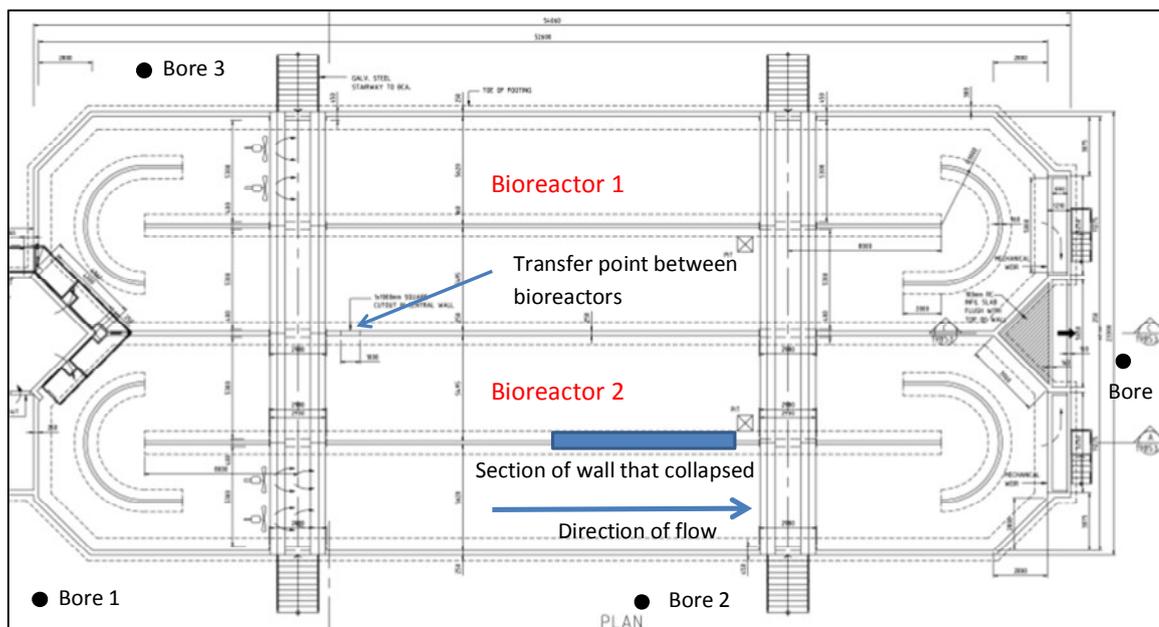
Figure 2: *Diagram of Warragul WWTP bioreactors*

The presence of groundwater was raised as a concern, but the extent to which it would impact the proceedings was, at first, an unknown. Contractors were engaged to drill bores around the perimeter of the bioreactors (see Figure 2 for the location of these).

The bioreactor system includes a transfer point between the two reactors as seen in Figures 2 and 4. Being below the normal operating level of the bioreactors, any isolation of this point required a diving crew to guide a steel plate, suspended from a crane, into a frame in bioreactor 2. This was an expensive exercise and posed a number of risks, including the extent of isolation achieved when the water forces in the bioreactor 1 would act outwards on the plate. It was decided to install a penstock valve and this was achieved by a diving crew while the bioreactors were full. A gear box and spindle were also installed to allow the valve to be safely operated from the aerator bridge.
