# STROMLO WATER TREATMENT PLANT UV LAMP BREAKAGE INCIDENT

**Kate Smith**, *Senior Water Treatment Engineer,*

ACTEW Water

*9<sup>th</sup> Annual WIOA  
NSW Water Industry Operations Conference and Exhibition  
Orange PCYC,  
24 to 26 March, 2015*

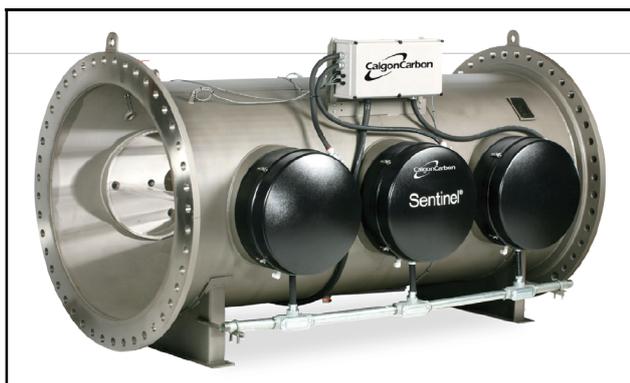
**Figure 1:** *Calgon UV Treatment Unit with 3 Lamp Banks*

**Figure** Figure 1 shows a typical single train with lamps visible through the left side.

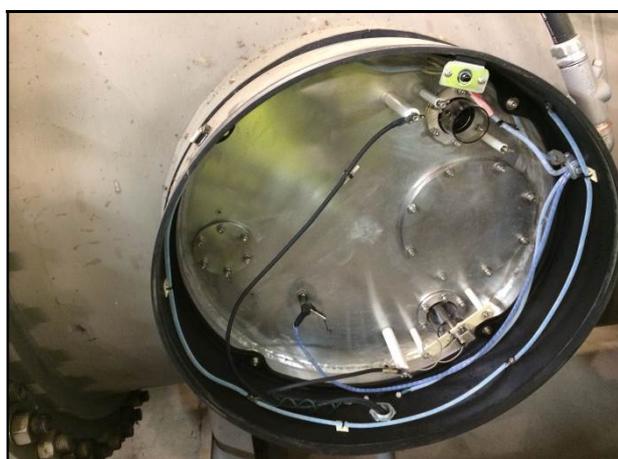
**Figure 2:** *UV Lamp Bank with Cover Removed*

Figure 2 shows a single lamp bank at Stromlo WTP with the cover removed. Two lamps are installed and the position for a third has been blanked off.
