## **FINDING THE SOURCE OF HYDROCARBONS IN DRINKING WATER – A CUSTOMER COMPLAINT**

**Steven Newham,** *Process & Water Quality Specialist,*

Goulburn Valley Water

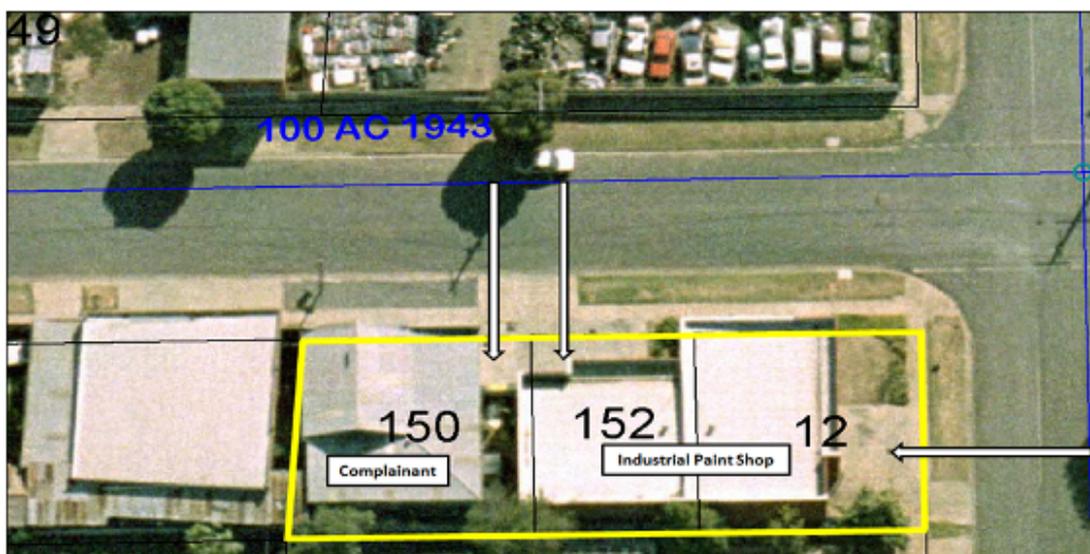
A property history check revealed that three lots had been created from the original property (Figure 1, #12) and that the owner was a plumber. Assuming the possibility that the plumber could have done something creative with the plumbing, the theory that the source of contamination may be a cross-connection was further supported.

**Figure 1:** *GIS with Aerial Photo Overlay Indicating Original Lot and Service Locations*
