# **PETROL & SEWAGE DON'T MIX: THE 2007 SOUTH KEMPSEY PETROCHEMICAL INCIDENT**

**Peter Anderson & Barry Young**

Macleay Water  
(Business Unit of Kempsey Shire Council)

*2<sup>nd</sup> Annual WIOA NSW Water Industry Engineers & Operators  
Conference  
Jockey Club - Newcastle  
8 to 10 April, 2008*

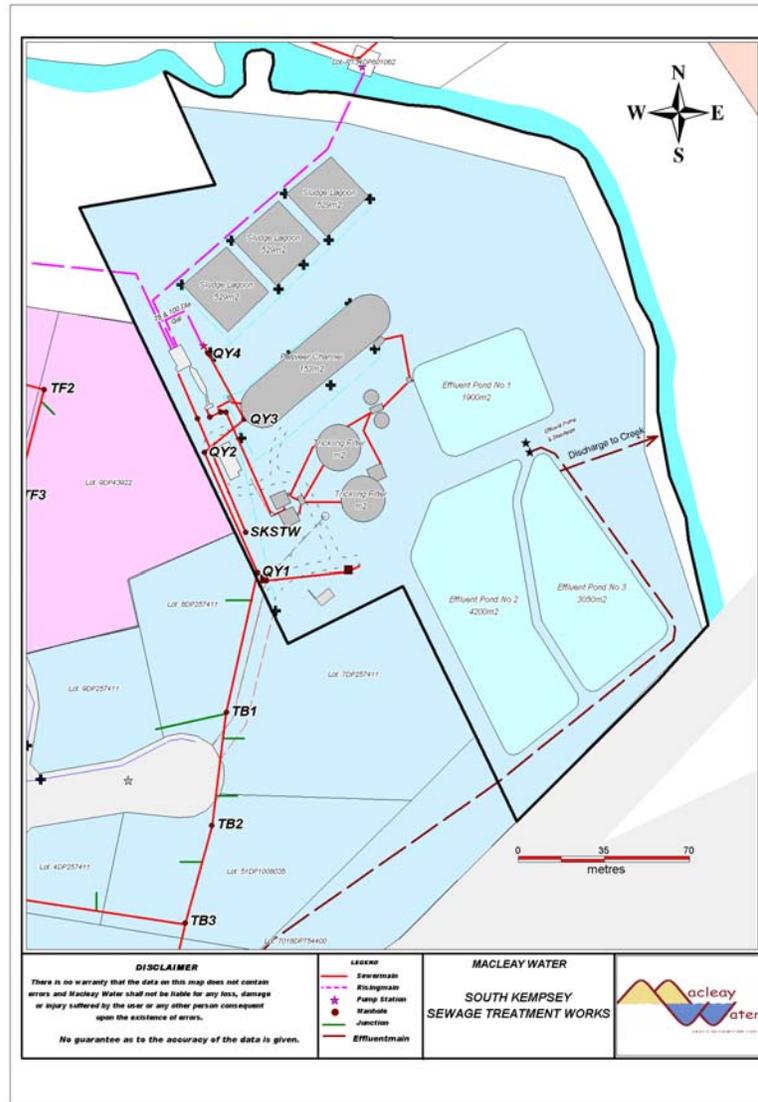
**Figure 2:** *South Kempsey sewage treatment plant lay out*

There are also three [3] Effluent ponds including a catch pond. The effluent ponds have a detention time of 10 days at ADFW for a 5400 EP. Other features of the Plant include:

- Storm bypass from the balance tank to the catch pond.
- 3 sludge lagoons.
- Supernatant pump station
- Sludge pump to return humus sludge to head of works.
- New amenities building.
- Programmed sludge withdrawal system.

The wastewater transportation system is divided into 3 separate systems which independently discharge to the Wastewater Treatment Works.
