SELECTING SEWER MAINS FOR AN ANNUAL CCTV INSPECTION PROGRAM

Alan Tonks, Technical Officer,

Goulburn Valley Water

73rd Annual Water Industry Engineers and Operators' Conference Bendigo Exhibition Centre 31 August to 2 September, 2010

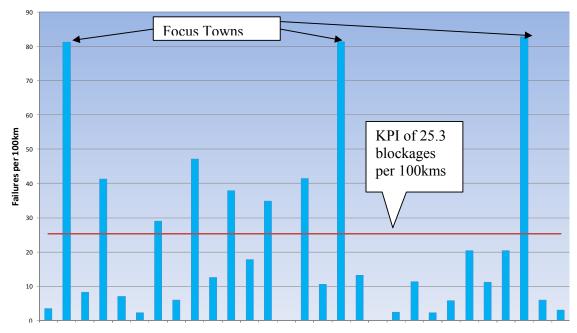
A review of the GVW sewer network identified that particular serviced towns had a higher sewer blockage rate than others and that some pipe cohorts were also more prevalent to sewer blockages. Sewer blockage rates for GVW serviced towns for 2010 is presented in Figure 1.

Figure 1: Sewer Blockage Rates for GVW Towns 2010

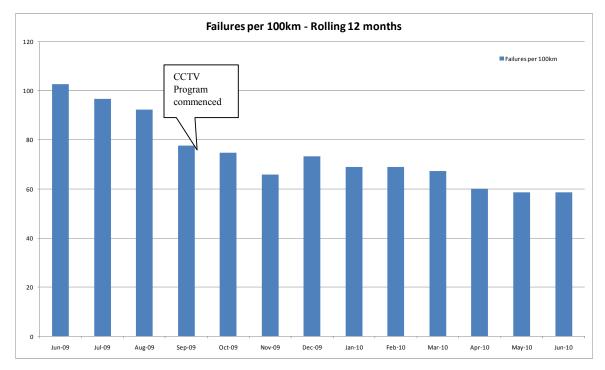
The failures per 100km shown in Figure 2 are of a town within the Corporation that received focused CCTV treatment due the high sewer blockage rate. The figure shows that since the CCTV program started in October 2009 there has been a 16 point decrease in the blockages per 100km.

Figure 2: Sewer Blockage Rates for CCTV Focus Town
