pH BUFFERING IN THE GREAVES CREEK WATER SUPPLY SYSTEM

*67th Annual Water Industry Engineers and Operators' Conference
Sports and Leisure Centre - Wodonga
1 and 2 September, 2004*

Carolyn Haupt, *Production Officer*, Sydney Water

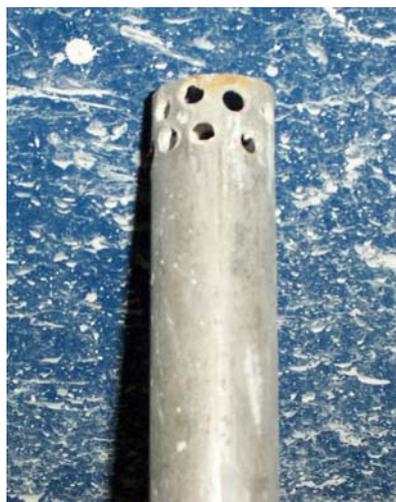
As a part of this project, the suction tubes of the venturi system were changed from the original design (Figure 4). The production officer's at the plant had noted a strong correlation between lime blockages in the suction tubes and the lime dose rate. At a final water alkalinity of less than 20mg/L there were few problems with lime blockages in the suction tubes.

The suction tubes were re-designed to draw lime through the bottom of the tube (diameter 20 mm), and the tube length was shortened to prevent sludge from the bottom of the tank being dosed. The plant team also introduced regular flushing of the sludge from the base of the tank, and made some minor modifications to the mixers to prevent sludge build up.

Figure 4: Lime System Suction Tube Prior to Modifications. Hole Diameter = 3mm
