Vibration & Condition Monitoring in the Water Industry

Noise and Vibration can be an environmental problem as well as the cause of potential damage to valuable assets.

Vipac Engineers & Scientists have been called on to assist in ascertaining the cause of vibration and noise within the water infrastructure and coming up with innovative solutions.

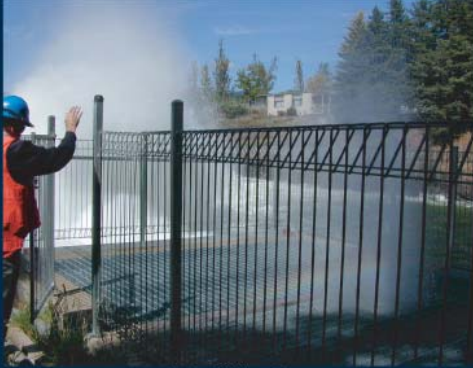
Lake Eildon Dam

In the cases highlighted here, a howling noise and severe vibration was occurring on a water outlet at the gate opening when the water reached certain levels.

Vibration measurements were taken to determine the cause and assess the structure for damage.

As water flowed past the bottom gate, vortices were created giving rise to periodic force being exerted on the structure. When the vortex shedding frequency matched the resonant frequency of the gates, the vibrations are amplified until the gates operating conditions change.

Vipac recommended that the water pass through the gate rapidly at a certain water level or avoid setting the gate within a certain range to minimise the vibration.

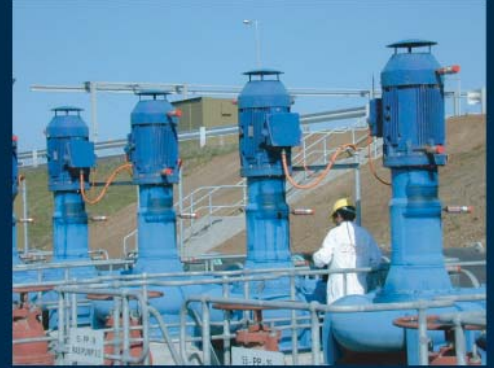
Pump Station, Werribee

Another investigation involved noise and vibration on pumps in a Pumping Station in Werribee.

Audible noise occurred when the pump was running at a fixed speed and was coming from the pump housing. Adjusting the speed of the pump did not affect the vibration or noise. The noise & vibration was determined to be caused by cavitation.

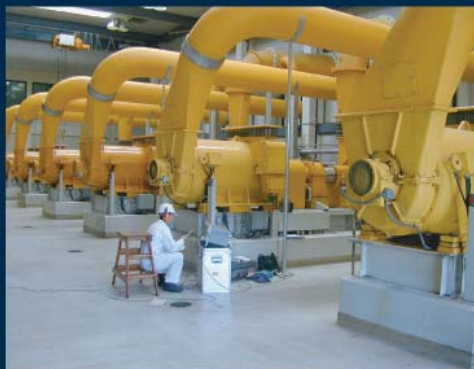
Water Treatment Plant, Chelsea

During operation testing, it was found that vibration was occurring to some parts of the water outlet structure during selected water flow rates of various water levels. The vibration occurred around 80%-90% of valve opening and caused looseness/breakage of the hold down bolts of the backlash plate.

The evaluation of the vibration level in relation to the concrete structure and the access of the orifice plate, determined that breakages were caused by the orifice resonance vibration generated by the water inflow turbulence and exposure to long hours with this condition.

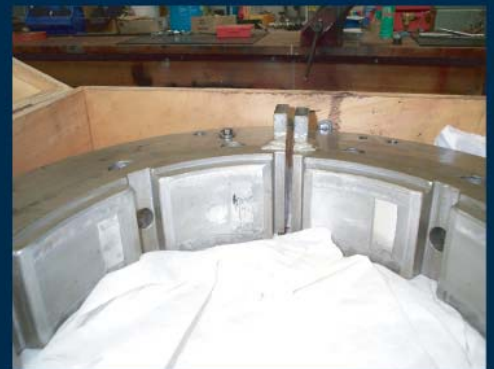
Vertical Pump Bearing Wear by the Pump Resonance
