WATERWORKS

OFFICIAL JOURNAL OF THE WATER INDUSTRY OPERATORS ASSOCIATION

June 2009

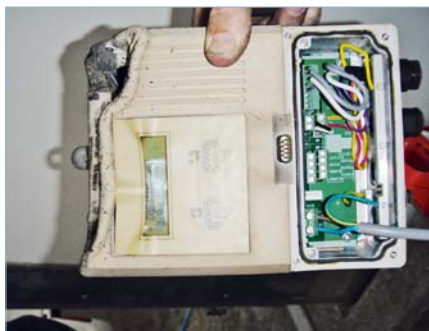
Melted instrument controller which, miraculously, was still functioning even though everything it had been connected to had been destroyed.

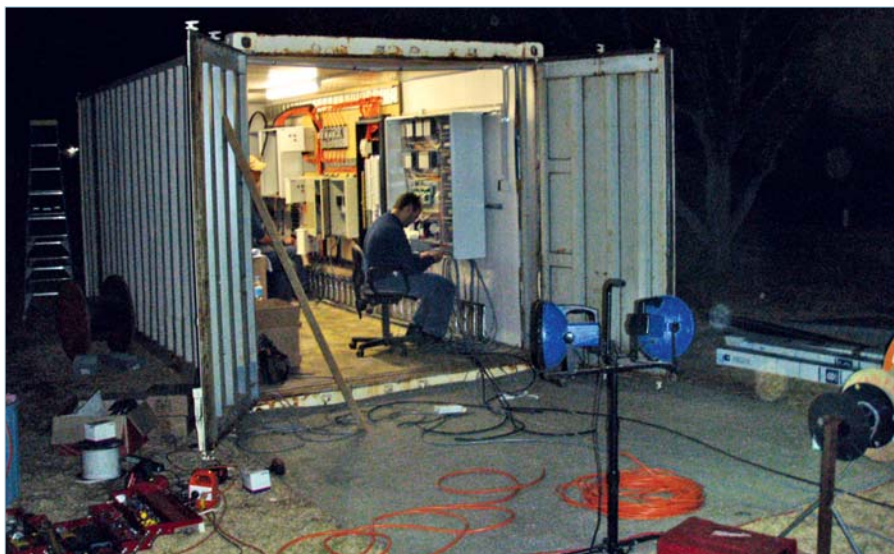
New switchboards being wired.

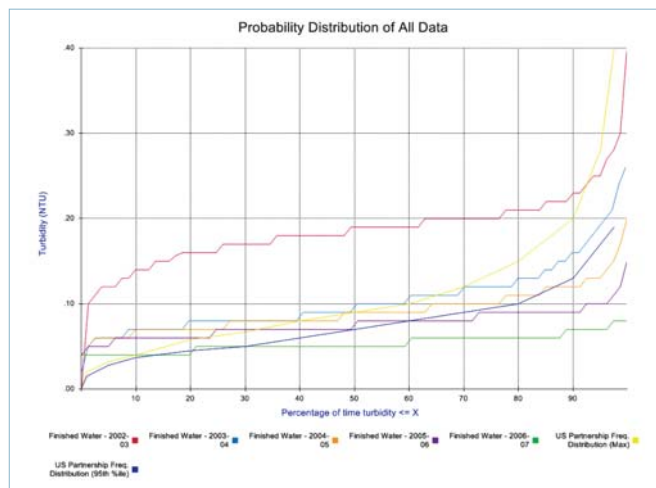
Figure 1. Cumulative probability curves for Utility 1 Plant 1 for the period 2002 to 2007.

This data set covers the 5 years 2003 to 2008 for two WTPs. Figure 1 shows the cumulative performance plots for one of the plants.

The line for 2003 is well above that for the PfSW plants and indicates poor performance and generally unsafe drinking water. There is then a progressive improvement in the quality of the water over the next 4 years with the data for 2006-2007 well below the US PfSW lines. This shows clearly the benefit of the improvement program implemented by that utility. Figure 2 shows the simple time plots of the turbidity for the two years. Clearly performance in 2006-2007 is far better than that in 2003.

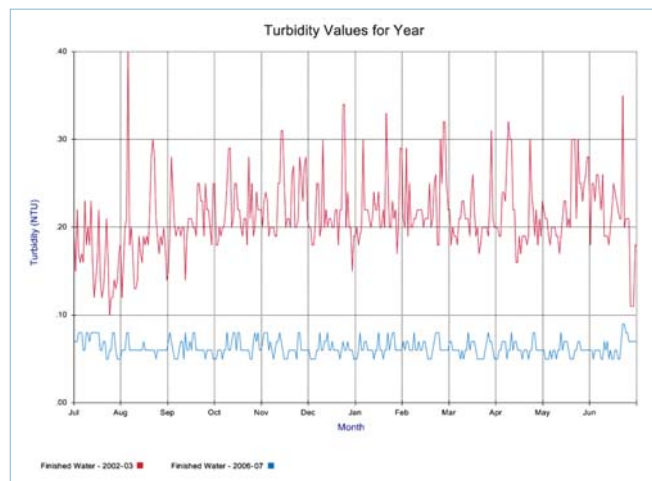
Figure 2. Simple time series plots for Utility 1 Plant 1 for the years 2002-2003 and 2006-2007.

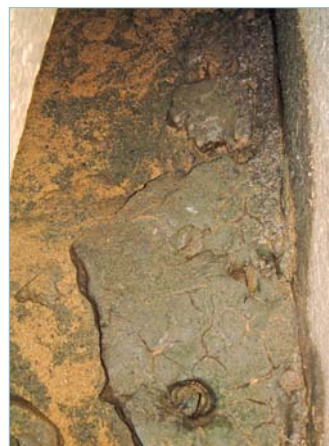
Figure 4. The state of the filters in 2003 in Plant 1 Utility 1.

The three types of graphs combine to provide a powerful and clear reporting tool. Just to complete the picture of this period at Utility 1, Figure 4 shows the state of the filters at Plant 1 in 2003 where a thick layer of mud covered most of the surface of the sand filters and filter performance was at best marginal.

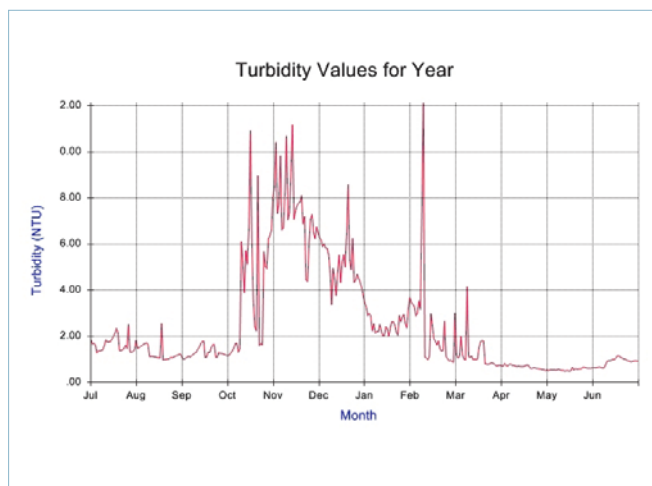
Figure 6. Times series turbidity data for the raw water supplying Plant 2 (Utility 2).

Turbidity data for the raw water supplying Plant 2 shows a significant period of elevated turbidity from October to January (Figure 6).

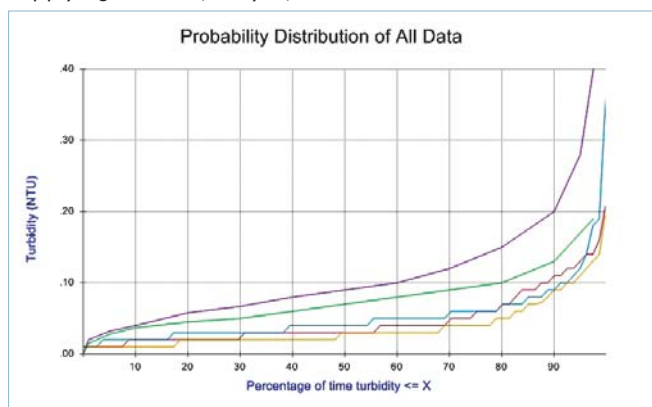
Figure 8. Cumulative frequency distributions for filters 1,2 and 6 at Plant 2 (Utility 2).

Analysis of the cumulative frequency distribution graphs for filters 1, 2 and 6 (Figure 8) shows very good performance despite the slight increase in filtered water turbidity seen in Figure 7.

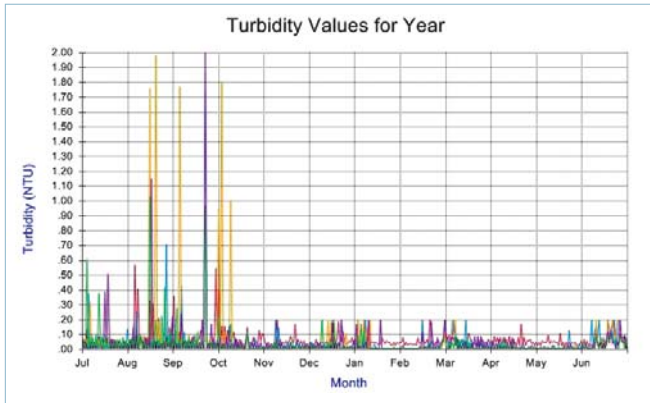
Figure 11. Time series turbidity data for filters 1 to 5 at Plant 3 (Utility 2). Note the greater variability in data from July to October 2006. This could be due to poorer performance of the turbidity meters.

Importantly however, the increases in turbidity in the raw or settled water are not reflected in the filtered water turbidity which remains consistently low during the period of elevated raw and settled water turbidity (Figure 11). This indicates the filters are performing very well despite these periods of increased load.

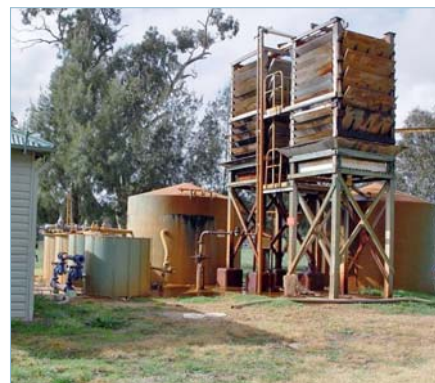
Figure 1. Tarcutta Water treatment plant as it was.

Prior to the upgrade, treatment included aeration followed by contact time and then sand filtration. The village water had not previously been chlorinated and the residents were generally very happy with the unchlorinated supply. Figure 1 shows a picture of the plant prior to commencing any work.

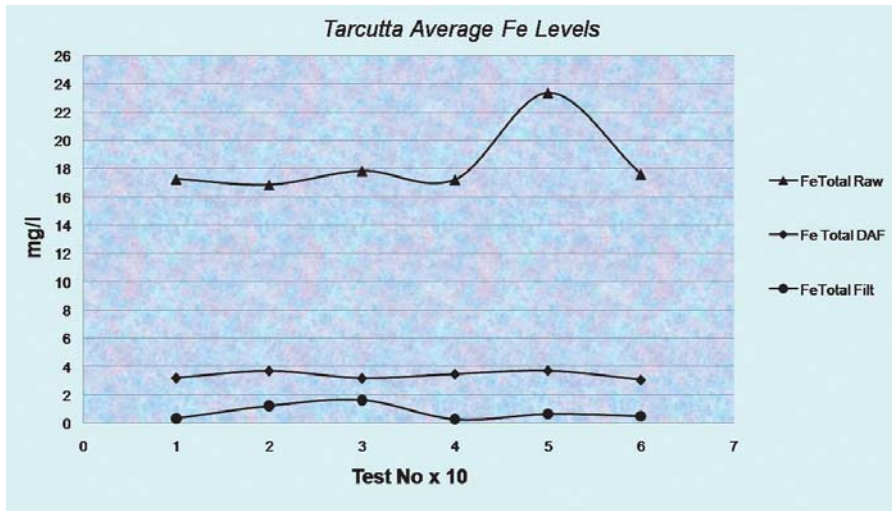
Figure 2. Performance of the DAF trial plant for iron removal.

Figure 2 summarises the DAF/Filtration train performance over an extended period.

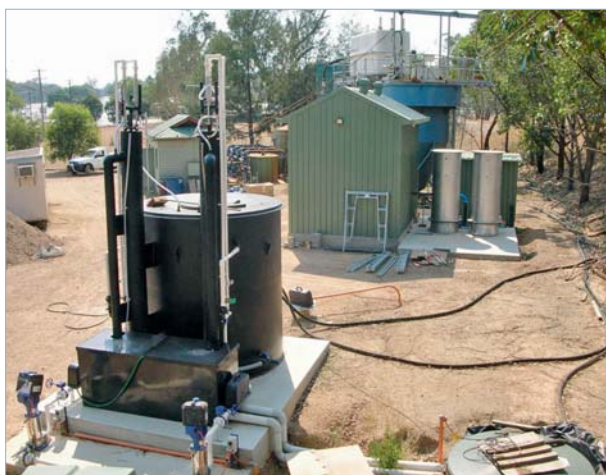
Figure 4. Tarcutta WTP upgrade progress to date (February 2009).

Currently the new treatment plant is under construction (Figure 4). A Deferum filter has been purchased from Pure Water Corporation based in Western Australia and installed on-site; the filter is capable of approximately 500 kL/day production. Stainless steel filters for the DMI65 media have been supplied by Water Treatment Australia.

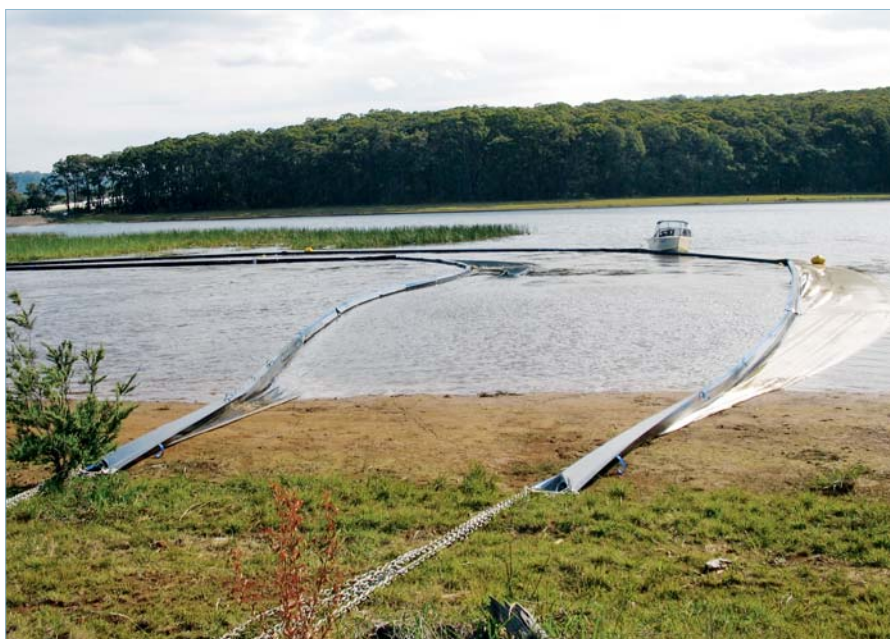
Figure 1. The double curtain system in place at the Silvan Reservoir.

To minimise the impact of the scouring of the YVC on water in Silvan reservoir, it was decided to install silt curtains in the reservoir as a barrier to the high turbidity water that would be entering Silvan. Due to the location of the inlet and the force of the flow, a double curtain system was installed (Figure 1). The first curtain was configured to reduce the velocity of the water entering the reservoir and to spread the flow across the length of the curtain. In addition the primary curtain would provide primary removal of large particles (>70micron). The second curtain featured a high strength polyester skirt to screen fine particles >10 microns.

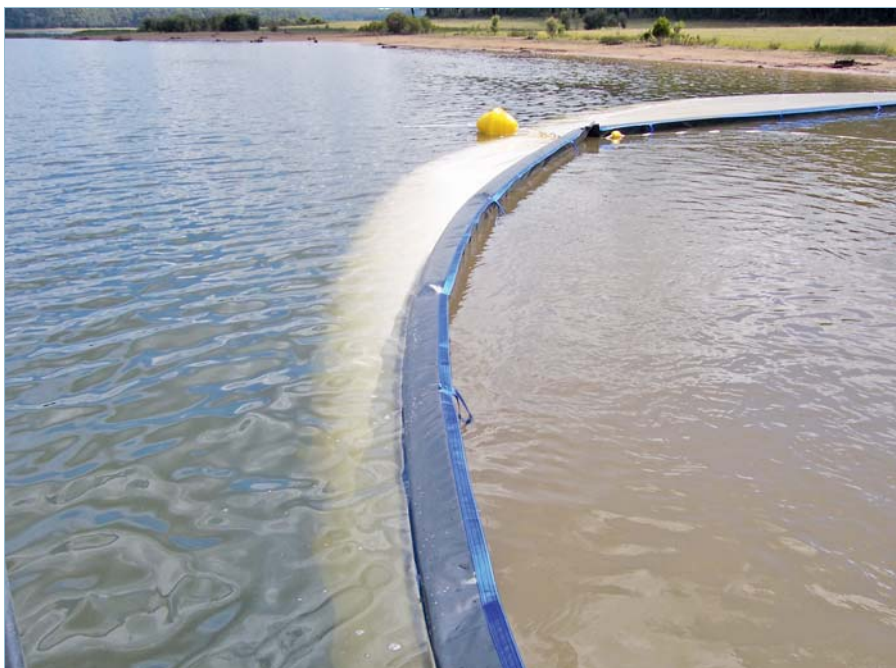
Figure 3. The silt curtain in operation with high turbidity water on the upstream side.

The turbidity of the water beyond the second curtain remained reasonably constant throughout the recharge (Figure 3) and only started to increase towards the end of the day when the turbidity gradually rose from 2 to 3 NTU. There was an obvious plume that short circuited beneath the curtain mainly via the inlet channel but this water only extended approximately 20m from the curtain and settled quickly.

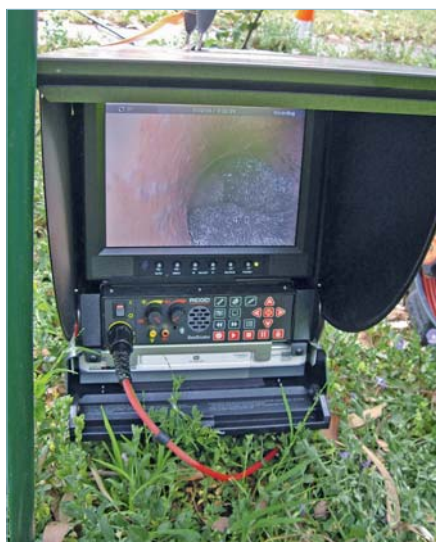
Figure 2. CCTV being used in the field.

In cases where the blockage is difficult to clear or there is evidence of broken pipes, the contractor will proceed to issue a scheduled job to CCTV (closed circuit television) the HCB (Figure 2).

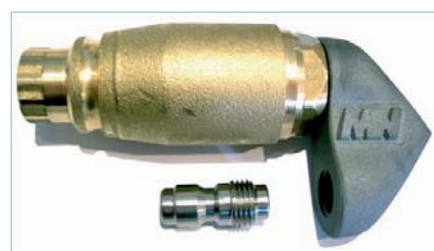
Figure 3. A high pressure nozzle.

SRU consisted of a light commercial van with high pressure pipe clearing (Figure 3) and CCTV equipment.

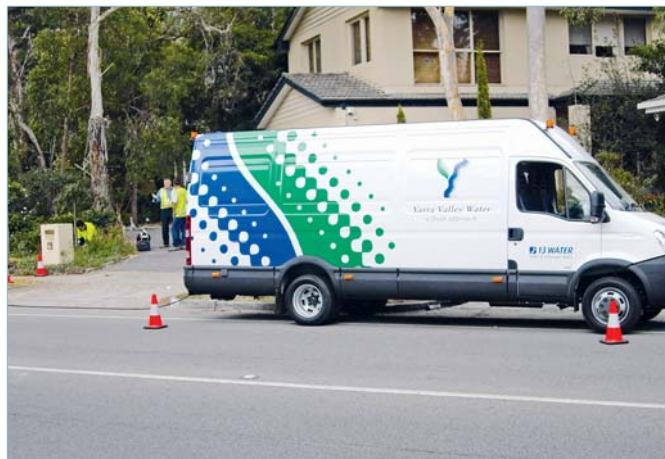
Figure 4. One of the new sewer response vans.

In September 2007 two SRU vans fitted out with specialist high pressure pipe cleaning and CCTV equipment were purchased by YVW for a cost of \$275K

(Figure 4). Two new operators were employed and trained in the SRU's use.
