**IN THE DEEP END! BUSHFIRES, FLOODS,
MUDSLIDES AND SWIMMING POOLS**

Mark Samblebe, *Water Treatment Technologist,*

Gippsland Water

*33rd Annual Qld Water Industry Operations Workshop
Indoor Sports Centre, Carrara – Gold Coast
3 to 5 June, 2008*

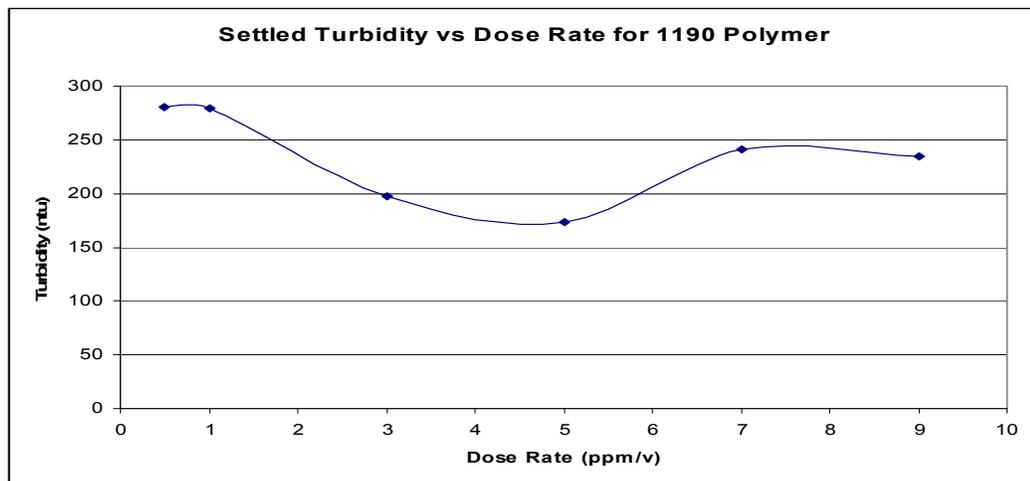
Polymer 1190 was trialled and found to be unsuitable as a coagulant/flocculant reducing turbidity as seen in Figure 1, where optimal dose resulted in settled water turbidities of >150ntu.

Figure 1: Jar Test Results for Polymer 1190

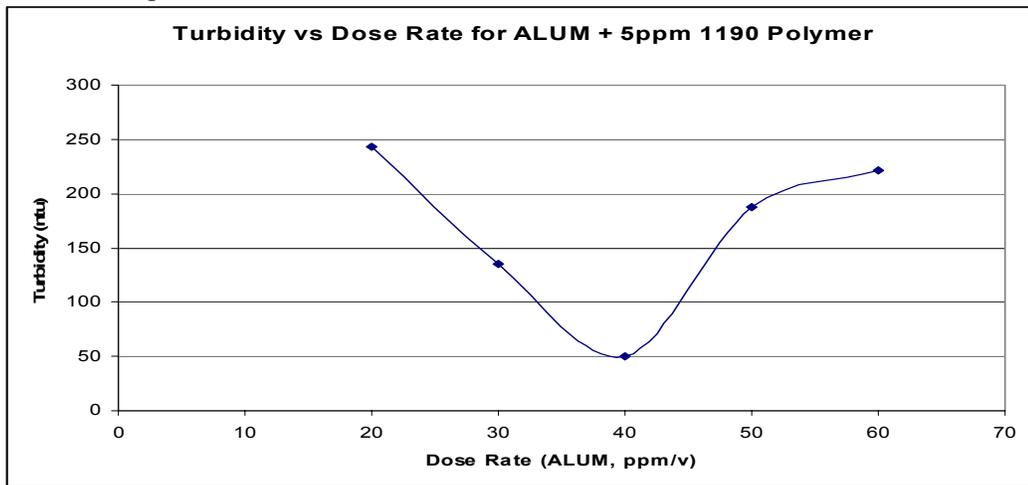
Alum was then dosed in conjunction with 1190 (at 5ppm which showed best results in first trial) showing improved results as seen in Figure 2. Settled turbidities were reduced to 50ntu. Although to improve performance pH correction was required, and was disregarded due to increasing complexity of the process fairly narrow working range also

makes this option less attractive.

Figure 2: Jar test results for Alum

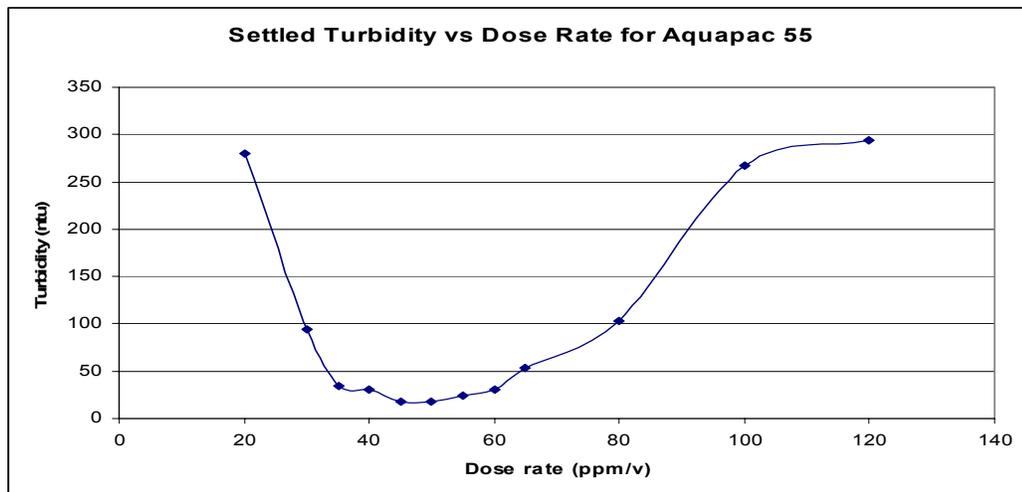
Aquapac55 was tested showing much improved results. Figure 3 shows settled water turbidities of 17ntu at the optimal dose rates, which would be expected to improve in the actual application due to the extra settling time that will be available on site. 45 and 50ppm/v were the optimal dose rates.

Figure 3: Aquapac55 jar test results

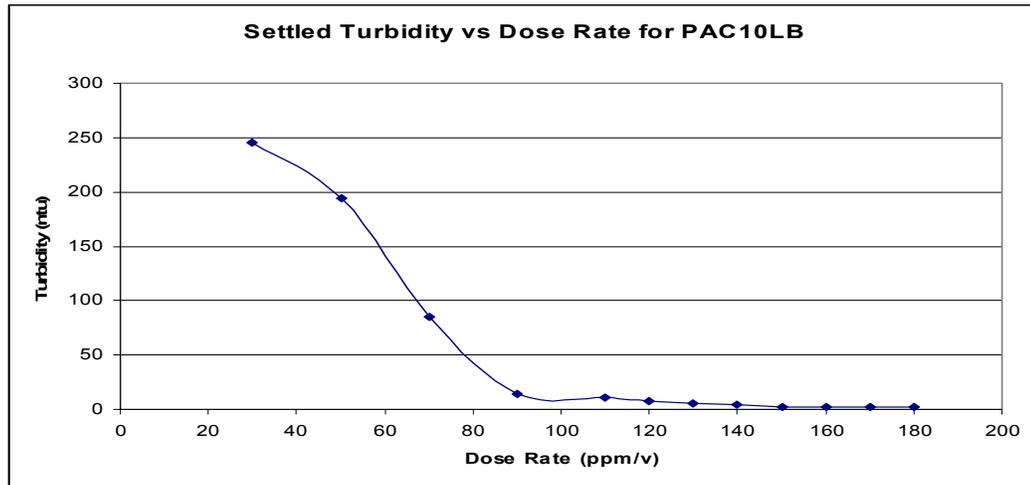
The preferred Chemical for flocculation proved to be PAC10LB (10% PolyAluminiumChloride – Low Basicity) as shown in Figure 4. Results of jar tests using PAC10LB gave excellent results with a very broad working range which suits the application and experience of operators likely to manage the system once installed. Settled turbidities of less than 2ntu were achieved.

Figure 4: PAC10LB Jar test results

The ability of PAC10LB to floc over such a wide range of dose rates was seen as an ideal characteristic, to ensure successful operation of the system. All other chemicals not only produced higher settled water turbidities, but also had a narrower working range which increased the level of expertise and control operators would need to have to keep the system working, especially where raw water turbidities varied so widely in such short time frames.

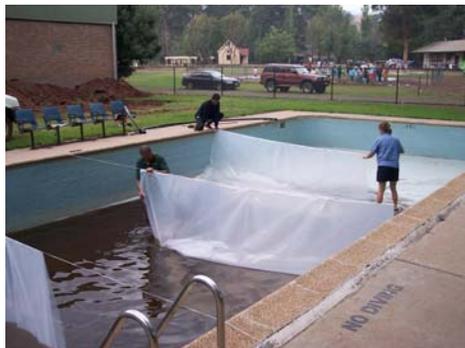
The concept for system was starting to take shape, and to minimise sludge migration through the pool three plastic baffles were installed to ensure the pool did not short circuit and as much sludge as possible was retained. Figures 5 & 6 show the temporary baffles being installed by Lions club volunteers and GW staff, and the Macallister River at 4000ntu.

Figure 5: Temporary baffles in the Licola swimming pool

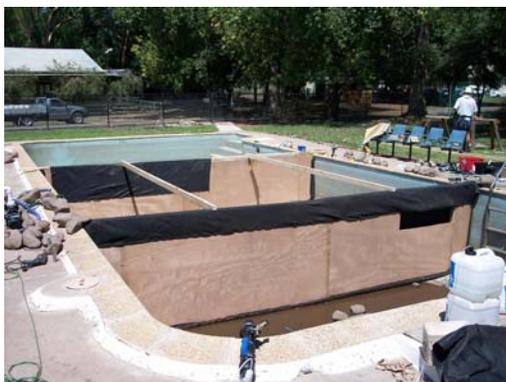
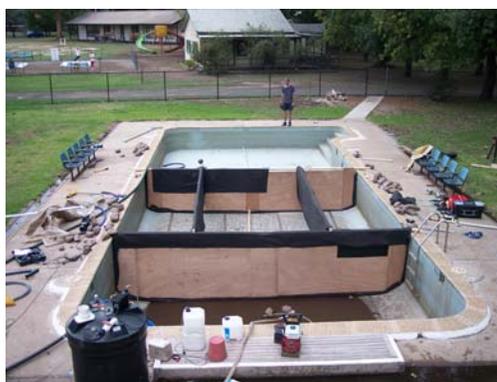
Aeramix were contacted for help with the PAC mixing system, and proved again that the water industry does have a heart, donating a mixer and a days labour to install and commission the PAC mixing and dosing system (Figure 9). In addition to this, we also needed to deal with the sludge migration problem! Aeramix donated more time to assist with construction of a more permanent solid baffle system as seen in Figure 7 and 8.

Figure 7: *Licola swimming pool baffles*

Figure 8: *Licola swimming pool baffles*

After installation of the PAC dosing system chlorine residuals increased and were maintained into the reticulation system at satisfactory levels. The solid baffles worked much better at keeping sludge from migrating throughout the pool reducing the amount of time and effort required to remove sludge significantly, as well as enabling the process to be run as a “flow through” rather than “batch” system.

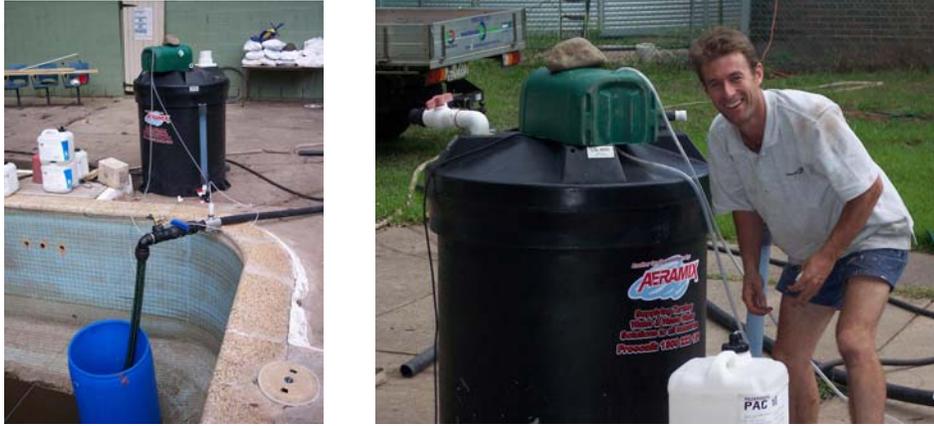
Chemical mixing was improved by adding a 200L container to the flocculation zone into which the inflow entered. It was half filled with rocks to improve the rapid mix and spread the flow to minimise short circuiting of the flocculation and settling zones and provide better mixing to aid floc formation at the inlet to the flocculation area (Figure 9).

Figure 9: *PAC mixing system and Jerry rigged rapid mixing and diffuser tank*
