**IN THE DEEP END! BUSHFIRES, FLOODS,
MUDSLIDES AND SWIMMING POOLS**

Mark Samblebe, *Water Treatment Technologist,*

Gippsland Water

*2nd Annual WIOA NSW Water Industry Engineers & Operators
Conference
Jockey Club - Newcastle
8 to 10 April, 2008*

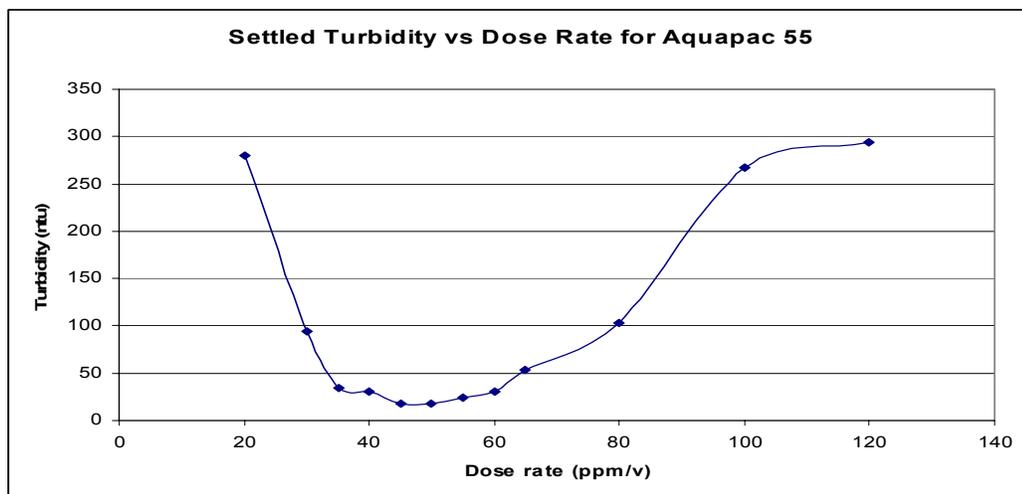
Aquapac55 was tested showing much improved results. Figure 3 shows settled water turbidities of 17ntu at the optimal dose rates, which would be expected to improve in the actual application due to the extra settling time that will be available on site. 45 and 50ppm/v were the optimal dose rates.

Figure 3: Aquapac55 jar test results

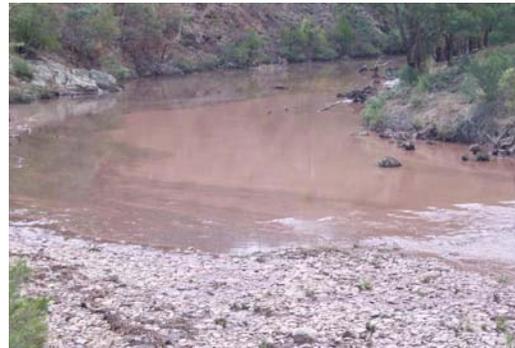
Figure 6: Macallister River, 4000ntu.
