# **CASE STUDY: BIO-AUGMENTATION OF DRU POINT WASTEWATER LAGOON AT MARGATE, TASMANIA**

**Craig Griggs**, *Team Leader Wastewater Treatment Plants,*

*71<sup>st</sup> Annual Water Industry Engineers and Operators' Conference  
Bendigo Exhibition Centre  
2 to 4 September, 2008*

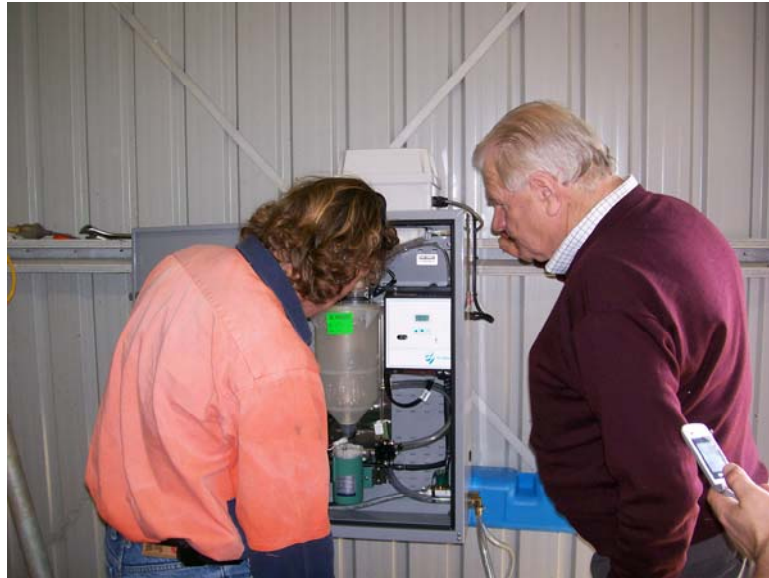
**Figure 1:** *Chemsearch’s Peter Bennett explaining the operation of the Bioamp to Council Treatment Plant operator Marcus O’Reilly. The Bioamp installed inside inlet screen room at The Dru Point Wastewater lagoons 13/10/07*

Bioamp is a programmable self contained unit that automatically dispenses live bacteria into the wastewater stream. The Bioamp system is a combination of two unique parts. The Bioamp GT unit, developed and patented by NCH (the parent company of Chemsearch) is an automated, computer controlled delivery system for a unique biological product called Freeflow.

The bacteria are activated and grown in the unit for 24hrs then dosed into the wastewater stream at a programmable desirable time which would be at the low flow to optimise the performance of the bacteria.

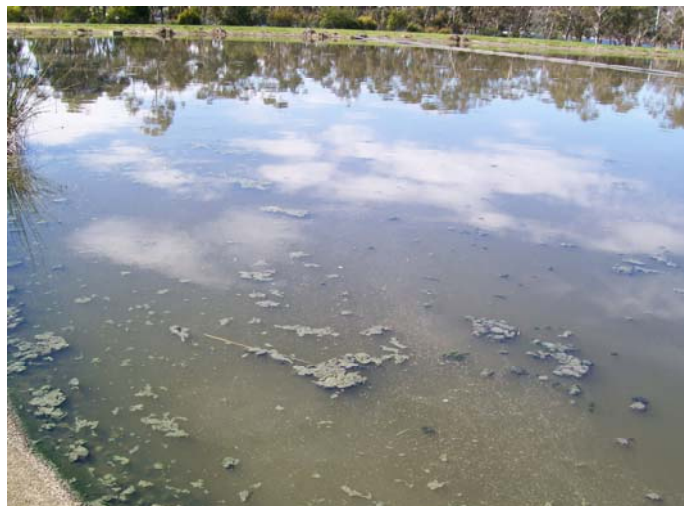
**Figure 2:** *Top end of Primary Lagoon showing algae and floating sludge on day of installation of Bio Amp (13/10/07). This was indicative of all of the primary lagoon. The floating sludge and algae settled in the corners of the lagoon depending on the wind direction. This caused odour*

*problems.*

Figures 2 & 3 above show a marked improvement in the appearance of the lagoon. The floating matter has disappeared which indicates the Bioamp is working on reducing the sludge level of the lagoon system. This will reduce the capital costs to remove excess sludge from the system. I believe we need to continue to use the Bioamp system as it is a very effective low cost solution to improve the effluent quality that is being discharged into very sensitive receiving waters

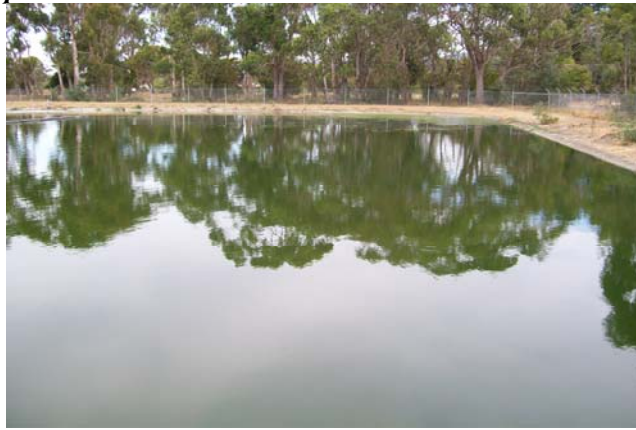
**Figure 3:** *Top end of Primary Lagoon showing a marked improvement of lagoon with no floating sludge 4/02/08.*
