KAWANA STP UPGRADE ISSUES.....UNPLUGGED!!

Stephen Will, *Operator* Sunshine Coast Regional Council

This paper focuses on selected upgrade experiences associated with the commissioning in 2005 as well as the plant's performance in the first two years of operation after this upgrade.

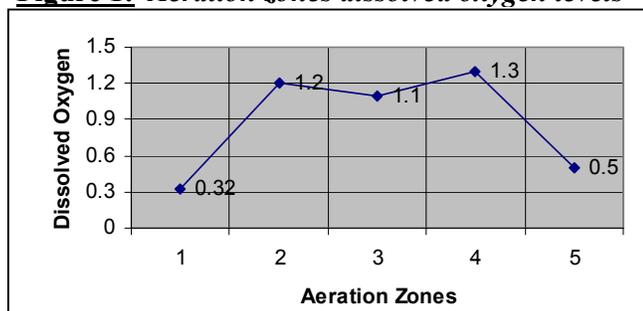
Figure 1: Aeration zones dissolved oxygen levels

a glimpse of the typical DO trend in the aeration zones performance under load during the hours from 7am until 3pm is shown in Figure 1 below. Notice that the DO drops in zone # 5. This could be because of the aerators not keeping up with the hydraulic capacity, but this is yet to be confirmed. DO is only achieving set point of 1.5 in zone # 5 during off peak flow periods.
