# CASE STUDY: BIO-AUGMENTATION OF DRU POINT WASTEWATER LAGOON AT MARGATE, TASMANIA

**Craig Griggs**, *Team Leader Wastewater Treatment Plants,*

*3<sup>rd</sup> Annual WIOA NSW Water Industry Engineers & Operators  
Conference*

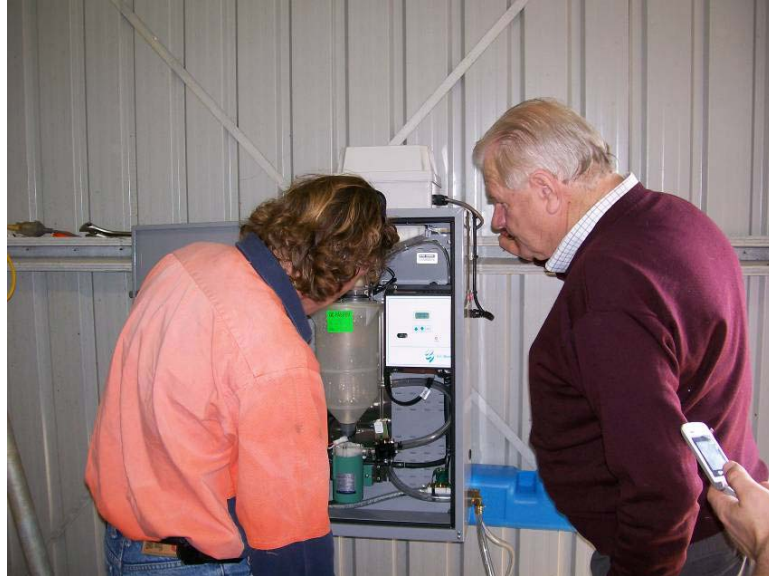
**Figure 1:** *Chemsearch’s Peter Bennett explaining the operation of the Bioamp to Council Treatment Plant operator Marcus O’Reilly. The Bioamp installed inside inlet screen room at The Dru Point Wastewater lagoons 13/10/07*

Bioamp is a programmable self contained unit that automatically dispenses live bacteria into the wastewater stream. The Bioamp system is a combination of two unique parts. The Bioamp GT unit, developed and patented by NCH (the parent company of Chemsearch) is an automated, computer controlled delivery system for a unique biological product called Freeflow.

The bacteria are activated and grown in the unit for 24hrs then dosed into the wastewater stream at a programmable desirable time which would be at the low flow to optimise the performance of the bacteria.

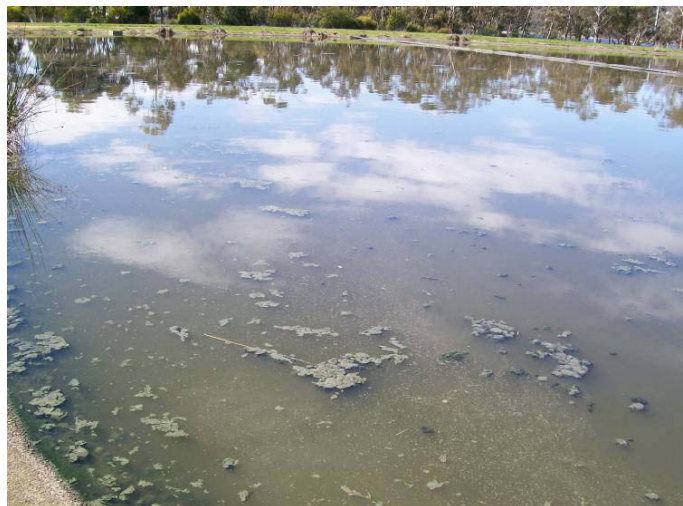
**Figure 2:** *Top end of Primary Lagoon showing algae and floating sludge on day of installation of Bio Amp (13/10/07). This was indicative of all of the primary lagoon. The floating sludge and algae settled in the corners of the lagoon depending on the wind direction. This caused odour*

*problems.*

We were having trouble controlling algae and sludge settling in the primary lagoon. The sludge was floating to the surface and the wind was pushing it into the corners of the lagoon where it was causing an odour source.

Figures 2 & 3 above show a marked improvement in the appearance of the lagoon. The floating matter has disappeared which indicates the Bioamp is working on reducing the sludge level of the lagoon system. This will reduce the capital costs to remove excess sludge from the system. I believe we need to continue to use the Bioamp system as it is a very effective low cost solution to improve the effluent quality that is being discharged into very sensitive receiving waters

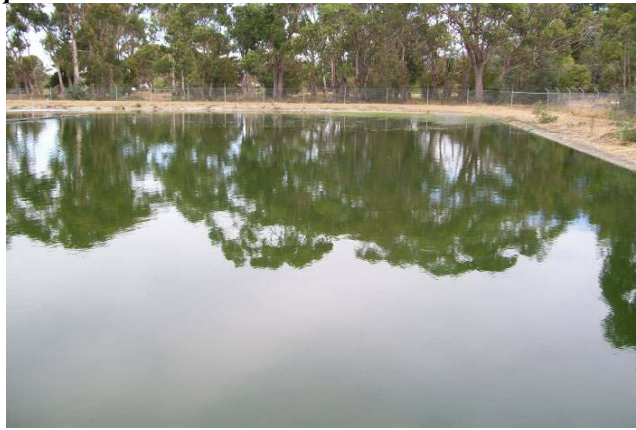
**Figure 3:** *Top end of Primary Lagoon showing a marked improvement of lagoon with no floating sludge 4/02/08.*
