# **INNOVATIVE SEWER BLOCKAGE MANAGEMENT TECHNIQUES; THE BENEFITS, GREATER IMPACTS AND BETTER OUTCOMES**

**John McCoy, General Manager,**

**Bartlett's Waste Management**

*72<sup>nd</sup> Annual Water Industry Engineers and Operators' Conference  
Bendigo Exhibition Centre  
1 to 3 September, 2009*

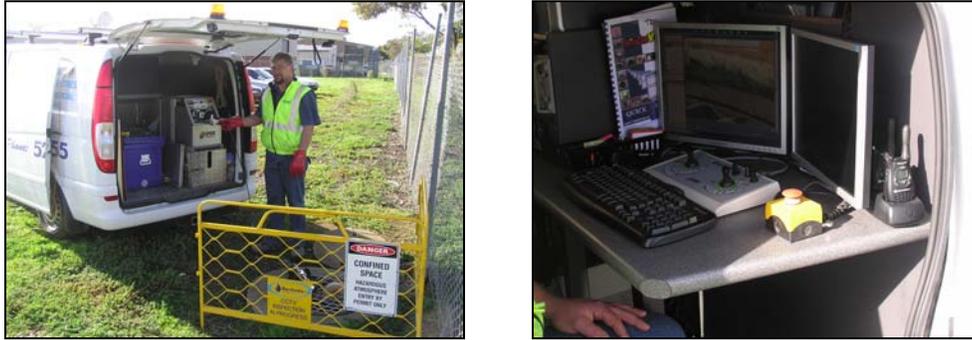
The spot spray process combines the use of the CCTV tractor with a spray arm fitted to the underside of the tractor for the purpose of spraying any tree root intrusions. A separate spray line delivers the herbicide to the spray arm that feeds out from the back of the CCTV van. The spray line delivers the herbicide at the speed CCTV tractor is travelling through the sewer main. The camera operator is in control of delivering the herbicide to the spray arm as required via a motorised solenoid switch mounted beside the camera controls within the van. Figure 2 shows the camera van and on board control room with spray controller.

**Figure 2:** Camera van and on board control room showing dosing switch
