PROACTIVE SEWER MAINTENANCE PROGRAM

East Gippsland Water

73rd Annual Water Industry Engineers and Operators' Conference
Bendigo Exhibition Centre
31 August to 2 September, 2010

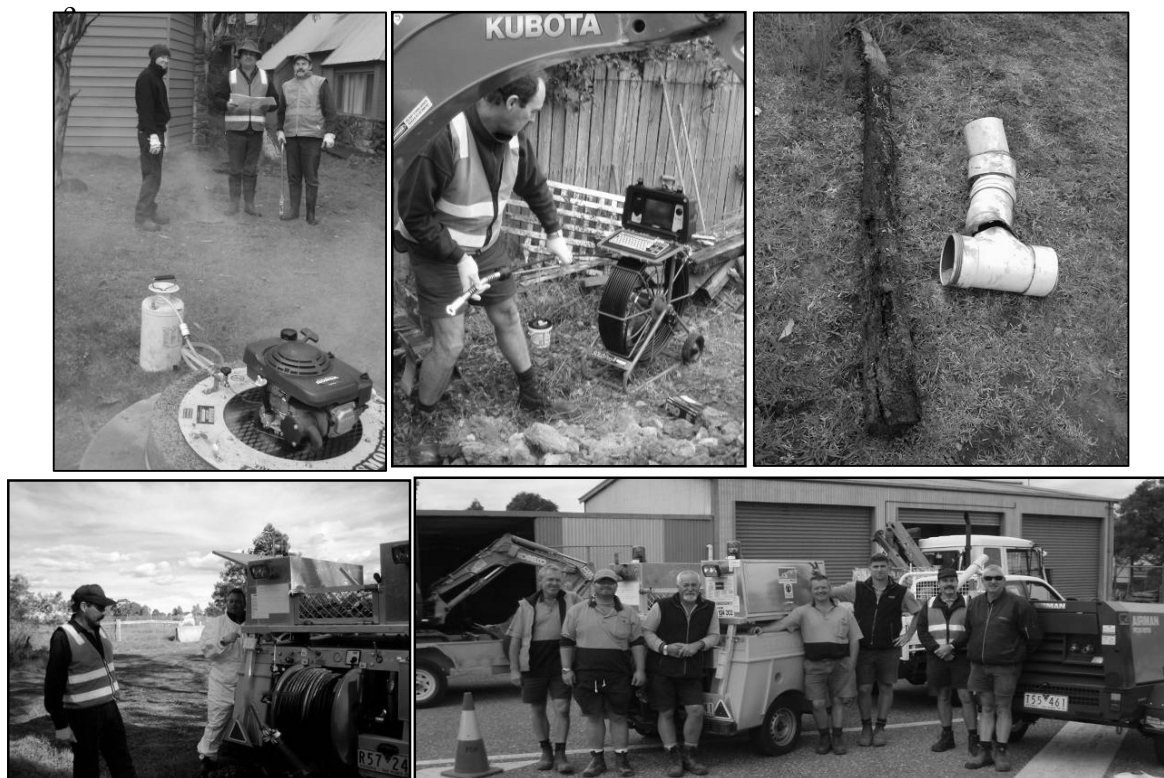
Below are examples of the sewer maintenance team and operations staff undertaking various proactive maintenance programs and investigations. Clockwise from left: smoke testing for infiltration at Dinner Plain, camera investigation / inspection of sewer main, example of root mass extracted from pipe, maintenance crew and sewer rodding

A specialist Sewer Maintenance Team has been formed to undertake both reactive and proactive responses to sewer issues such as blockages and spills. This team undertakes scheduled maintenance activities such as block sewer cutting, gathering visual data via a dedicated CCTV unit, smoke and dye testing (in suspected infiltration areas), routine manhole inspections, relining and replacement works. They are also involved in investigating and resolving issues that arise, for example, repeat sewer blockages and infiltration issues.

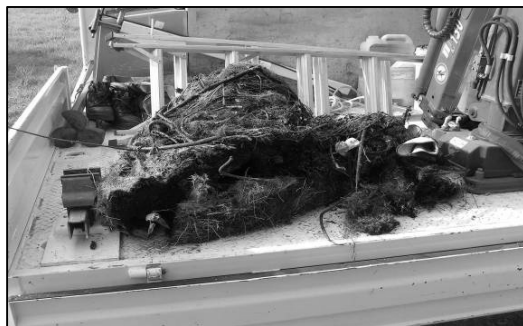
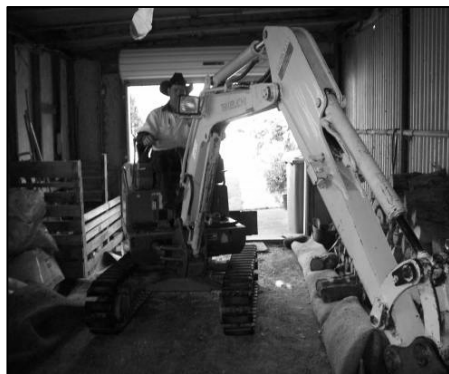
Examples of root masses removed from manholes (above) and some of the tricky situations (right) that can occur when undertaking repairs!
