OPTIMISATION OF SECONDARY TREATMENT AT BOWRAL STP

Chris Carlon, *Supervisor of Sewerage Plants & Pump Stations,*

*7th Annual WIOA NSW Water Industry Operations Conference
and Exhibition*

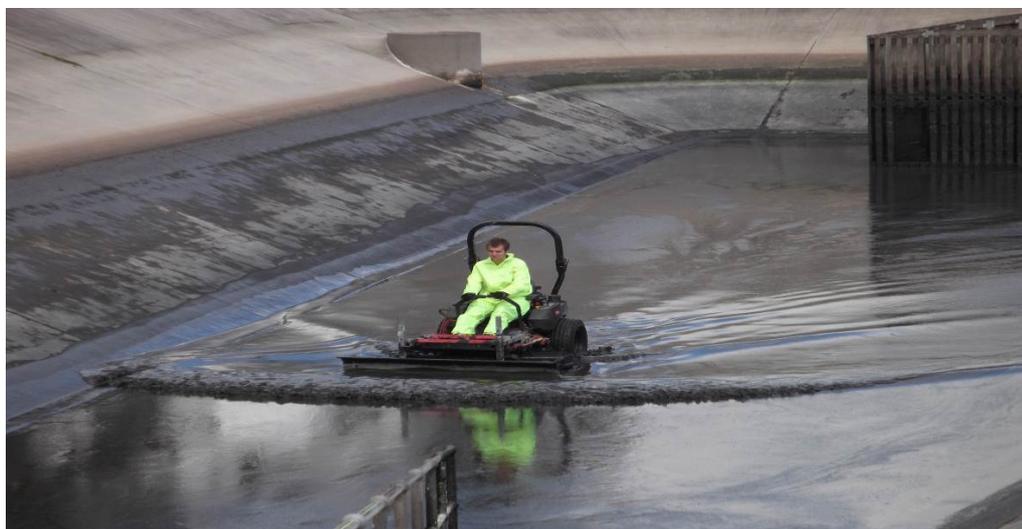
In the original design it was proposed that a creepy crawly sludge removal system be used to remove sludge from the catch pond. A trial of this system deemed it unsuitable for the application so we had to look at other alternatives to cleaning the catch pond. We programmed a project to install a sump and pump arrangement, including lifting equipment, access walkway and associated pipe work. We also included an extension of the re-use system which allowed us to use recycled effluent for cleaning and washing down the catch pond. This worked well but the size of the catch pond still caused us problems. With the catch pond being so big and opening up on the inlet end, and the fact that it was basically designed with a flat bottom, meant it was very time consuming to empty the catch pond and get the sludge to the sump.

Figure 1: *The blade attachment on the lawn mower*

The fact that our diesel pump can pump more than our supernatant system can handle means the level in the sludge lagoon must be closely monitored to prevent an overflow. By morning we are left with a layer of sludge in the bottom of the catch pond. We still have the problem that our pumps suction lines can only be utilised in the sump so we have to get the sludge to the sump. This required many hours of squeegeeing by up to five people. The innovative operators at the plant then designed and manufactured a blade with a rubber squeegee to attach to the front of the ride on mower at the plant (shown in Figure 1). This worked very well and led to a significant reduction in the time and the manual handling involved in carrying out the task.

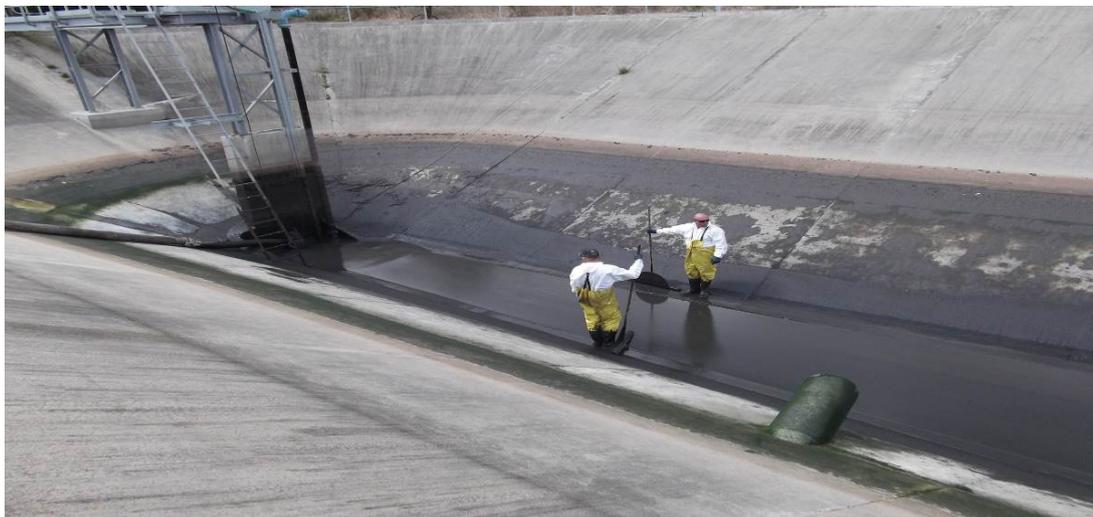
Figure 2: *Cleaning the catch pond*

The operators at the plant realised an operational procedure was necessary for this activity as it was going to be very disruptive to plant operations. The procedure involved the setting up of all necessary equipment during normal working hours on the previous day. The size of the catch pond means we cannot use the sump pump in the pond for emptying as the plant would be required to be off line for a week which is not operationally possible. To minimise the time to empty the pond we hire a diesel pump to ensure we can empty the pond in 8-10 hours. At 10.00 pm two staff go to the plant and carry out the plant shutdown which effectively isolates the catch pond ready for emptying. After shutdown and the isolation occurs, one person leaves the site. The other person stays on site all night to monitor the pumping.

This is necessary because we can't pump everything into the sludge lagoons as this would cause an overflow. While pumping clear effluent we deliver it to the filter feed pump station. When we start to pull sludge we change the delivery line to the sludge lagoon.
