## **WETALLA SOLAR HALL OPERATIONS 5 YEARS ON**

# WETALLA SOLAR HALL OPERATIONS - 5 YEARS ON

**James Coonan**, *Operator*, Toowoomba Region Council (Wetalla)

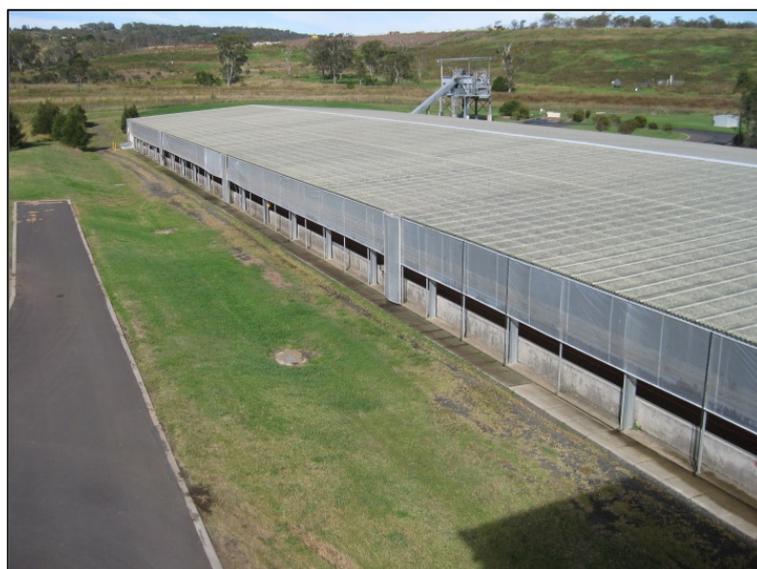
**Figure 2:** *Solar Drying Hall*

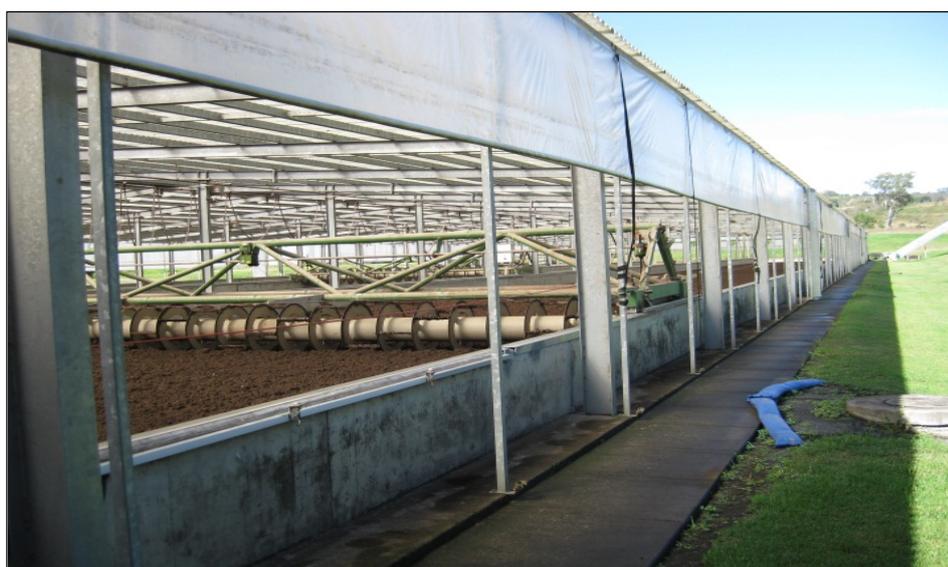
**Figure 3:** *Solar Drying Hall curtains*

The solar hall has an automated weather protection system using complex technical weather detection (weather station), and automated weather curtains that deploy along both sides of the hall to prevent rain interfering with the drying capabilities. This system has never been effective due to the curtains needing to lift once wind speed is above 20 km/h. Unfortunately the weather conditions in Toowoomba are such that much of our rainfall is storm generated and the curtains are in the raised position when this happens because of the wind speed. For the best use of the side curtains the automatic control system has been disabled and the curtains fixed about a third of the way down.

The automated curtain system is a highly technical response to a very simple problem. A simple extension of the alsynite roof beyond the wall line of the solar hall would be a possible effective substitution. As air flow is critical to the air drying process it is important to not substantially restrict air flow, and equally important to allow solar radiation to facilitate the drying process. This solution would meet both these criteria in a cost effective and maintenance free manner.

Over the last few seasons the downtime of the one hall due to weather conditions has been substantial. The shutdown time of one hall due solely to these weather conditions is estimated to be in the vicinity of six weeks per year.

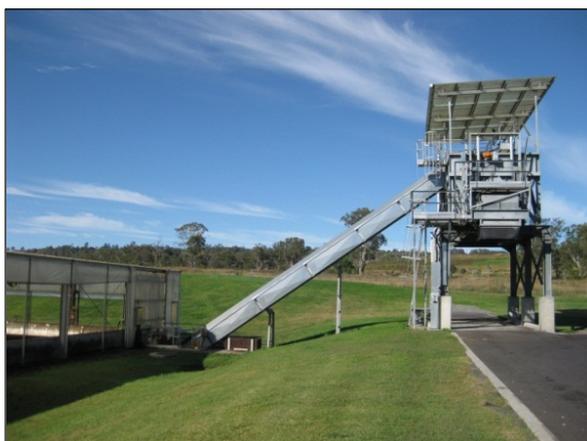
**Figure 5:**     *Conveyor to Dry Hopper*

The main concern of the initial design is the angle of elevation needed for the transfer of biosolids to the dry hopper. This inclined conveyor was originally a screw lift but due to clogging issues it was replaced with a flat belt conveyor. The flat belt conveyor was then replaced with a ribbed conveyor to enable the dry biosolids to be raised to the dry hopper.

The original design has the dry hopper positioned quite high above and close to the solar hall to allow under pass access for semi-trailers. This has meant the angle of elevation is quite steep and has led to substantial problems with the transfer of biosolids along the conveyor.

This change from screw to belt conveyor means we now have problems with belt slippage on the top roller, particularly during moist conditions when belt slippage is common.

Maybe the height of the dry hopper in relation to the solar hall is a major design factor that needs attention, reducing the angle of the incline conveyor to the dry hopper would result in substantially fewer failures. Not only would the conveyor system itself be simplified, e.g. non-cleared, but the total product displacement would be substantially increased.

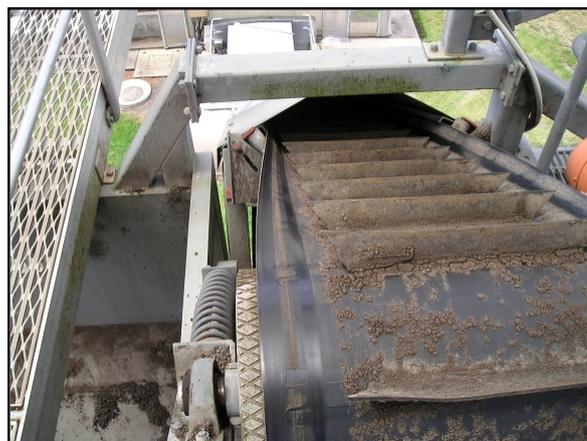
**Figure 6:**     *Cleated Conveyor*

A cleated conveyor was needed as a flat conveyor at this angle did not handle the load as rolling back of the biosolids on the incline conveyor belt keep clogging bottom causing conveyor failures.
