INCIDENT RESPONSE TO 2013 HARRIETVILLE BUSHFIRES

North East Water

*76th Annual WIOA Victorian Water Industry Operations
Conference and Exhibition
Bendigo Exhibition Centre
3 to 5 September, 2013*

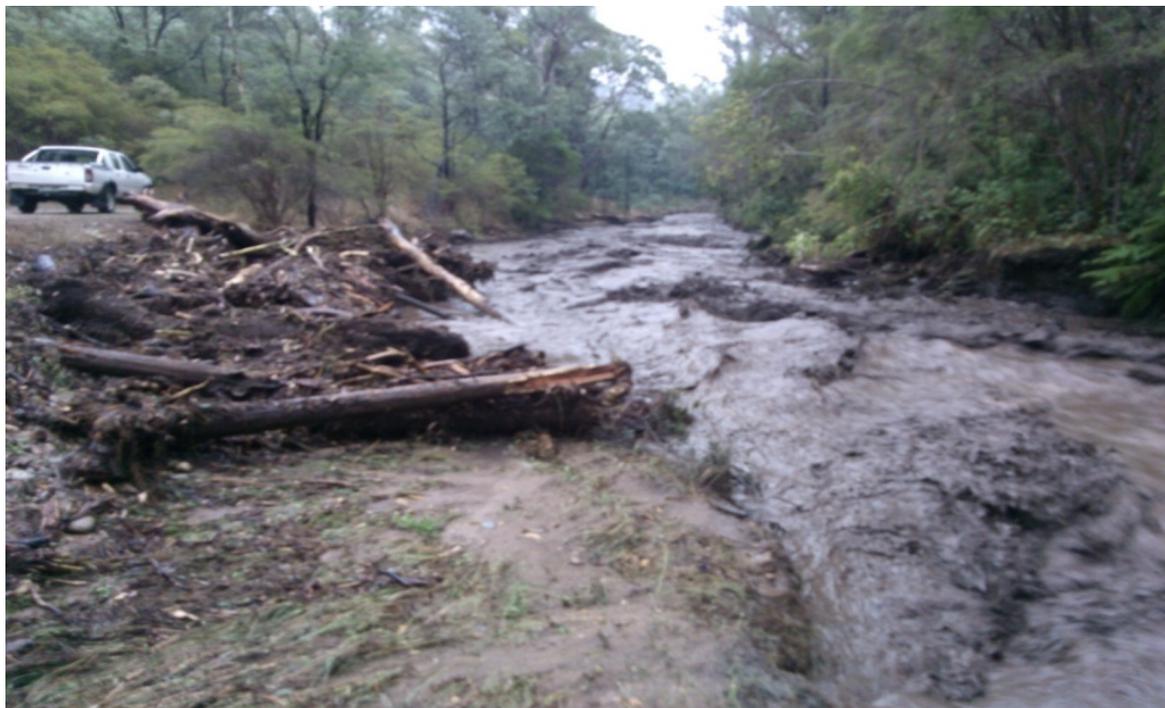
Figure 2: *Harrietville Ovens River Off-take, February 2013*

With the Harrietville water supply unfiltered, impacts from firefighting activity within the catchment were significant due to 16 vehicle crossings per day above our raw water off-take. The typically clean (<1NTU) waters were being disturbed, disrupting our ability to provide safe drinking water. North East Water coordinated within the ICC that vehicles would avoid the section above our off-take from dusk to dawn, allowing us to maintain water quality. Despite this cooperation, the fire took another run at Harrietville triggering dual shifts and full fire response from ground crews and aerial attacks. It was at this point we realised that we could not guarantee safe drinking water. With the Harrietville still under threat, we opted to issue a precautionary Boil Water Notice (BWN) to allow unrestricted supply to the Harrietville consumers. A media release was distributed. This message was also conveyed to the ICC where it was disseminated into daily media releases. This approach proved to be very beneficial to NEW as the messaging remained consistent and the customers that remained in Harrietville were well informed of the precautionary BWN. Staff also undertook a walk through Harrietville informing larger customers such as the school, hotels and accommodation managers of the BWN.
