RESERVOIR INSPECTIONS TO PROTECT AND PRESERVE WATER QUALITY

Jillian Busch

*8th Annual WIOA
NSW Water Industry Operations Conference and Exhibition
PCYC in Orange,
1 to 3 April, 2014*

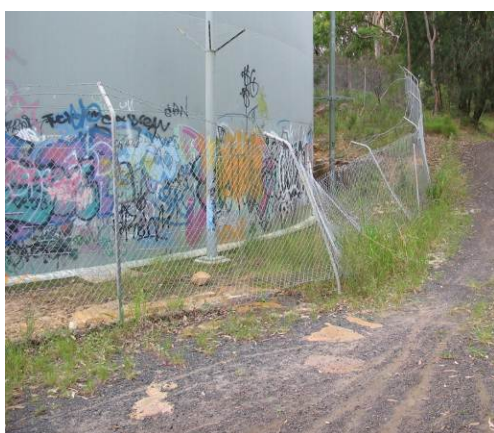
Figure 1: *Security breach evidence*

Walking around the site gives information on compound fence effectiveness for keeping out unauthorised persons (Figure 1&2). Can the security of the site be compromised by the overhanging trees, how far up the tank does the graffiti go, or can the security system on the external ladder be bypassed by determined persons? How many other 'users' have access to the site? This information gauges how much non-controlled activity occurs on site.

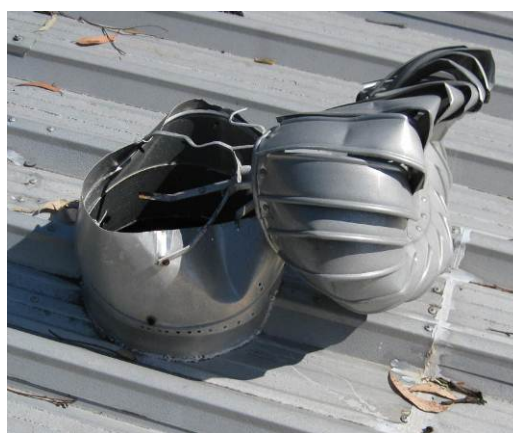
Figure 2: *Vandal activity evidence*

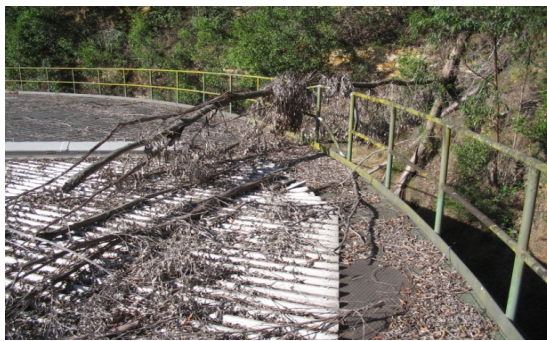
Figure 3: *Overhanging tree hazard*

For the tank, potential contamination issues can be identified without the operator even having to leave the ground. Upper wall features such as inlets and overflows may have ineffective sealing or fixture points. Vent panels with coarse mesh could allow the entry of small birds or vermin, and dust and leaf debris. Overhanging trees can damage roofs, leave significant debris requiring excessive maintenance and provide a path for both vandals and mammals to access the roof area. Significant graffiti on the walls indicates regular unauthorised access to the site and care must be taken to identify and eliminate potential roof access points.

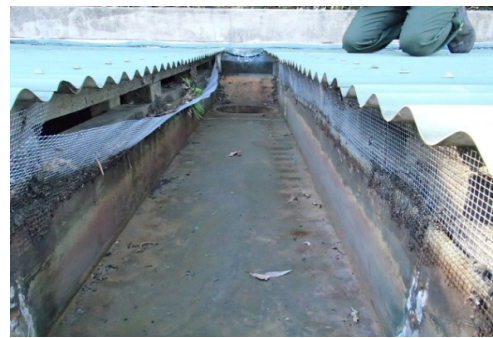
Figure 4: *Vents and gutter defective*

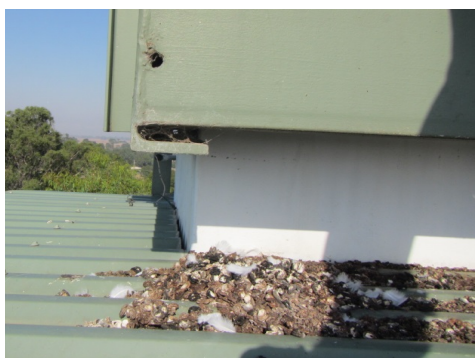
Figure 5: *Faecal debris & unsealed platform*

Other not so obvious contamination points can occur under ridge caps, sheeting joints or where debris accumulates and can be blown back into the tank (Figure 5). Areas that rely on sealant to protect the joint or edges of roof sheeting will need regular maintenance to reseal and freshen up the application area. UV exposure, constant flexing and subtle movement of the joints can create unsealed areas in a few short years (Figure 6).

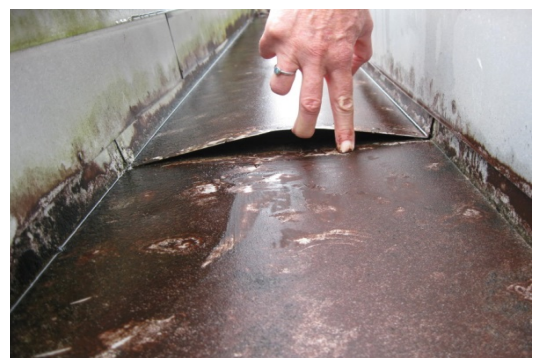
Figure 6: *Unsealed gutter joint*

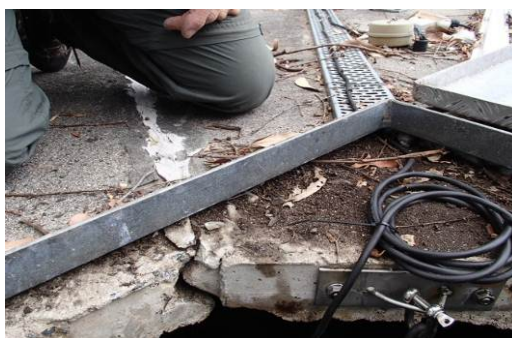
Figure 7: *Entry hatch unsealed*

The entry hatch cover should be securely locked and made with a continuous raised edge to protect against any direct drainage, ponding or debris build up (Figure 7). Hatches have often been compromised by OH&S standards such as ladder stiles protruding through the cover and front edges removed to eliminate trip hazards. These both create water entry points and a significant water quality risk (Figure 8). Entry hatches (or any other roof and platform covers) should be made of strong material that cannot be compromised or forced open by vandal activity on the roof area, and they must be secure against any prevailing wind or storm events.

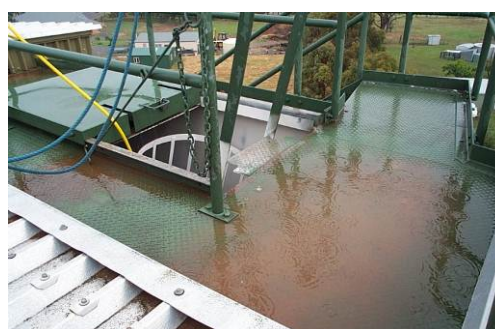
Figure 8: *Ponding & entry hatch unsealed*

When a platform is installed on the top of a roof, water will pond upstream of the platform, when there is limited or no dedicated drainage. Ultimately, the silicon seals will degrade and no longer hold the water out. Similarly, if the platform is underneath the roof and doesn't slope away, then ponded water can flow back into the reservoir. Most platforms have kick plates around the edges and once again OH&S has taken precedence and helped to create ponded areas of debris and contaminated water. Kick rails need to be lifted up higher than normal to allow for effective drainage off the platform and away from the entry hatch area.

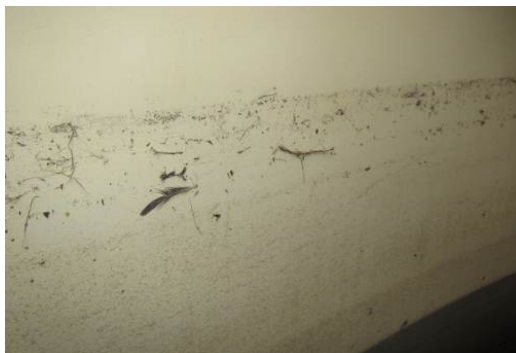
Figure 9: *Bird debris on high water line*

Opening the hatch and looking inside can quickly verify if contamination has been entering the tank. The presence of any floating debris such as dust, feathers, leaf litter or straw material on the surface or around the high water mark (Figure 9&10), can indicate external materials are entering the tank. Other floating debris observed could be from construction materials that have become dislodged (eg. insulating tape or sealing foams).

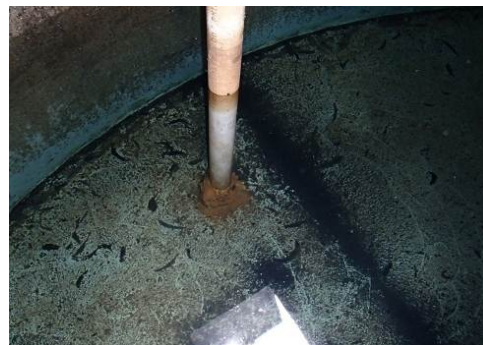
Figure 10: *Roof drainage sediment*

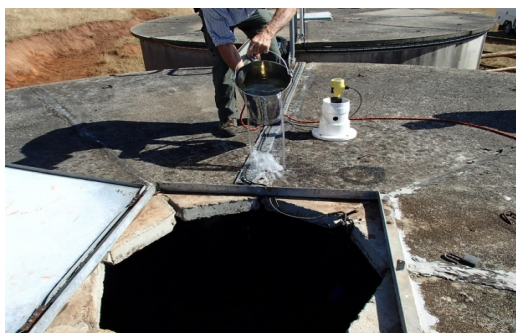
Figure 11: *Bucket of water test*

A bucket of water test is a simple way to confirm drainage entry points. This is easily performed by pouring a bucket of water around the area under suspicion eg. platform or entry hatch, , and observing if water drips back into the tank. (Figure 11&12) The bucket of water test is also recommended after any maintenance works to confirm that there is effective sealing present.
