DEALING WITH ALGAE AND MANGANESE TO IMPROVE THE BACKWASH WATER RETURN PROCESS AT BOOTAWA WATER TREATMENT PLANT

Craig Stone, *Water Treatment Plant Operator,*

MidCoast Water

*9th Annual WIOA
NSW Water Industry Operations Conference and Exhibition
Orange PCYC,
24 to 26 March, 2015*

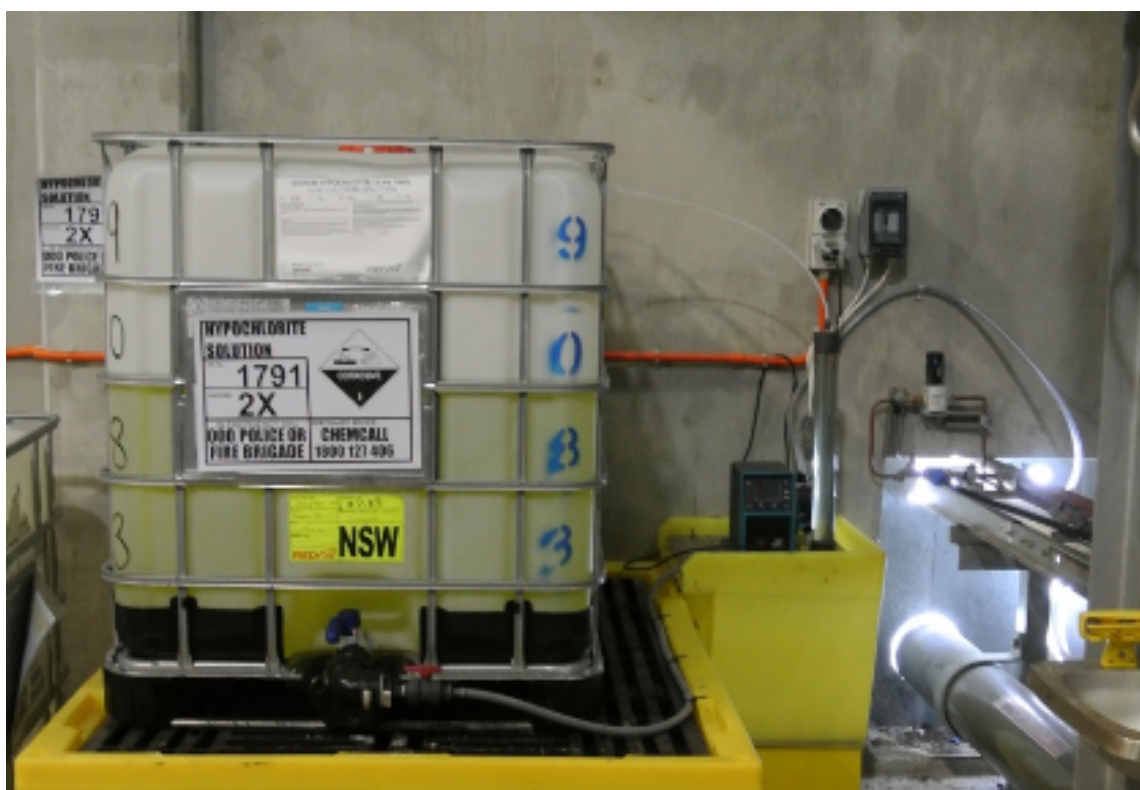
Figure 2: *Chlorine Dosing System*

We then looked at installing a more permanent chlorine dosing system. We only wanted to install one dosing system that could kill algae in both the backwash water tank and the clarifiers. We decided to install it in the membrane building next to the backwash water tank. The dosing system consisted of a 1,000L IBC tank on a bund, a peristaltic pump, calibration tube and a dosing line running into the top of the open backwash water tank. The backwash water would receive a dosage of 5 mg/L of chlorine whilst the plant was running, which would eventually stop any live algae reaching the clarifiers. This did not work as well as expected and better results are being achieved by slug dosing the backwash water tank with hypo whilst the plant is not running and then letting that be pumped up to the clarifiers. The chlorine residual in the backwash water then killed most of the algae in the clarifiers. We now do this routinely every Friday morning. This has helped keep algae numbers to a manageable level in the clarifiers, which improved the supernatant return to less than 1.5 NTU and greatly improves filter run time in our membranes. We have also turned off our clarifier rakes which created less turbulent conditions and improved settling even more. We now only turn the rakes on when we are dewatering the sludge. Figure 2 shows the Bootawa WTP chlorine dosing system.

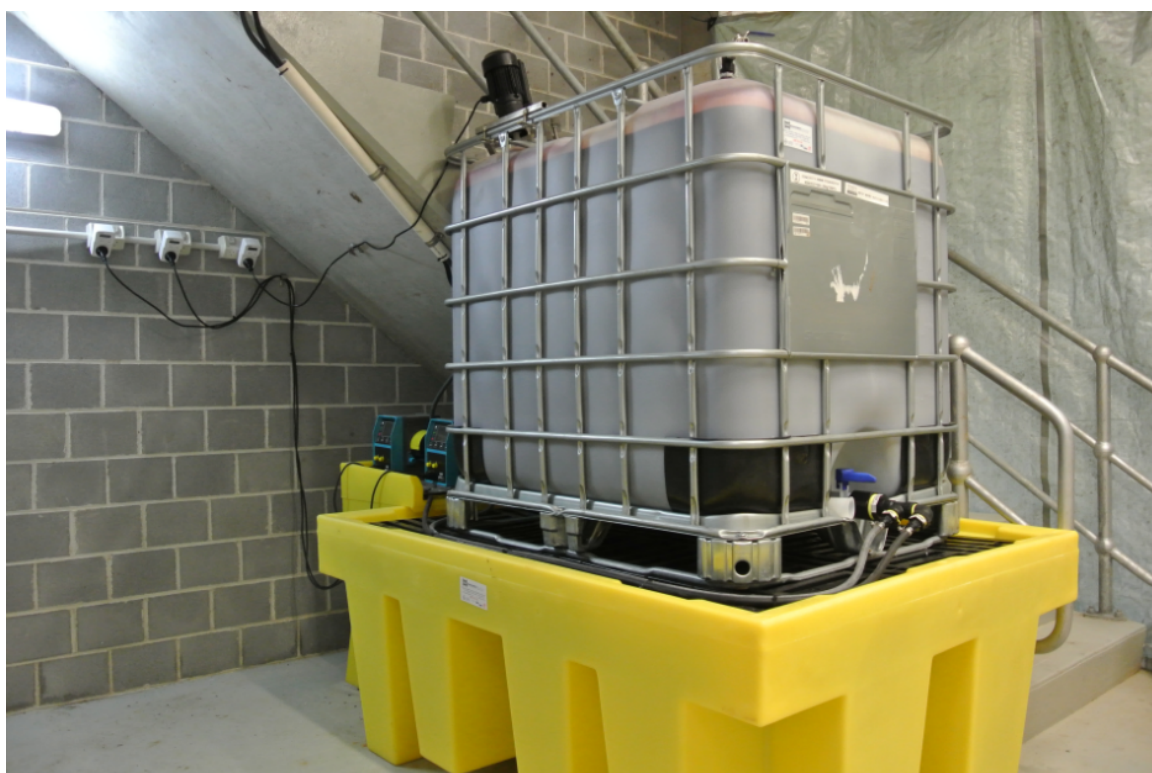
Figure 3: *Potassium Permanganate Dosing System*

We installed a 1,000L IBC with a mixer and two peristaltic pumps to dose the KMnO_4 into the stilling well of each clarifier via separate dosing lines. We batch a 5% solution in the tank by adding two 25kg buckets of dry chemical to 1,000L water. We are currently dosing 0.5mg/L of this into each clarifier with the aim of slowly increasing the dosage until maximum oxidation of Mn is achieved. Table 2 shows Manganese levels before and after KMnO_4 dosage to clarifiers. This dosing system has been successful in reducing the amount of manganese re-entering the membrane tanks. The Bootawa WTP potassium permanganate dosing system is presented in Figure 3.

Jar tests were carried out to determine if we could use the strong oxidant, potassium permanganate (KMnO_4) to oxidise the manganese (Mn) in the backwash water as it enters the clarifiers. Our chemist confirmed that 1.92mg/L of KMnO_4 would oxidise 1 mg/L of Mn ion, and would work best at a pH >7.5.
