KNOW YOUR SEWER - CORROSION PROTECTION OF SEWER ASSETS

Nitin Apté, *Business Manager Spray Slurry,*

Calix Limited

*40th Annual WIOA
Queensland Water Industry Operations Conference and Exhibition
Clive Berghofer Recreation Centre,
University of Southern Queensland, Toowoomba
16 to 18 June, 2015*

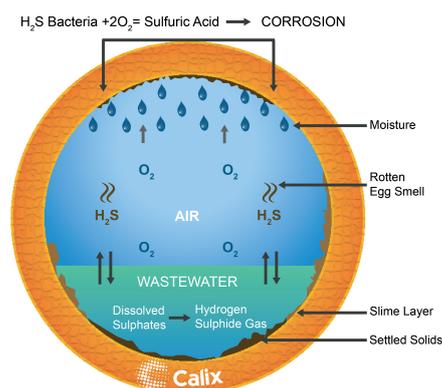
Concrete sewer assets and asbestos lined assets are highly prone to corrosion due to acid attack. The corrosion phenomena in concrete sewer assets is a 2 stage process. The sulphur reducing bacteria present in the slime layer of the asset reduce the sulphate (SO_3) in the waste water to sulphide ions, as S^- or HS^- (Hydrogen Sulphide). At low pH, the HS^- is volatilized to the gas phase to form H_2S , hydrogen sulphide gas. This gas generated in the sewers is the cause of the rotten egg smell. Thiobasillus Bacteria, also known as Sulphur Oxidising Bacteria (SOB) reside on the crown of sewer lines, and above the water level in sewer assets. The SOBs, with the help of moisture, convert this gas to Sulphuric acid (H_2SO_4), as shown in Figure 1.

Figure 1: Mechanism of H_2SO_4 Production in Sewers

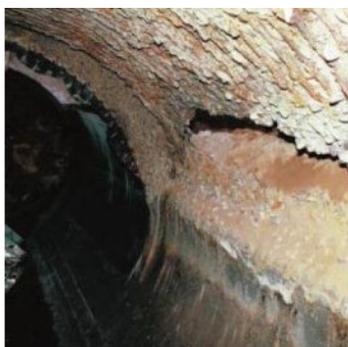
Figure 2: *Sewer Line Corroded by Acid Attack*
Source: Corrosion & Odour in sewerage systems – Engineers Australia Nov 2009

Stricter pollution laws have stopped dumping of industrial waste and poisons in the sewer system. In the past these wastes would counter the sulphur in the sewage keeping the H₂S and thus acid levels low. In addition our eating habits have changed over the last 2-3 decades with the food containing more sulphur. Also the detergents contain more sulphur. The combined impact of these changes in the material entering the sewer system, has been a ten-fold increase in the corrosion rate of sewer assets. Sewer assets originally designed to last 100+ years now corrode away in less than 50 years. Figures 2 and 3 below depict a corroded sewer line and maintenance hole respectively.

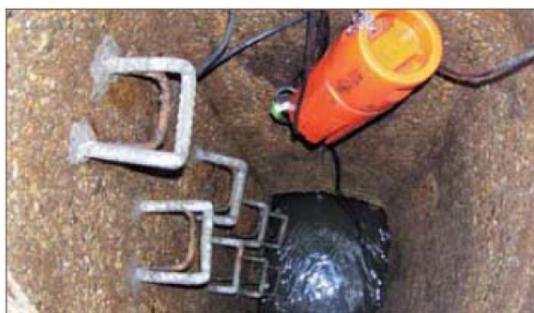
Figure 3: *Corroded Maintenance Hole*
Source - Corrosion Protection of Sydney Water's Sewer Assets Using Sulfalock HiIGEL™ –Barclay S Sydney Water Corporation

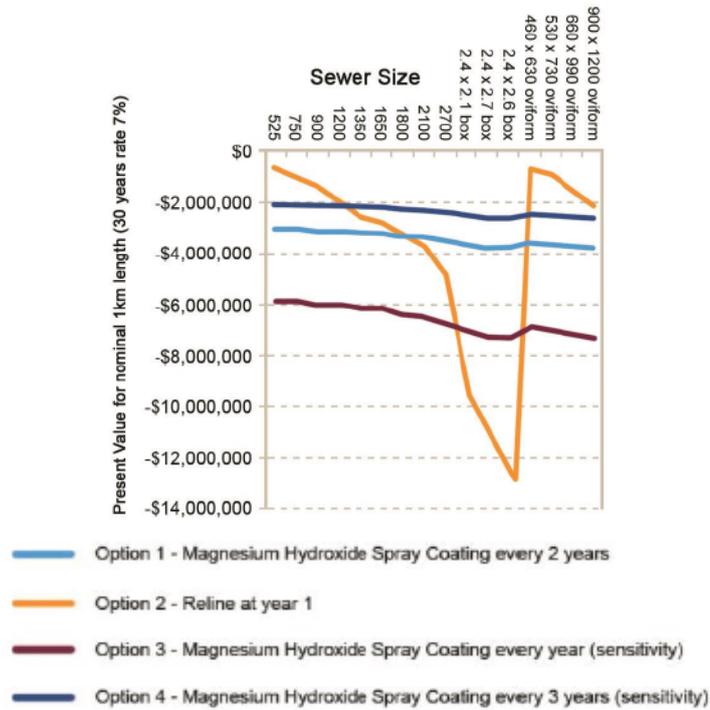
Figure 4: *Cost Comparison MHL Costing v/s Plastic Lining*
 Source - *Corrosion Protection of Sydney Water’s Sewer Assets Using Sulfalock HiGEL™* –Barclay S, Sydney Water Corporation

The remediation problem is enormous and is not limited to sewer pipes but also wet wells, manholes, manhole covers, inlet works to STPs etc (fig 10). There are limited options available today for corrosion protection. Currently the technology that is most frequently used is plastic relining. For larger diameter sewers, wet wells and manholes, the spray technology is 7 times cheaper over the life time of the asset compared to plastic relining, even if the coating has to be carried out every 3-4 yrs. Fig 4 below shows the cost comparison between MHL spray technology and Plastic lining. Above 1000mm diameter, MHL spraying becomes more cost effective.

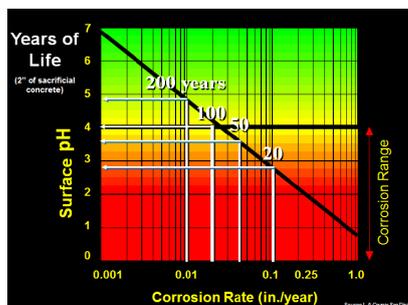
Figure 7: *Relation of Wall pH with Corrosion Rate and Life of Asset*
Source - Thioguard® TST and LA County San District USA

Figure 7 shows the direct correlation between the wall pH and the asset wall corrosion in inches/year. It also predicts the service life of an asset based on wall pH. Measuring the pH of the asset wall, can be an indicator of the state of the asset. Typically assets that are being corroded and have a large and effective SOB colony, will have a wall pH around 2 to 3. In these cases it can be safely assumed that the asset is losing its concrete layer due to acid attack at a rate of around 2.5-3.5 mm/year (0.1 to 0.2 inches/year). A low wall pH is the “Smoking Gun” indicating that immediate action is needed on the asset. Instead of waiting for the asset to further deteriorate, it is prudent to coat it with MHL and extend it’s life.

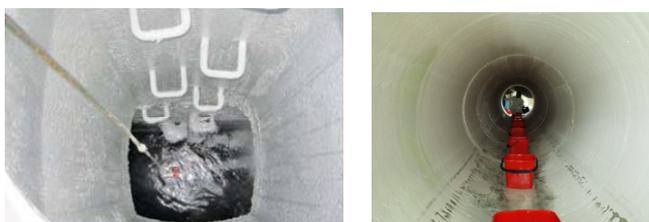
Figure 9: *Coated Man Hole*

Figure 10: *MHL Coated Sewer Pipe*

This technology can be easily implemented for assets like large sewer pipes, manholes, wet wells and parts of STPs. The asset is cleaned with a high pressure water jet and then MHL is sprayed using a gear or a air less pump. Coating thickness of 1.2mm can be achieved easily. The MHL itself is very safe to use and any overspray into the sewer itself actually helps reduce odour and the formation of H₂S. This is the best preventative maintenance technology available today and very cost effective.

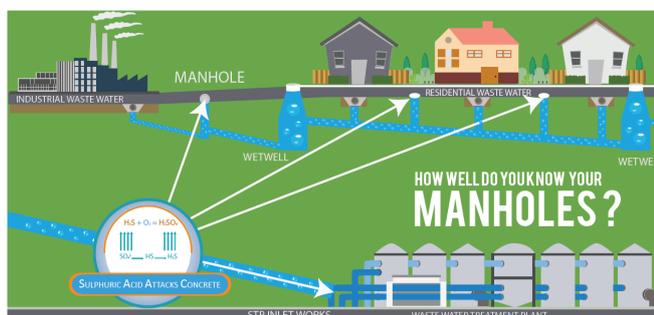
Figure 11 belows shows the of concrete sewer assets that can experience corrosion due to acid attack.

Figure 11: *Sewer Assets where Corrosion can Occur*
