BLOOMING BLUE-GREEN ALGAE – ARE YOU READY?

*79th Annual WIOA Victorian Water Industry Operations
Conference and Exhibition
Bendigo Exhibition Centre
31 August to 1 September, 2016*

Houa Tia, *Acting Team Leader, Water Program, Department of Health and Human Services*

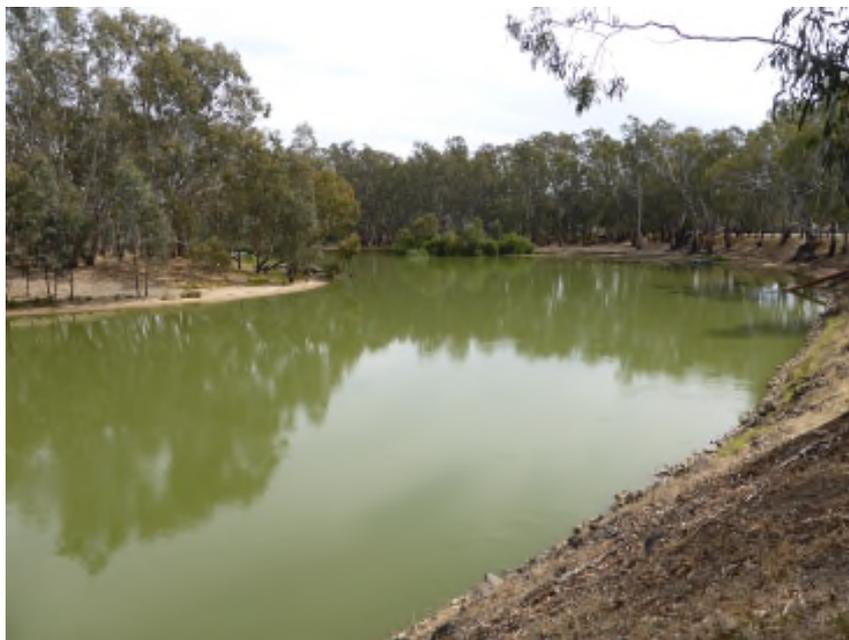
Figure 1: *Image of the Murray River at Barmah in March 2016 showing visible green colouring of the water due to elevated levels of BGA*
